APPENDIX E. STRUCTURAL DOCUMENTS

**Bellevue Toll Bridge
East Mission Avenue over the Missouri River
Bellevue, Nebraska**

**Structure No. S370 01918
Fracture Critical and Routine NBIS Bridge Inspection
April 2017**

Prepared for:
Bellevue Bridge Commission

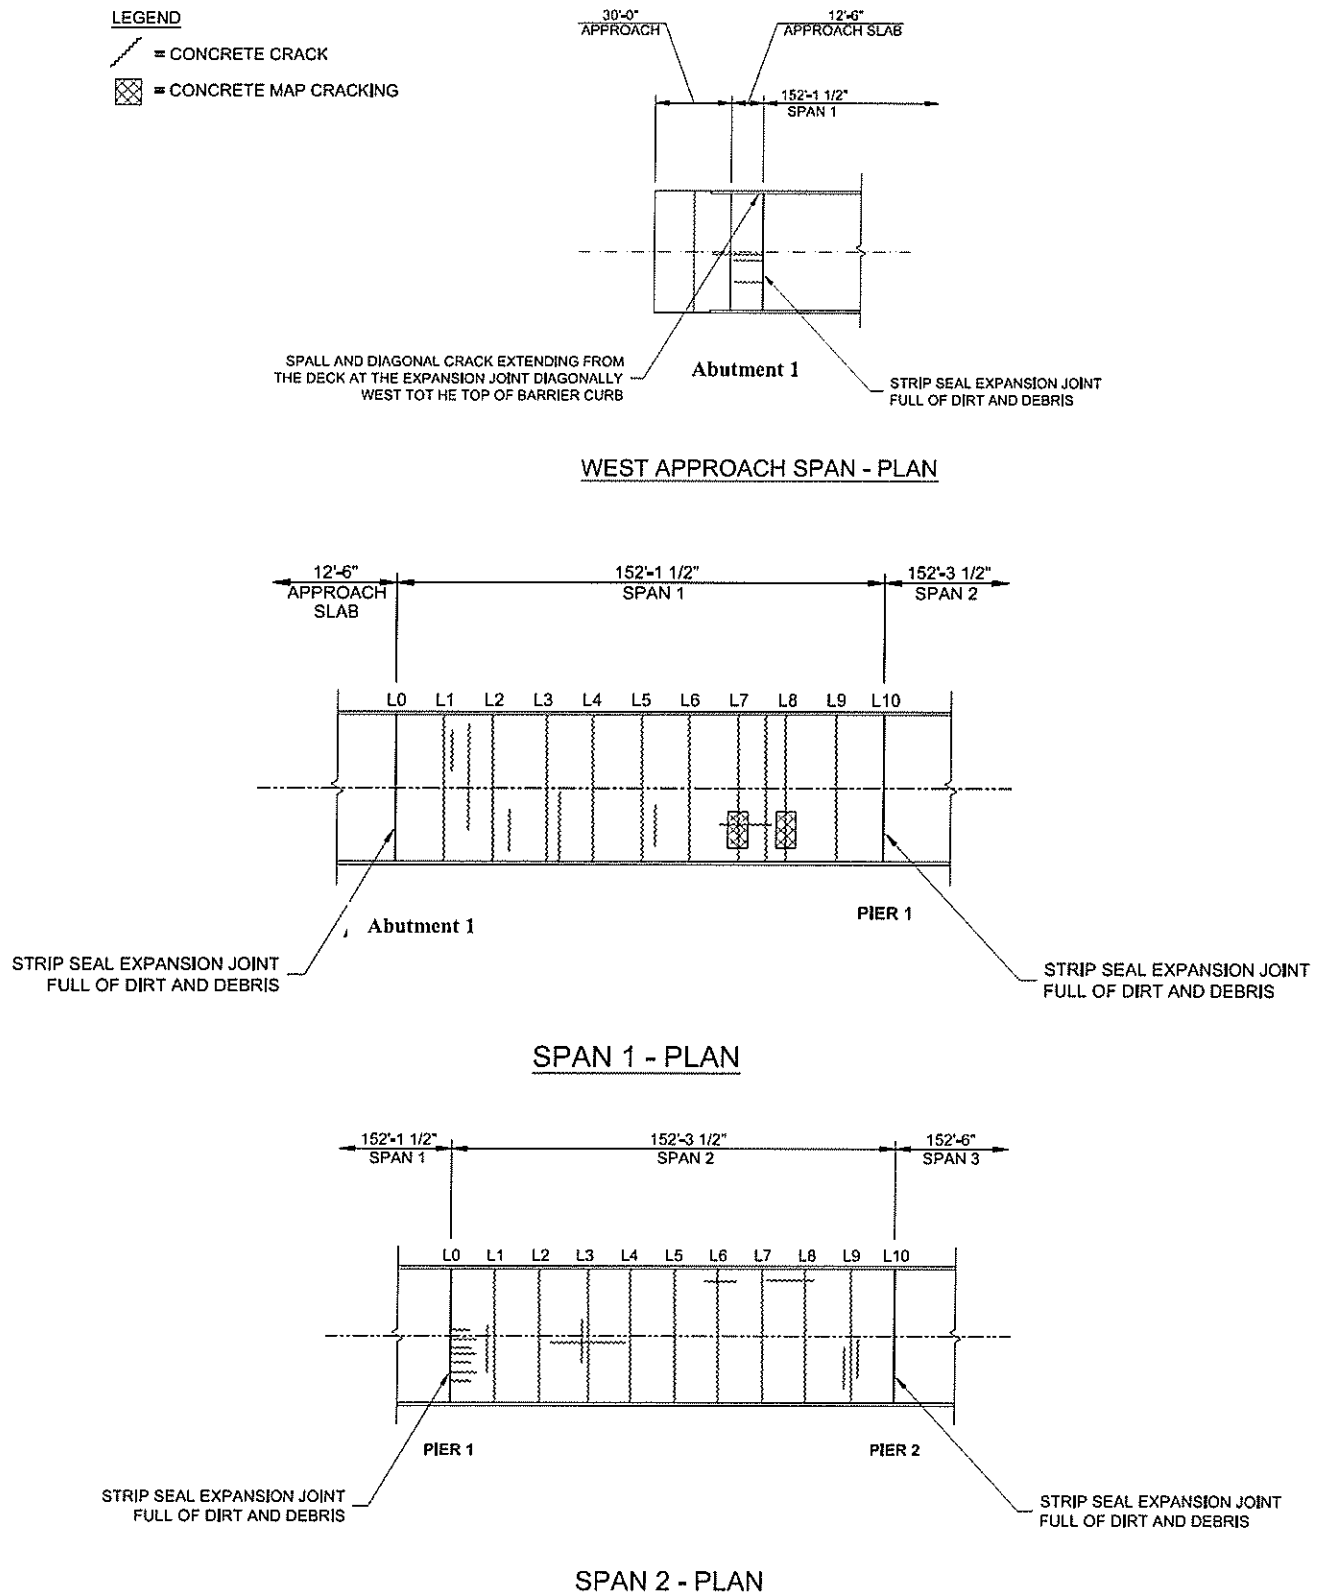
Figure 7: Plan of Deck Defects – West Approach to Span 2

The area within 2' of each curb is showing light scaling, 1/16" to 1/8". There are several small aggregate popouts, 1/4" to 1", (Photo 5) and other snow plow markings (Photo 6) scattered throughout the deck surface. Where the deck is continuous over a floorbeam there is transverse cracking (Photo 7). Other areas of heavier map cracking, higher concentration of transverse cracking over the floorbeams, and areas of wear are identified in deck deficiency drawings in Figures 7 through 10 on the following pages – note there are no changes in the drawing from the last inspection.

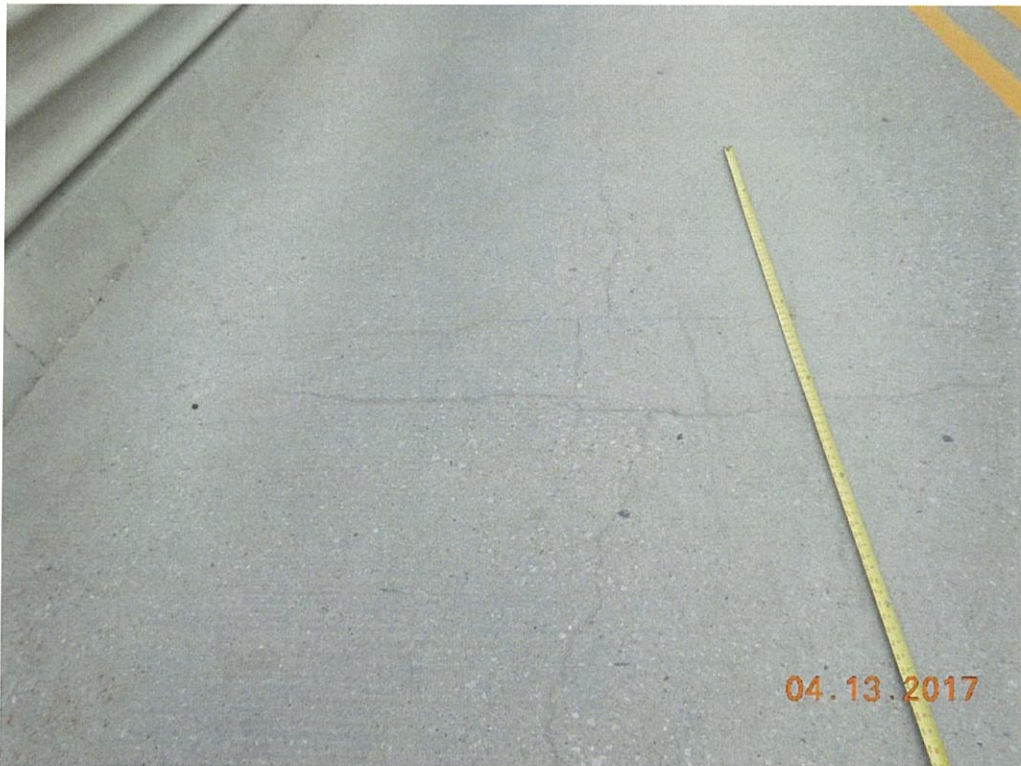
Photo 7: Where the deck is continuous over a floorbeam there is transverse cracking.

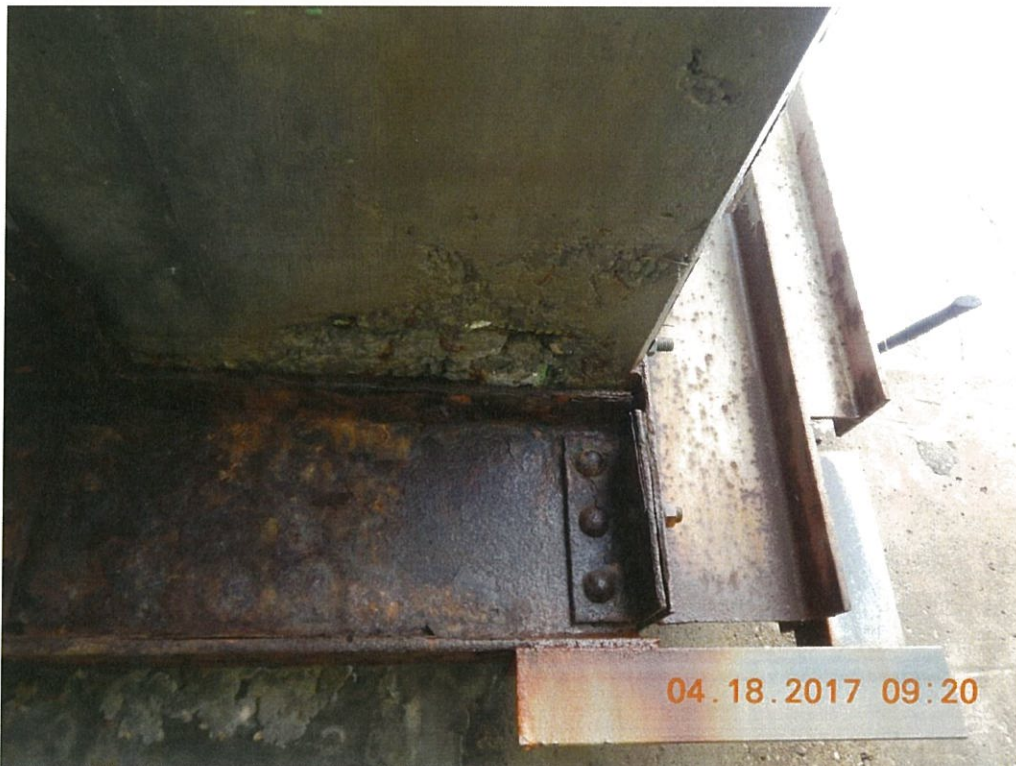
Poor consolidation of the concrete during construction has left exposed rebar at the bottom of the deck overhang at both corners of the East Abutment (Photo 8). Most of the epoxy coating remains on the exposed bars with some rust showing where there is no epoxy remaining. Transverse cracking with efflorescence are present randomly throughout the overhangs of Spans 9 through 11 (Photo 9). A few seam locations of the stay-in-place decking in Spans 9 through 11 are showing rust (Photo 10). The deck forms blew out during construction at Span 2 U5 Rt.

Photo 8: Poor consolidation of the concrete during construction has left exposed rebar at the bottom of the deck overhang at both corners of the East Abutment. South corner shown.

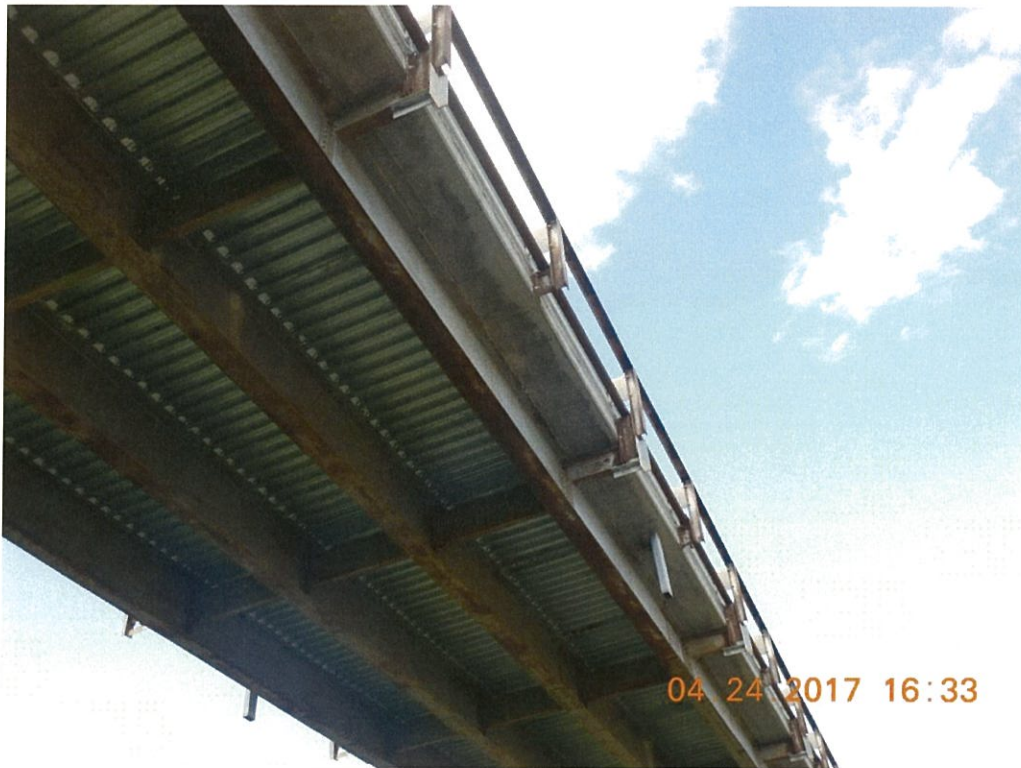
Photo 9: Transverse cracking with efflorescence is present randomly throughout the overhangs of Spans 9 through 11. South overhang of Span 9 shown.

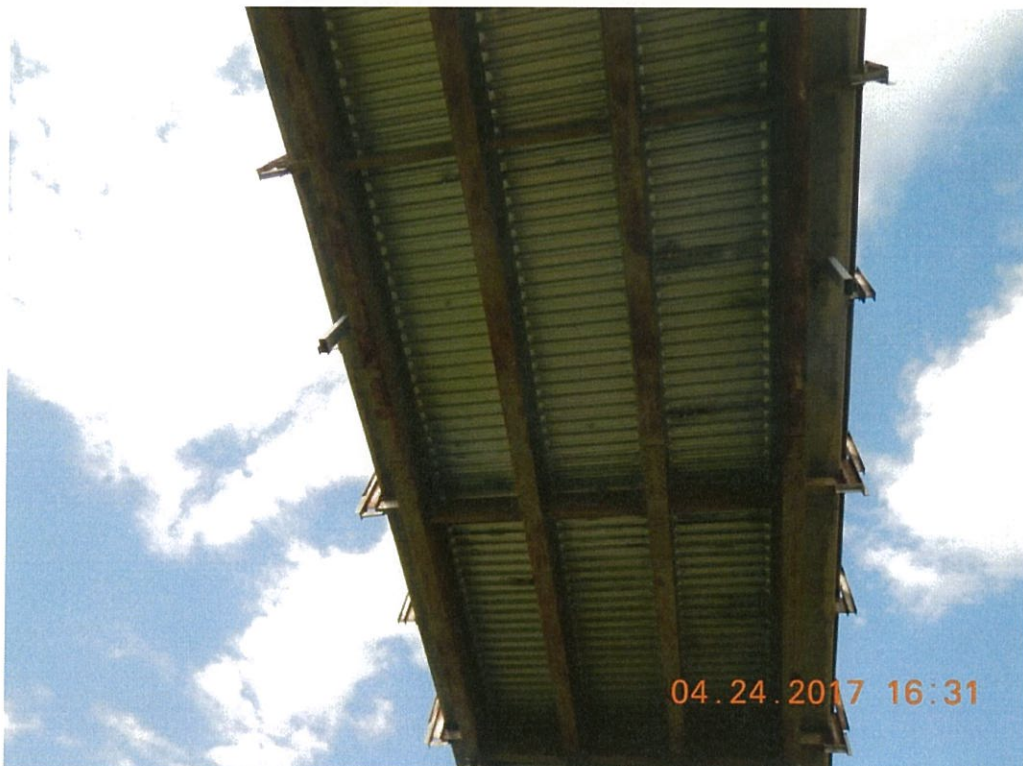
Photo 10: A few seam locations of the stay-in-place decking in Spans 9 through 11 are showing rust. Span 9 shown.

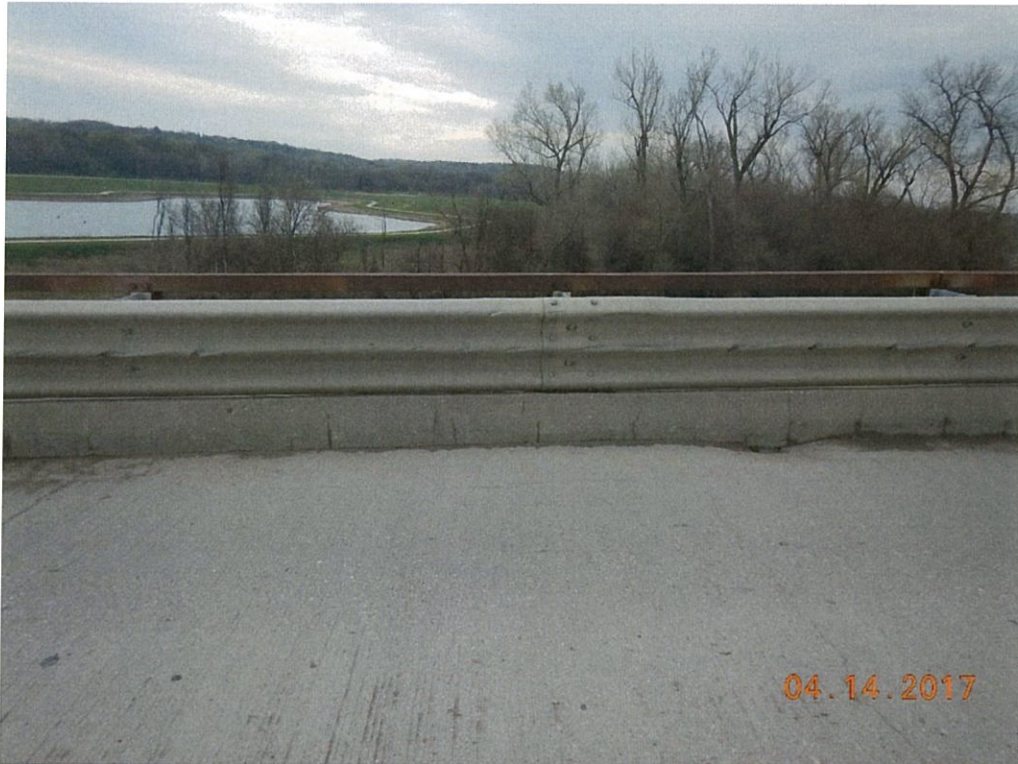
The curbs have hairline vertical cracking with spacing of 2' to 4' throughout their entire length (Photo 11). The north curb at the Abutment 1 has a spall and diagonal crack that extends from the deck at the expansion joint diagonally west to the top of barrier curb. The north curb at Pier 5 has a diagonal crack.

Photo 11: The curbs have hairline vertical cracking with spacing of 2' to 4' throughout their entire length. Minor impact damage is present along both rails with several jagged tears.

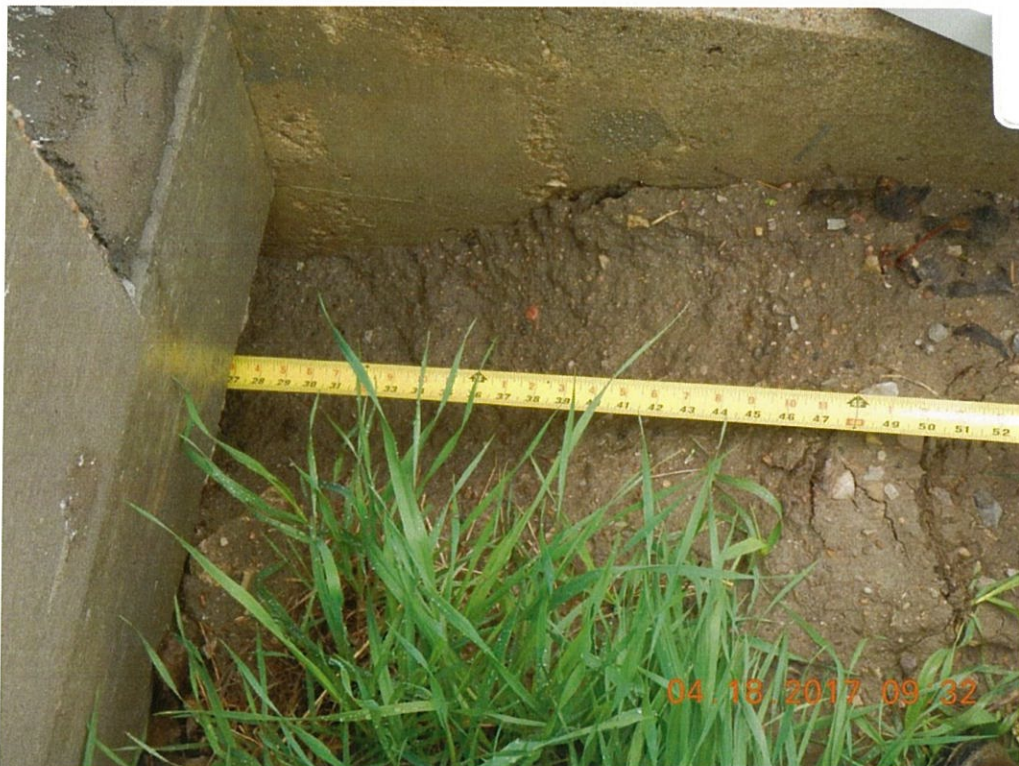
Both concrete approach slabs have transverse cracks and hairline longitudinal cracks; some of the cracks have previously been sealed. The east approach slab is undermined adjacent to the north barrier wall in two spots. At the abutment the penetration is approximately 6" tall by 4' wide x 3' below the slab (Photo 12). At the end of the slab where the ditch is eroding the penetration is approximately 6" tall by 2' wide by 2' below the slab (Photo 13). There is minor undermining along the south edge of the slab at the abutment. The undermining is causing some distress on the surrounding slab evident by diagonal cracking.

Photo 12: The east approach slab is undermined adjacent to the north barrier wall in two spots. Shown is at the abutment the penetration is approximately 6" tall by 4' wide x 3' below the slab.

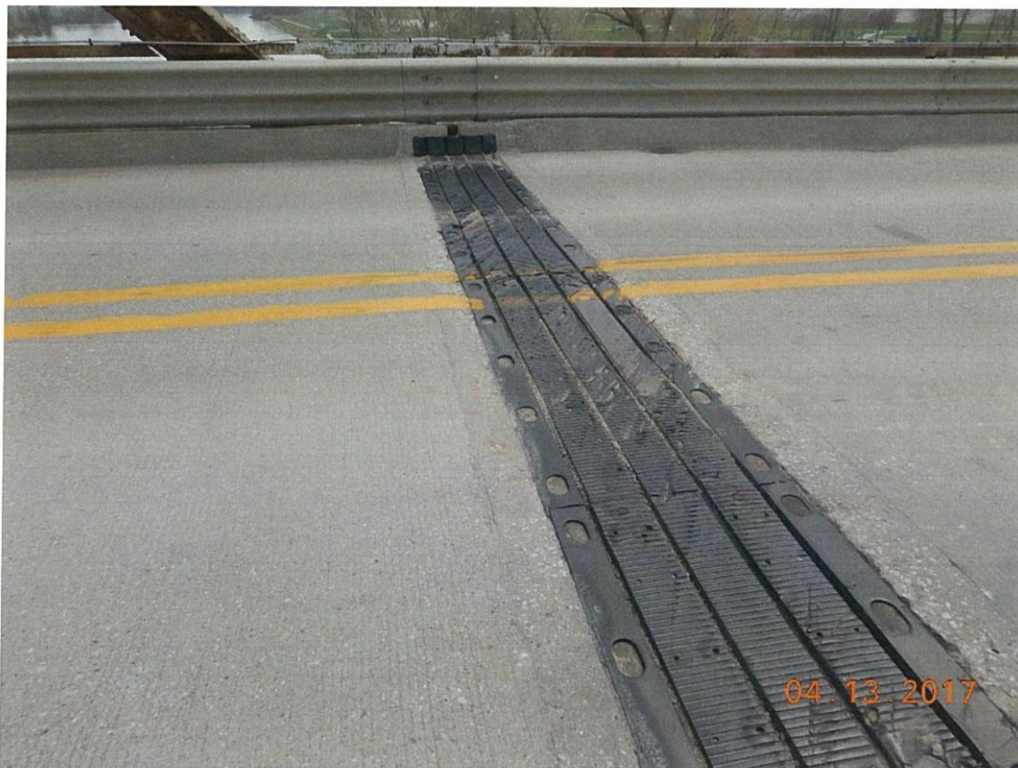
Photo 16: Both of the transflex joints have plow damage consisting of surface damage of the molded rubber and minor spalling of the adjacent concrete.

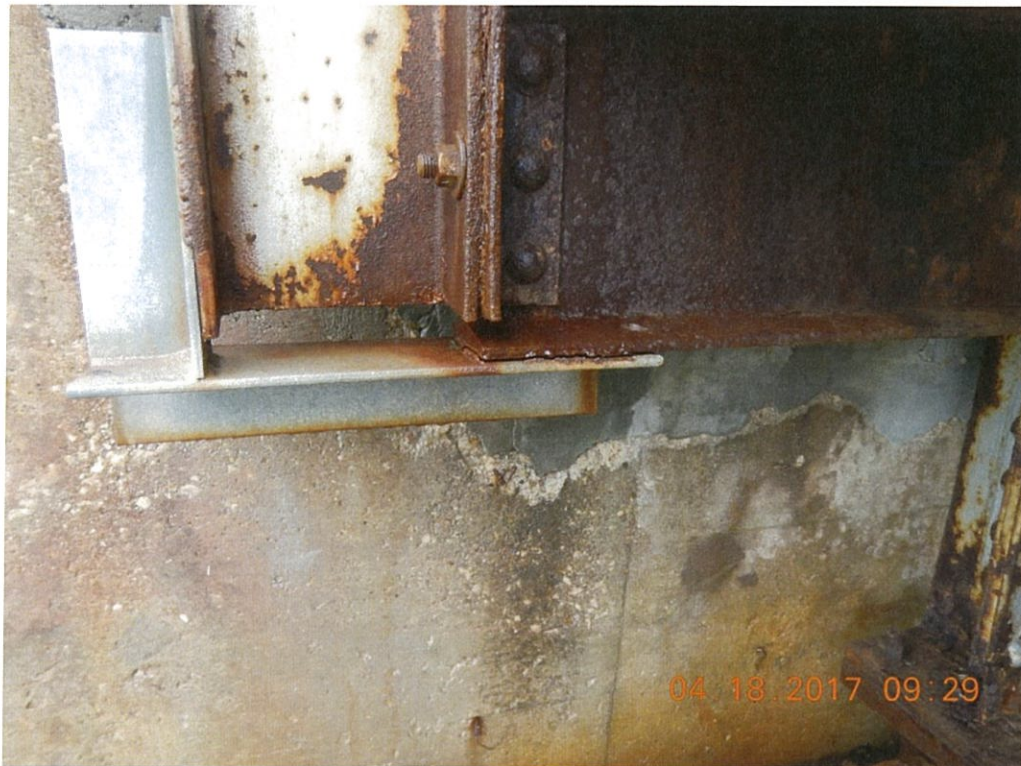
Photo 17: The bottom connection weld of the northeast rail at Abutment 2 is cracked at the beam; the rails are bolted into the deck and connected to the beam with bolts and angles.

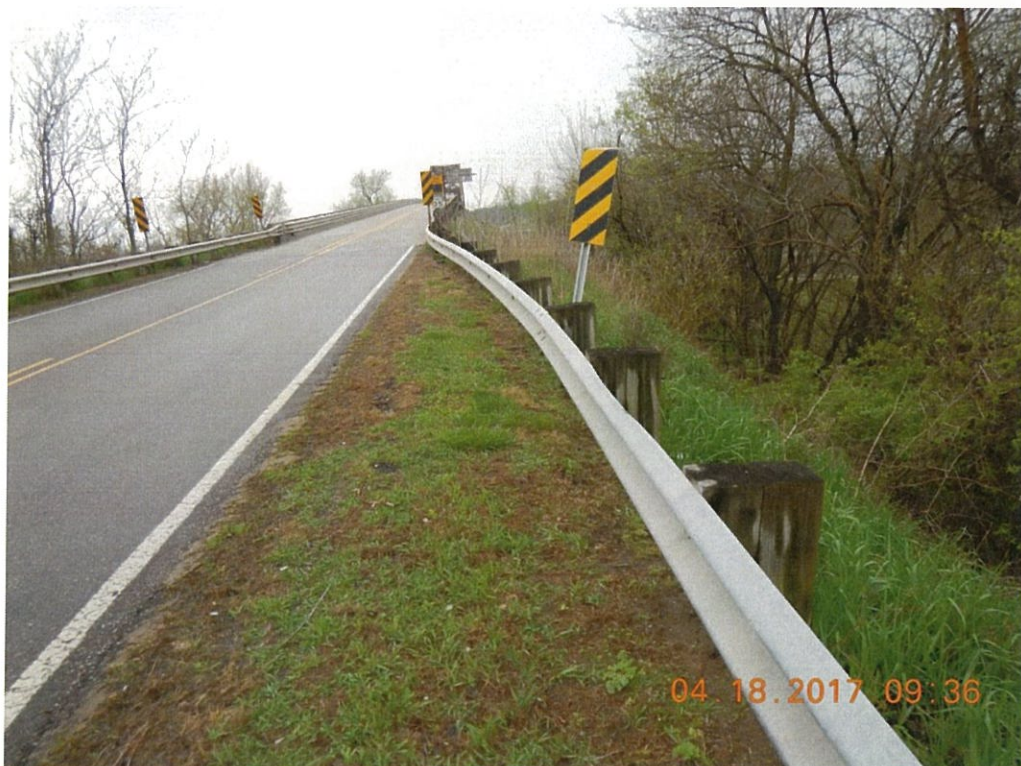
Photo 18: The northeast approach rail center has minor impact damage. One of the northeast delineators has minor misalignment and deformation.

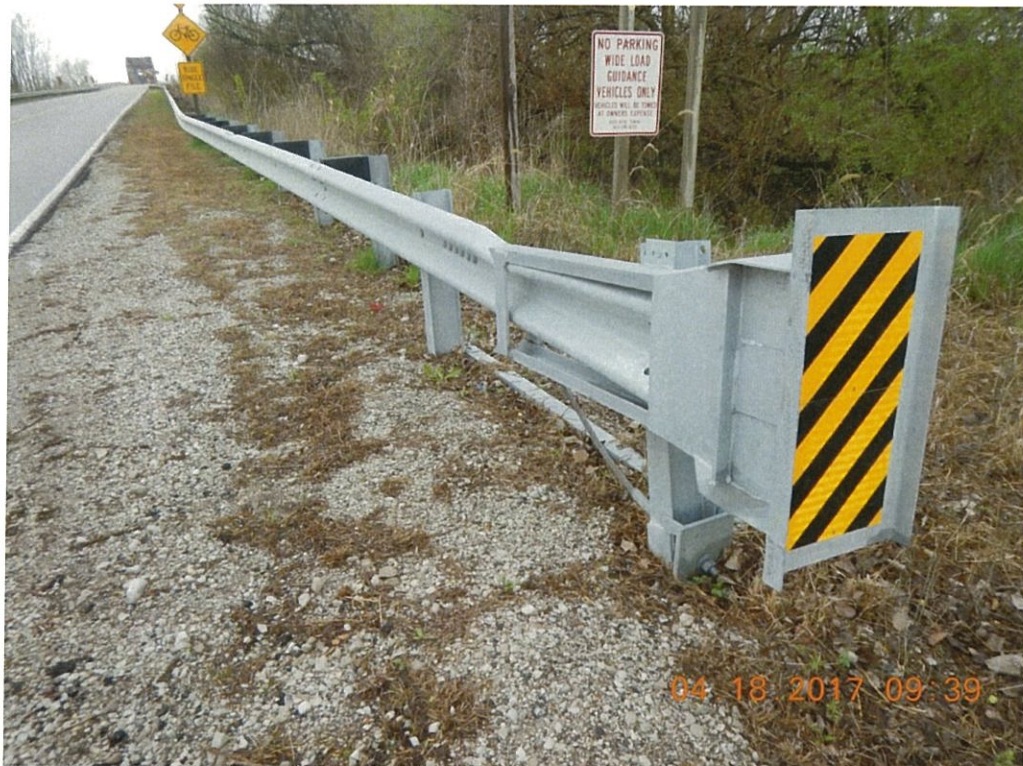
Photo 19: The northeast approach end terminal has minor impact damage.

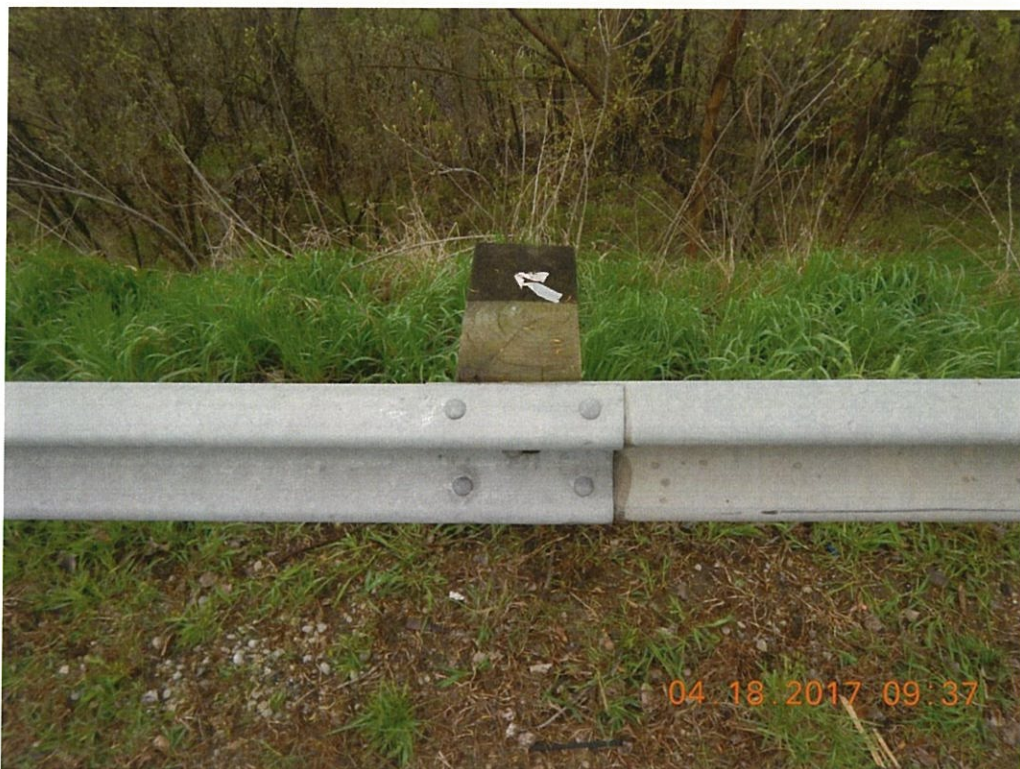
Photo 20: There are locations of improper rail splice lapping in both east approach rails.

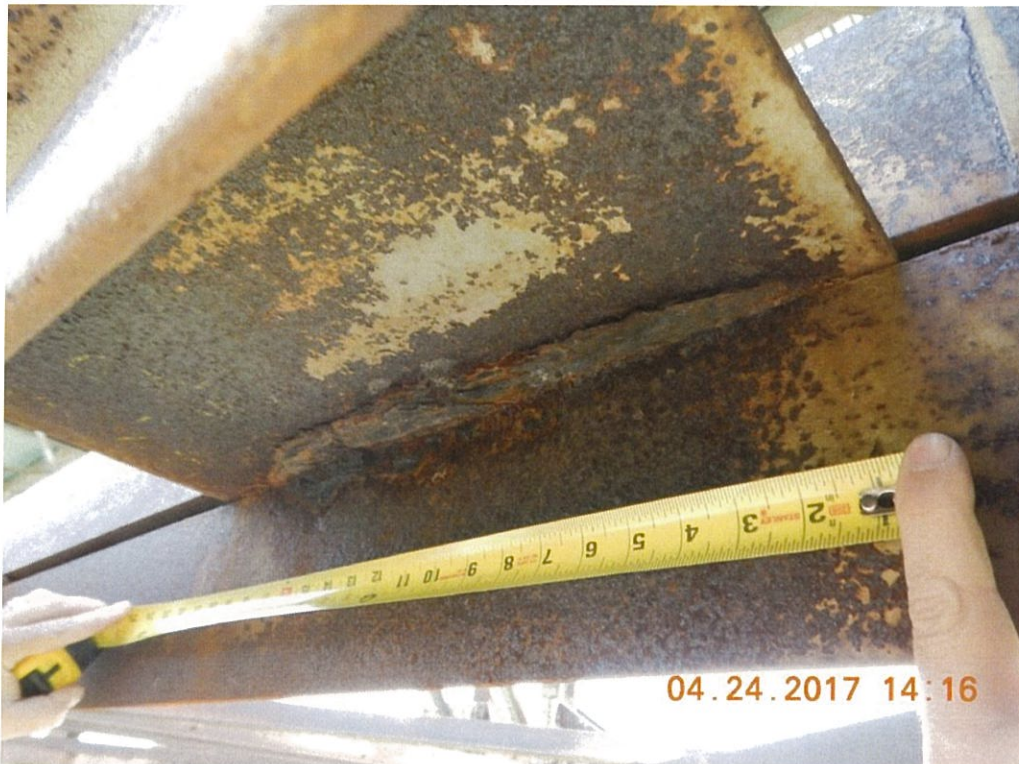
Photo 21: The section loss at the batten plates of the deck truss lower chords is typically on the inside of the lower chord angle above and below the batten plate. Span 7 L0L10 Lt. shown.

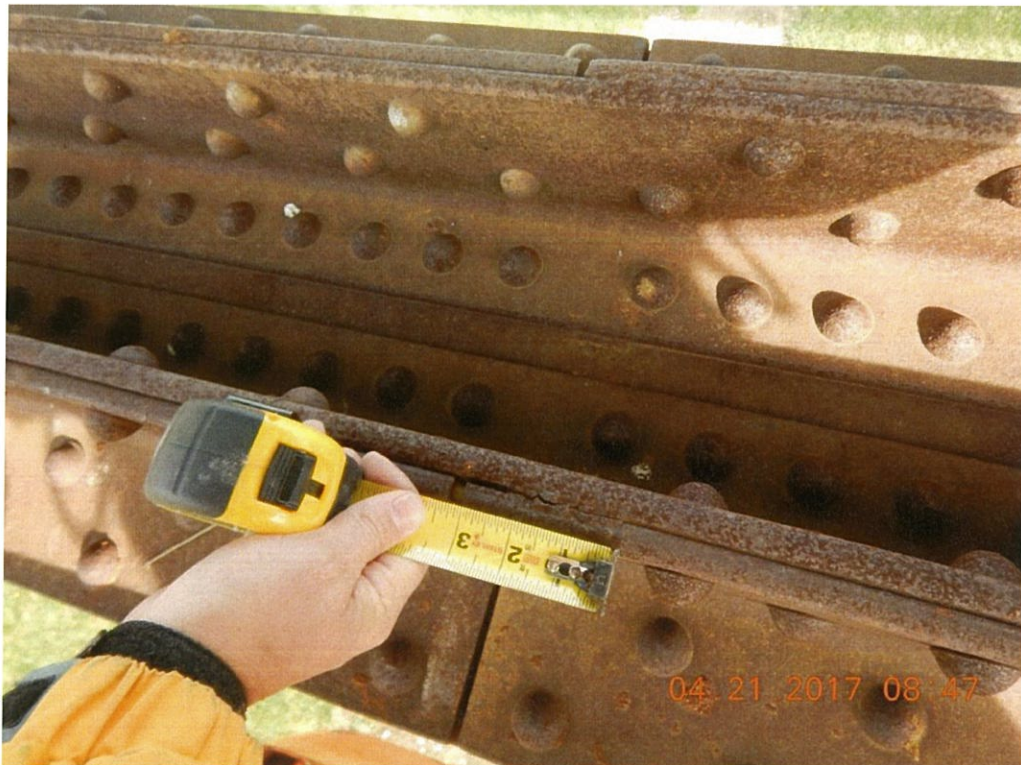
Photo 52: The riveted splice connections in the deck truss lower chords have tack welds placed during construction. Cracks found through welds at some locations. Span 2 L3L4 Rt. shown.

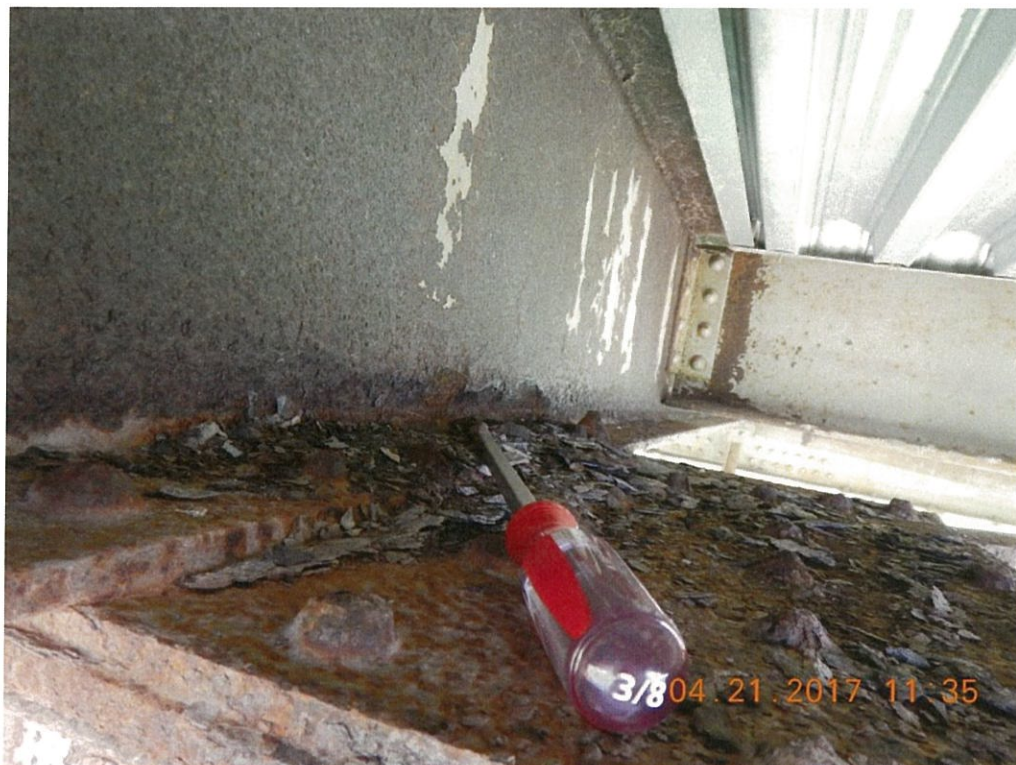
Photo 53: The deck truss floorbeams have minor surface rust throughout; heavier rust typically at the floorbeam ends overhanging the truss. Span 1 Floorbeam 2 Rt. shown.

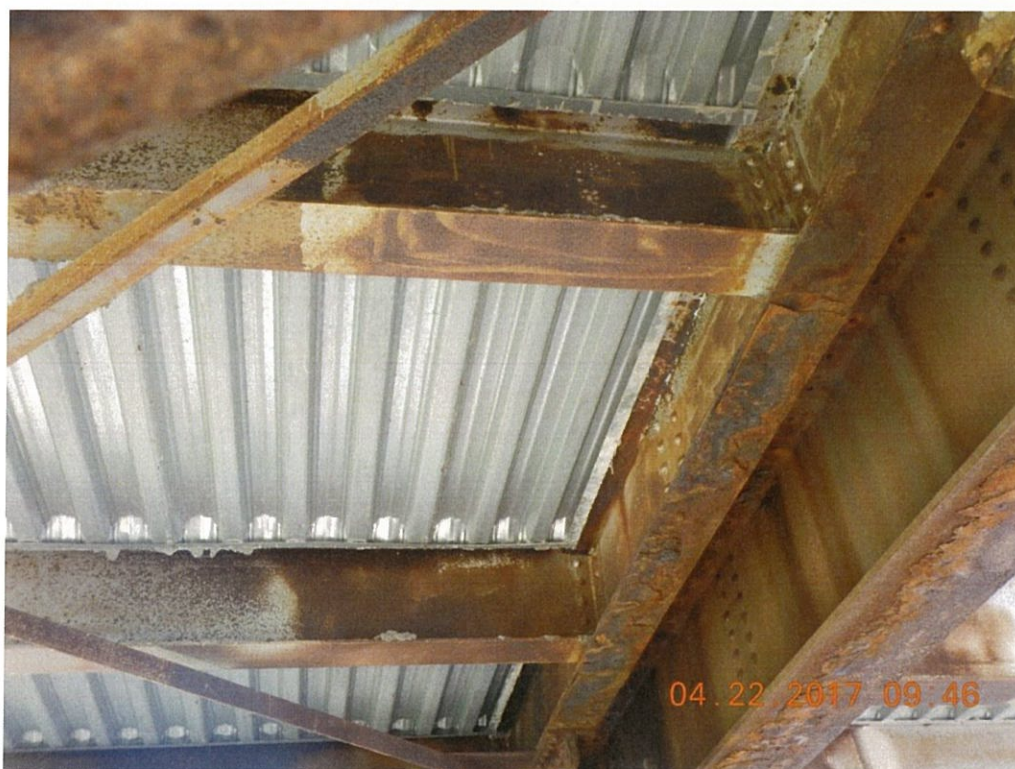
Photo 54: There are areas of delamination in the deck truss floorbeam faces below the deck joints. Span 4 Floorbeam 10 shown.

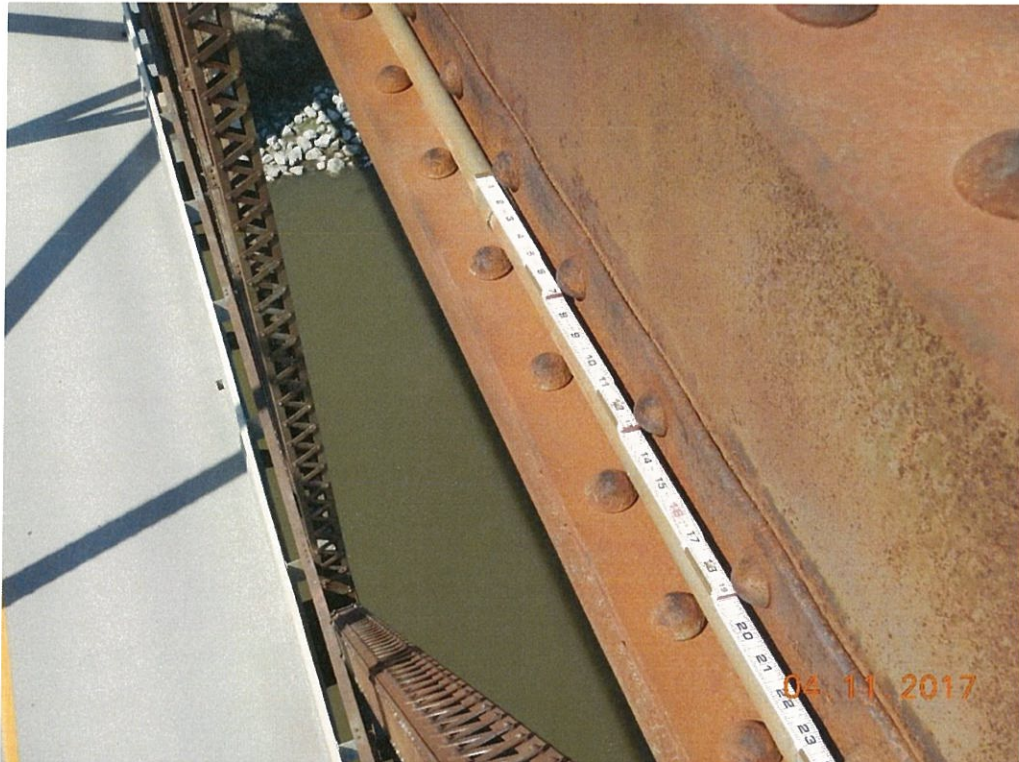
Photo 71: Minor, isolated areas of pack rust are present along the upper chord of the thru truss spans.

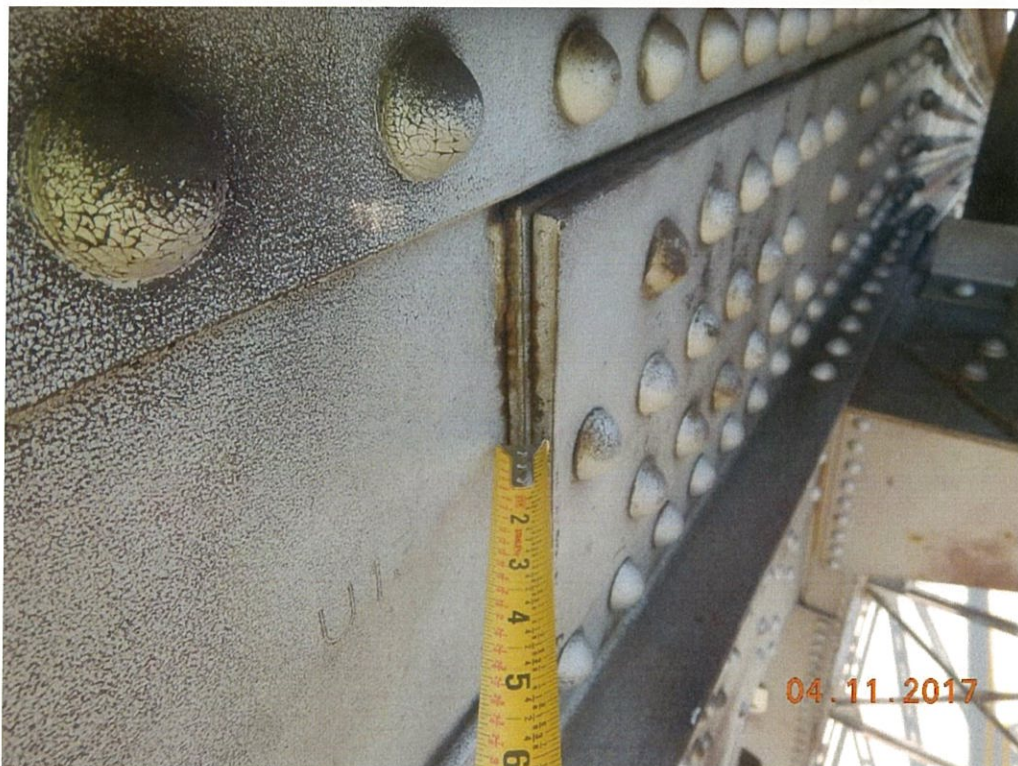
Photo 72: One thru truss upper chord tack weld was found with a crack through the weld with no sign of propagation into the base metal. The cracked tack weld is located at the north splice plate of Span 6 U13' Rt.

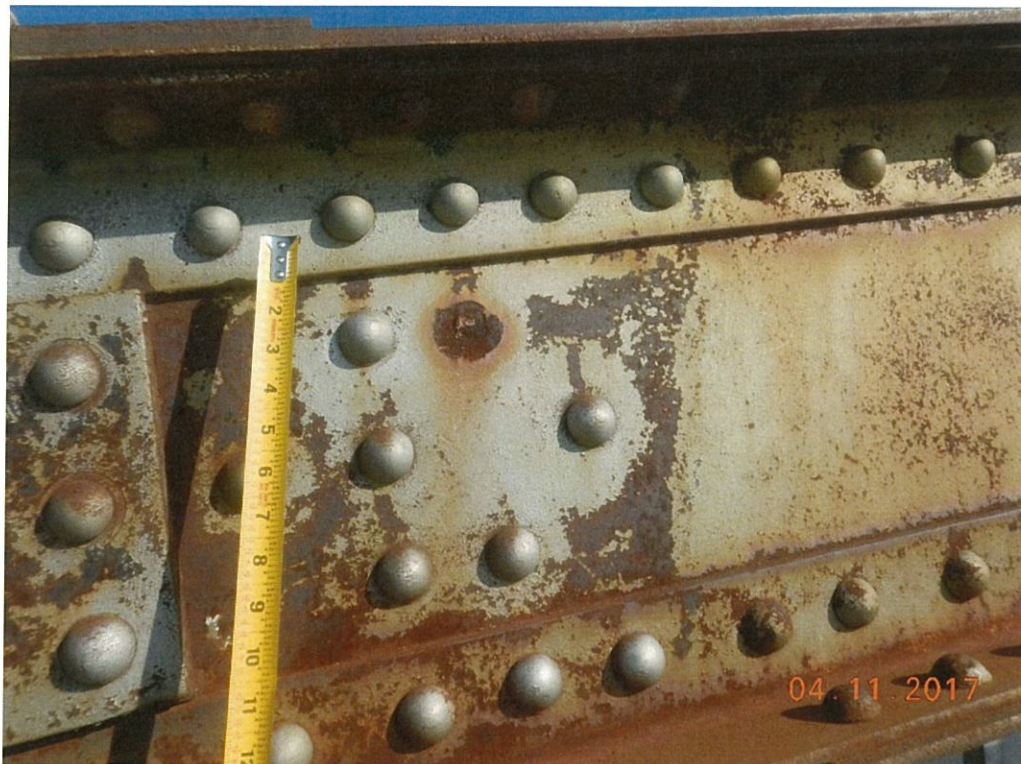
Photo 73: One rivet head is missing on the exterior face at Span 5 U1 Rt.

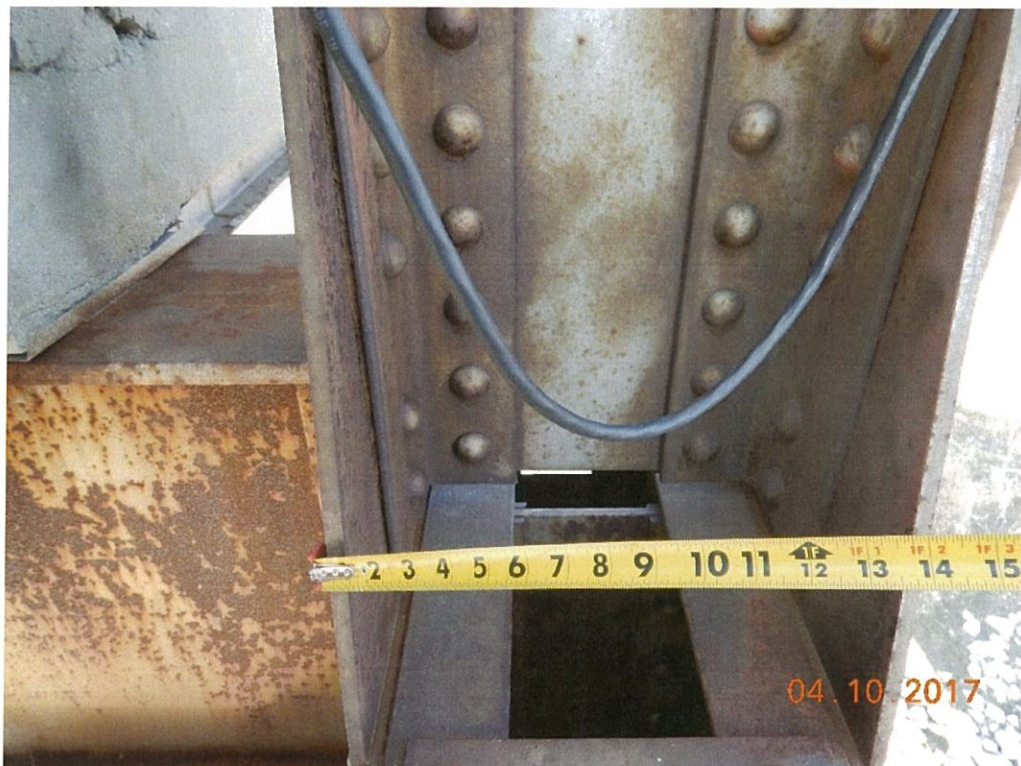
Photo 74: Packrust is present at most lower gusset plate connections of the thru truss spans.

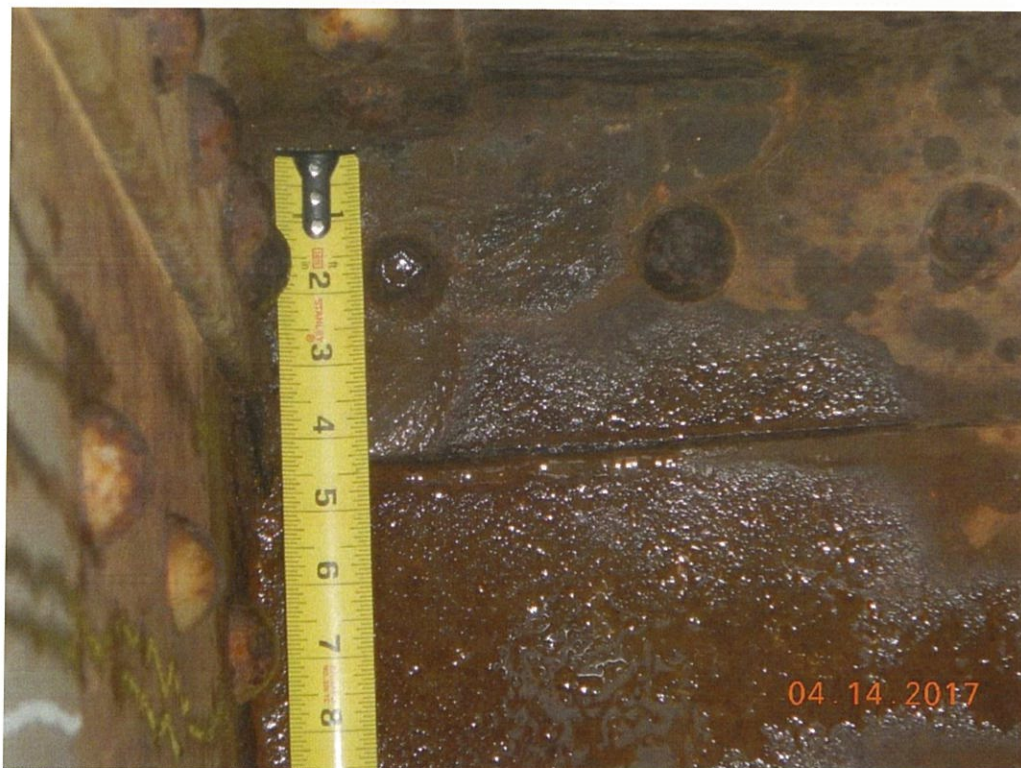
Photo 76: The packrust has broken rivets in several locations of the thru truss lower chords.
Span 6 L6'L7' Lt. at L6' shown.

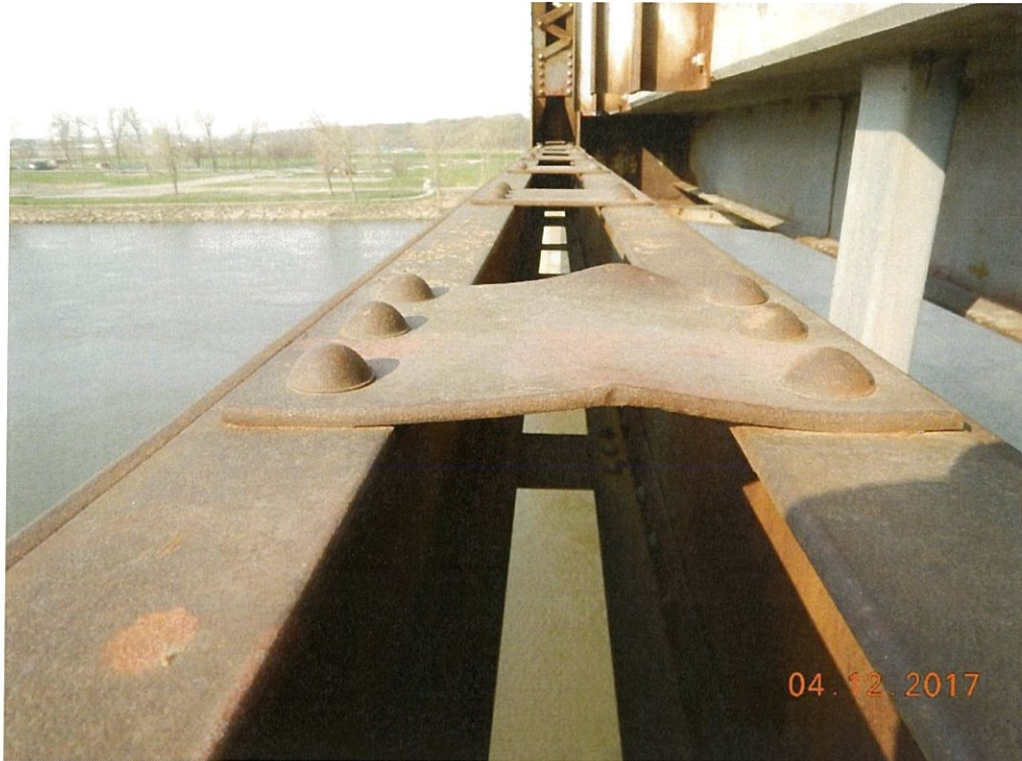
Photo 77: A few of the baton plates on the thru truss lower chords are slightly bent.

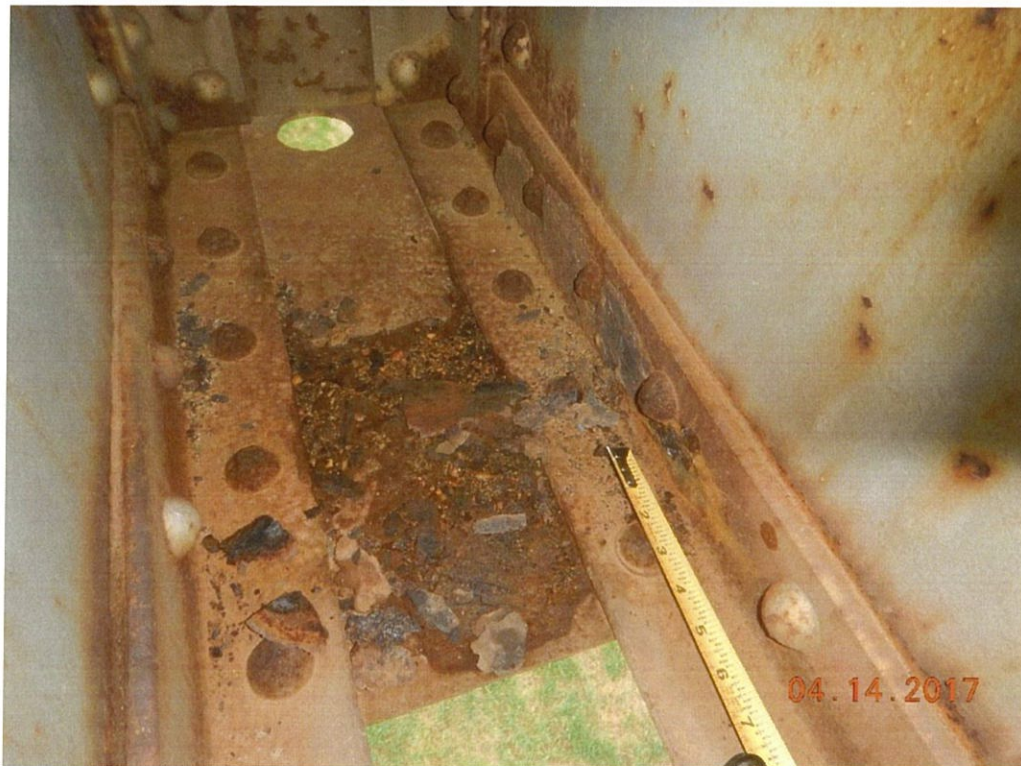
Photo 78: Span 6 L3' Rt. has flaking corrosion of the exterior bottom angle; when removed pitting is up to 1/8" deep in the vertical leg of the angle.

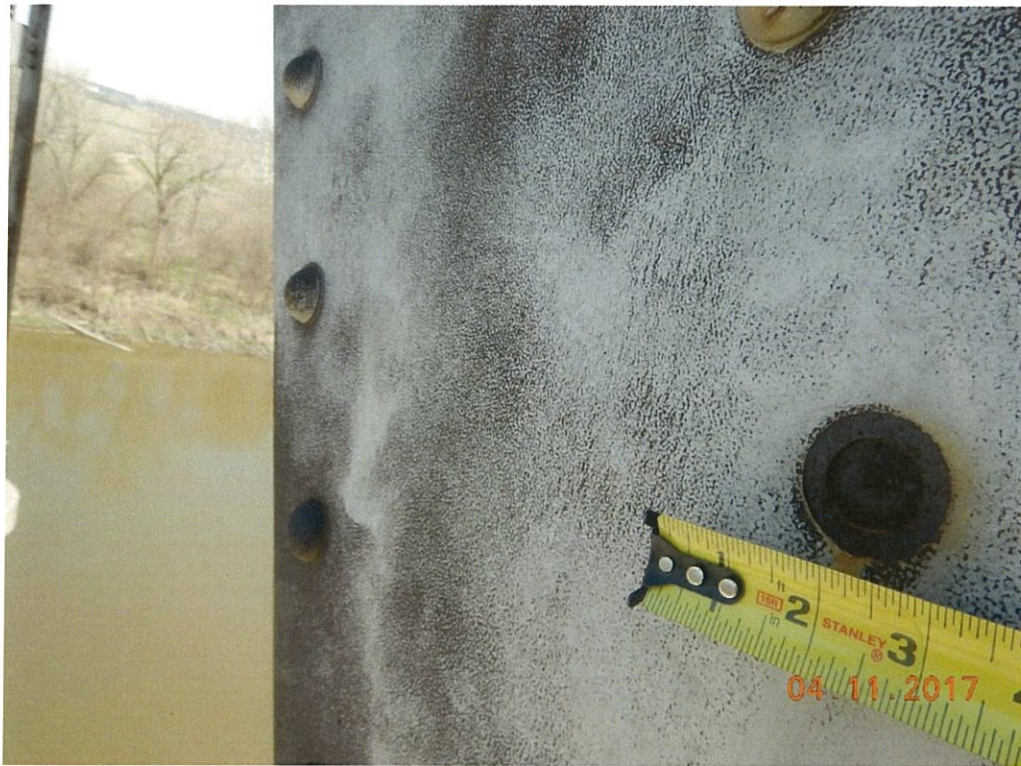
Photo 79: Span 6 U13L12 Rt. has 2 broken rivets on the interior face, only one shown.

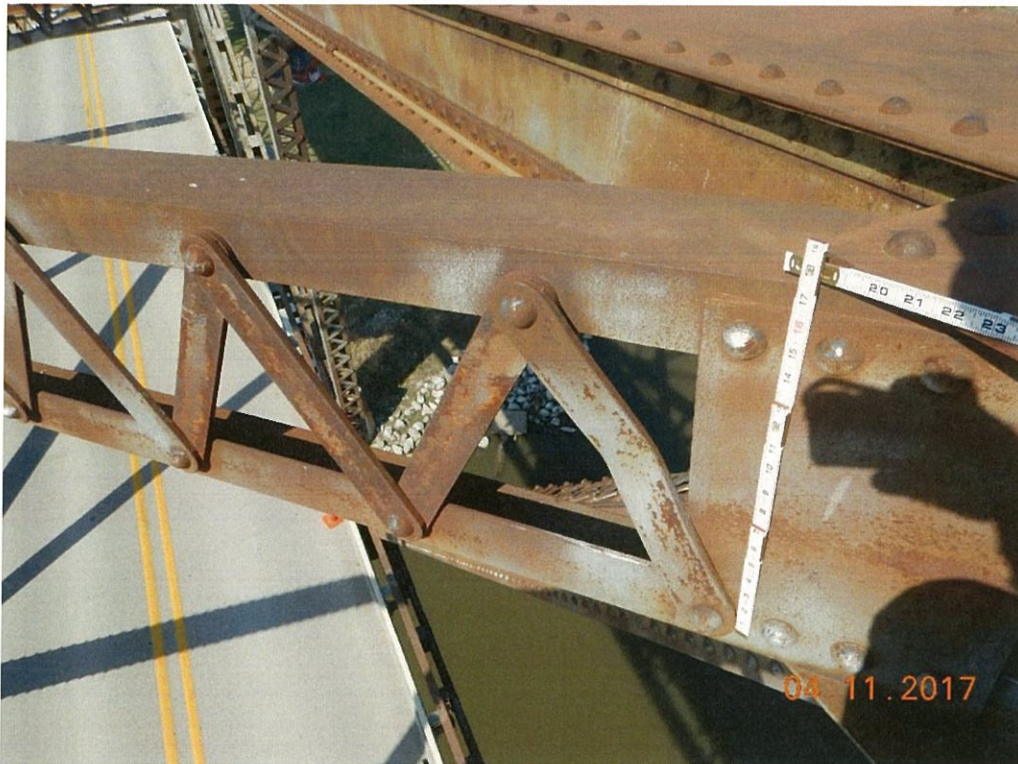
Photo 80: A few of the thru truss upper lateral bracing lattice bars of are slightly bent at random areas throughout.

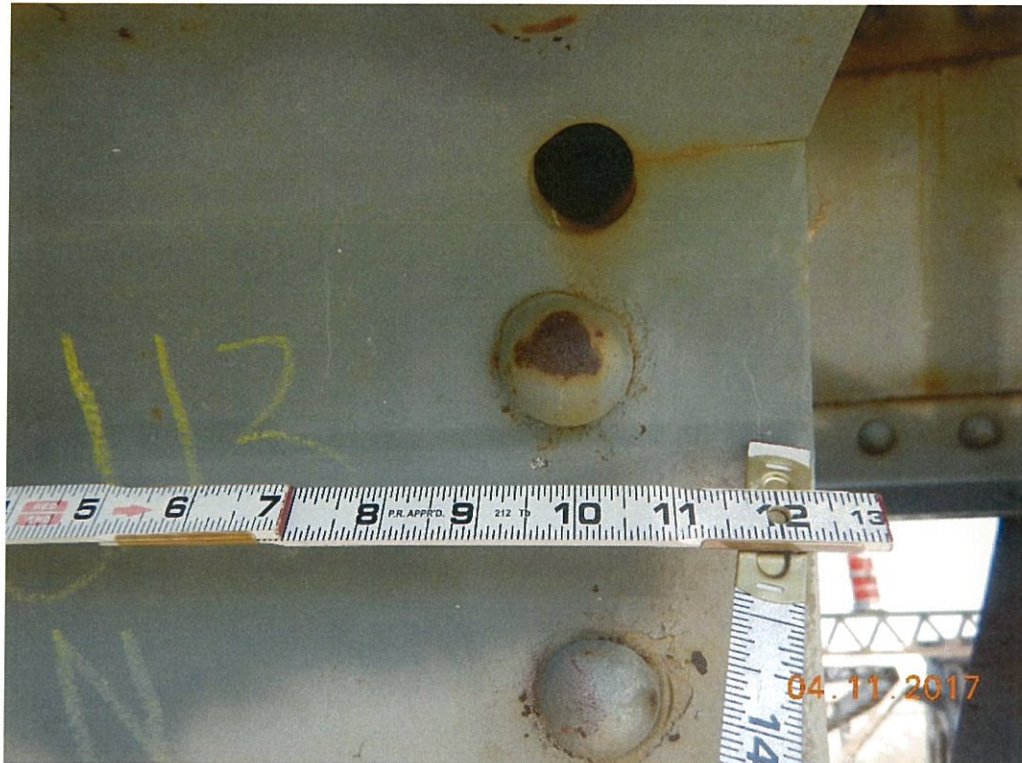
Photo 81: There is a crack with a previously installed arrest hole located in the sway bracing gusset plate at Span 5 U13 Lt.; the crack has not propagated beyond the hole.
