APPENDIX E. STRUCTURAL DOCUMENTS

**Bellevue Toll Bridge
East Mission Avenue over the Missouri River
Bellevue, Nebraska**

**Structure No. S370 01918
Fracture Critical and Routine NBIS Bridge Inspection
April 2017**

Prepared for:
Bellevue Bridge Commission

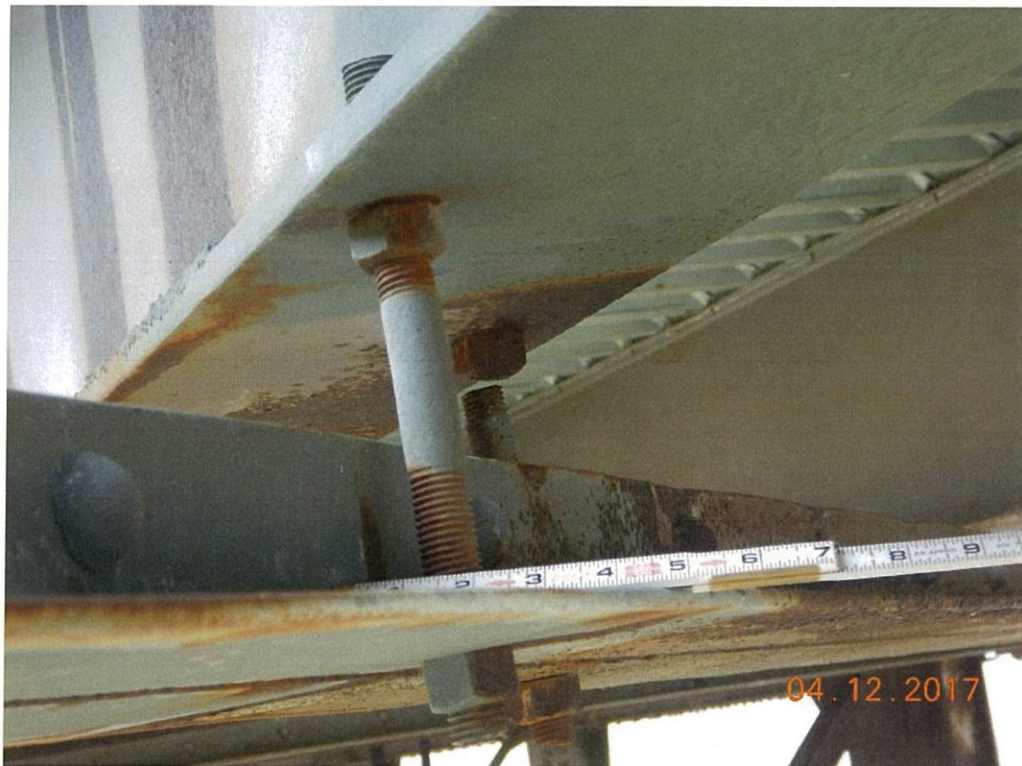
Photo 82: Some of the thru truss lower lateral bracing hanger bolts used to minimize vibrations of the bracing are sheared off.

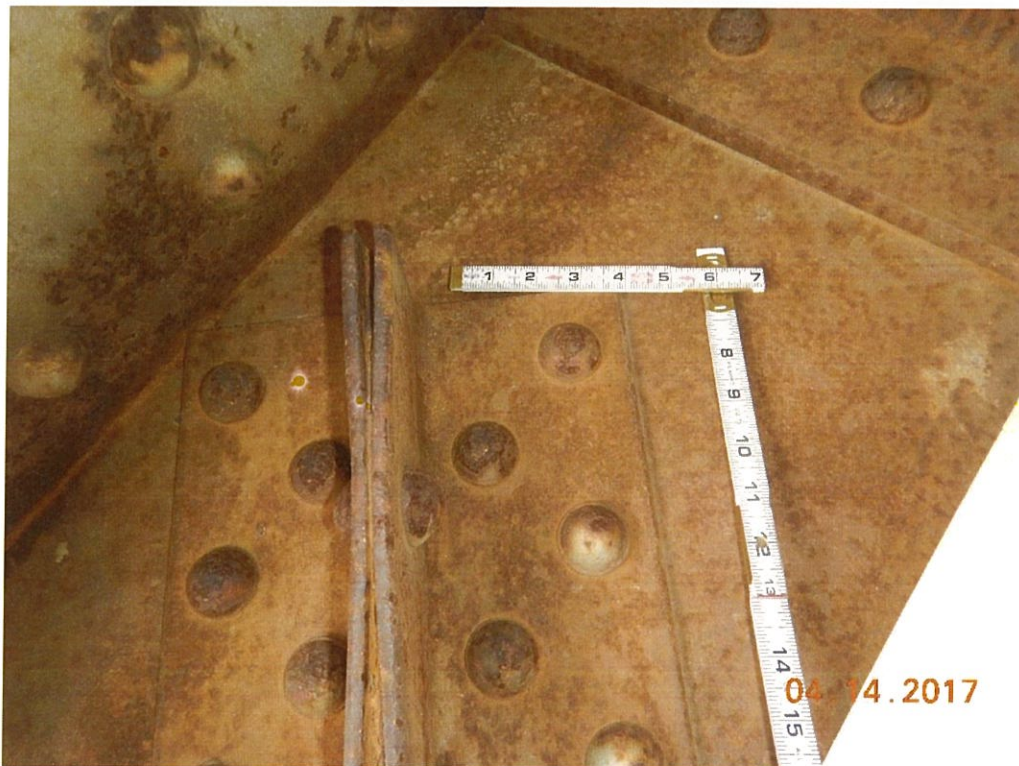
Photo 86: Areas of heavy corrosion and packrust are located at ends of the thru truss lower lateral bracing angles near the gusset plate connections.

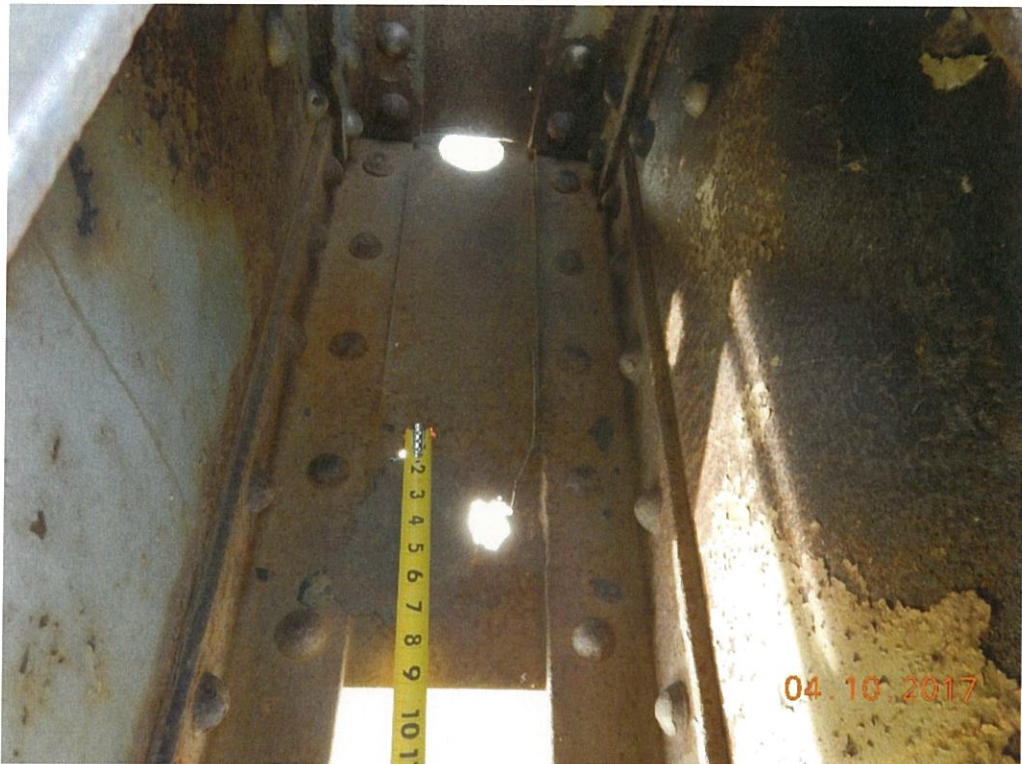
Photo 87: The thru truss lower lateral bracing gusset plates have corrosion and packrust; the L1' and L2' have significant section loss with holes forming. Span 6 L1' Lt. shown.

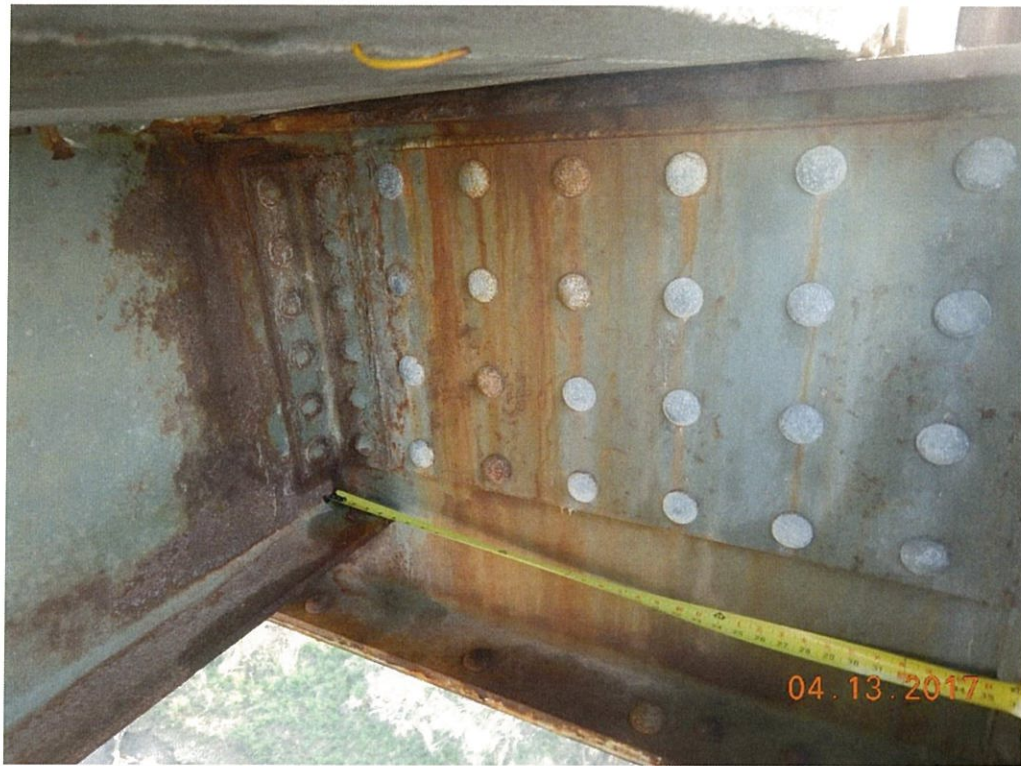
Photo 89: Typical thru truss floorbeam web repair.

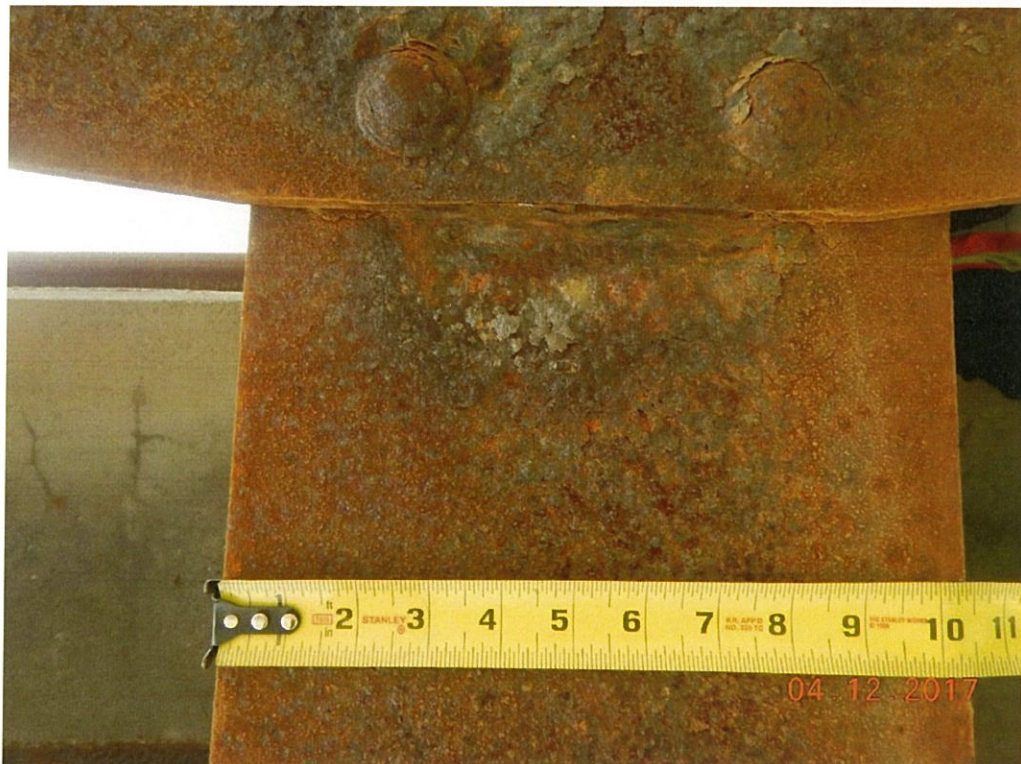
Photo 90: Many of the remaining, un-strengthened, floorbeams have significant section loss of the flanges, webs, and rivets. Section loss at an isolated area of the underside of the bottom flanges at the beam ends to gusset plate connection.

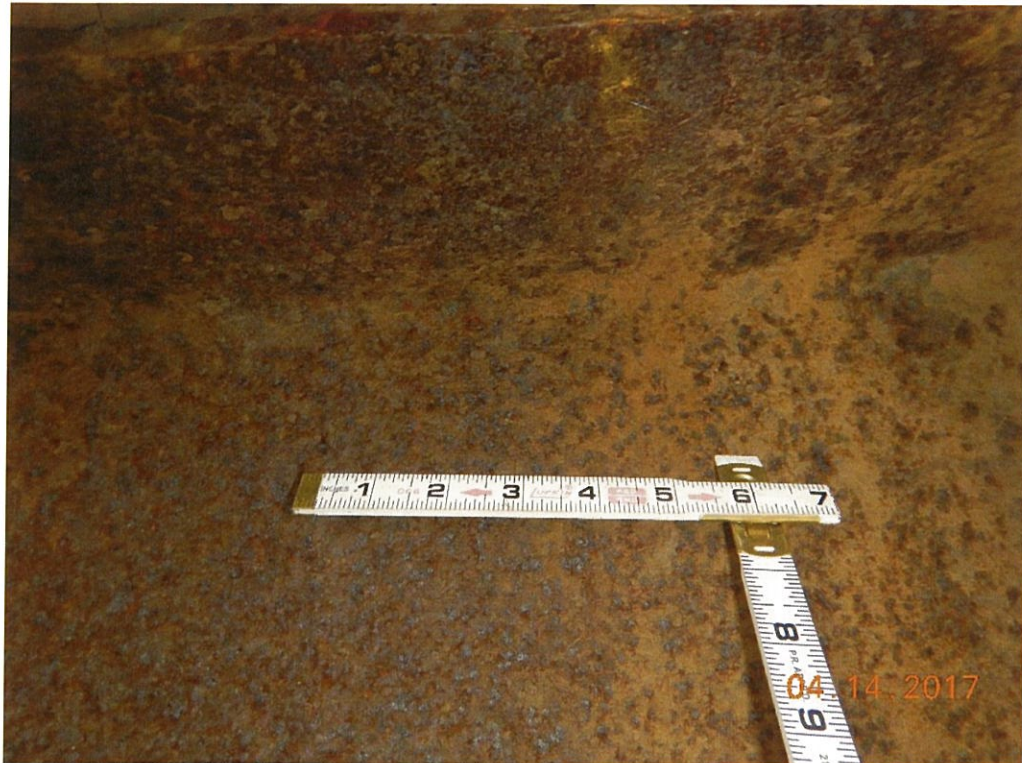
Photo 91: The thru truss floorbeam corrosion showing web to top flange.

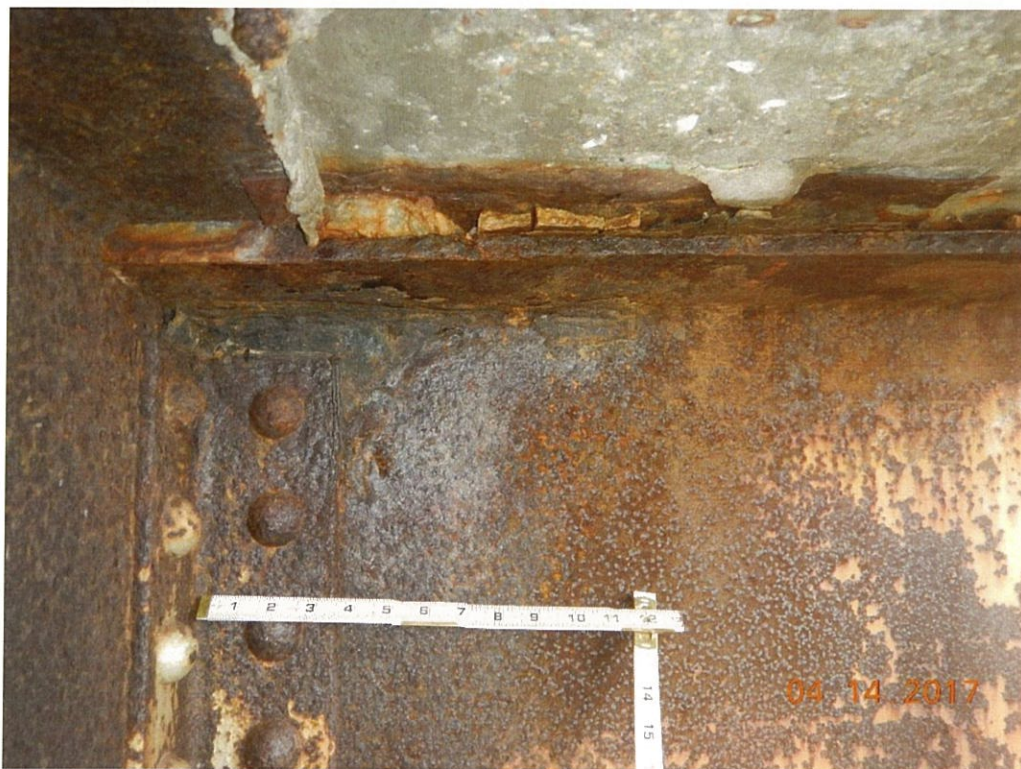
Photo 92: Typical thru truss floorbeam corrosion with packrust at stringers.

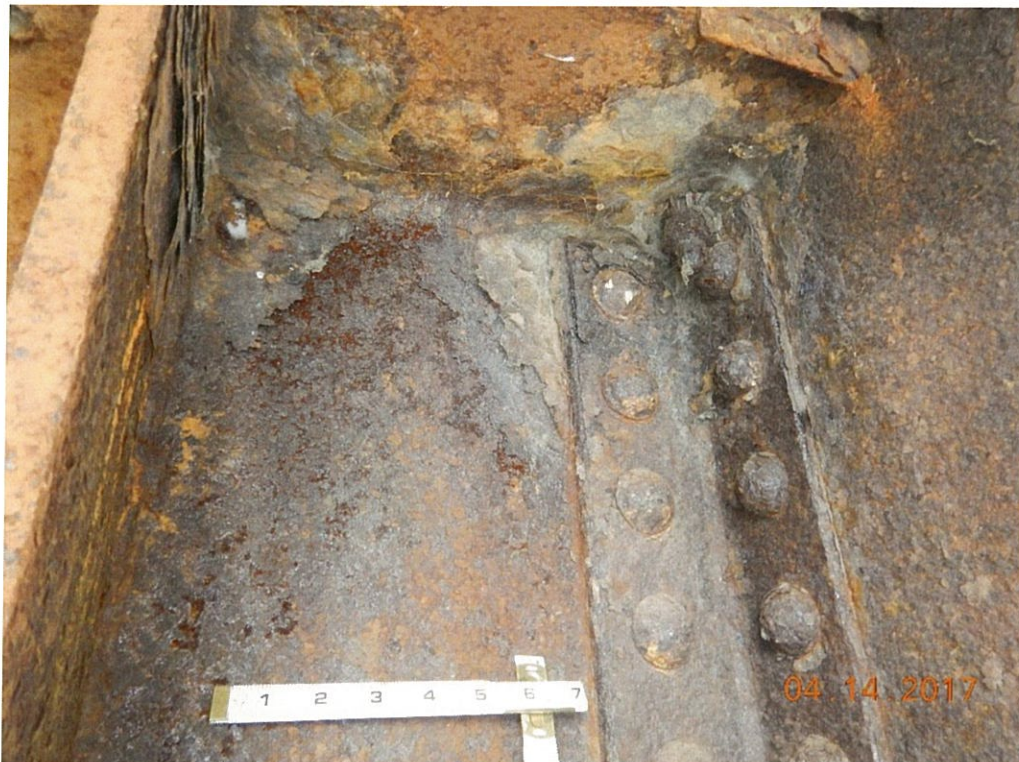
Photo 93: Thru truss floorbeam corrosion shown in Span 5 at Floorbeam 0 below the joint.

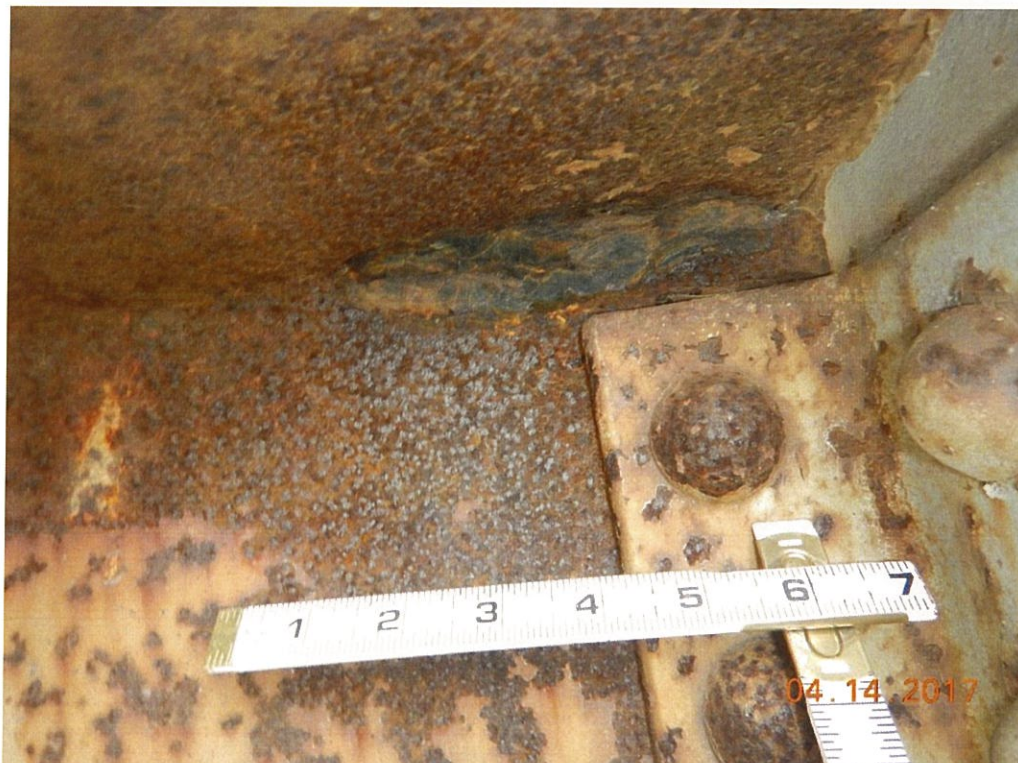
Photo 94: Thru truss floorbeam corrosion shown at Span 5 Floorbeam 2 Lt., web to bottom flange.

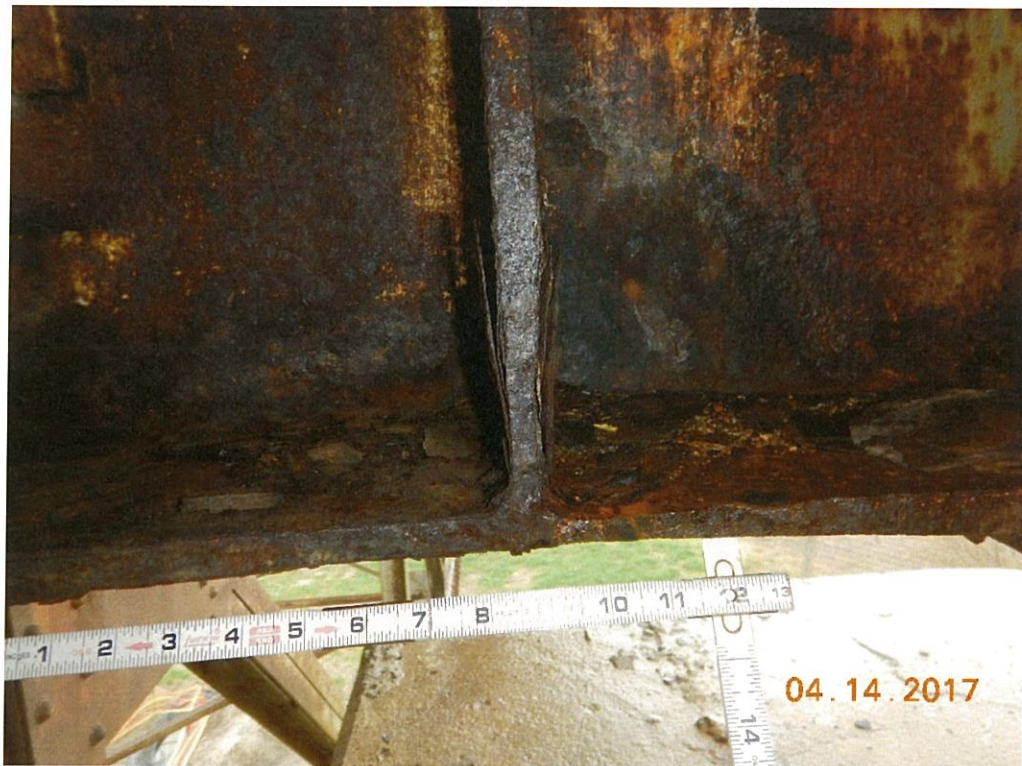
Photo 95: Thru truss floorbeam corrosion show at Span 6 Floorbeam L0' with section loss, below the joint.

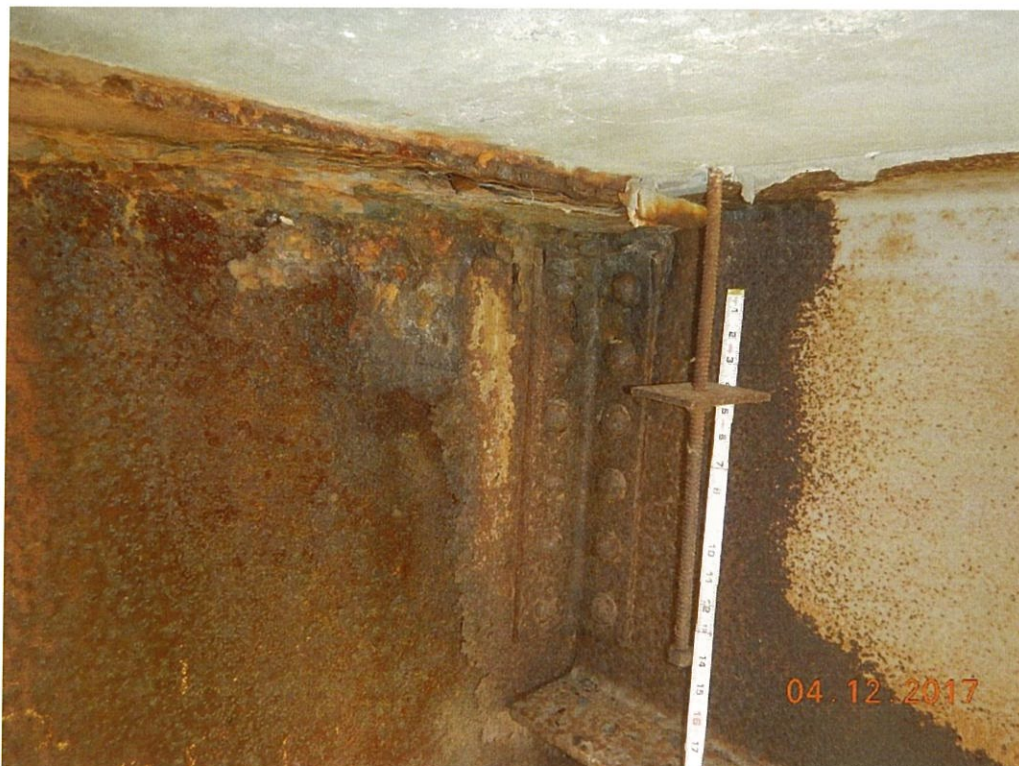
Photo 96: Two locations, Floorbeams L4' and L3', have 1/4" diameter holes in the web near the top flange. Floorbeam L4' shown.

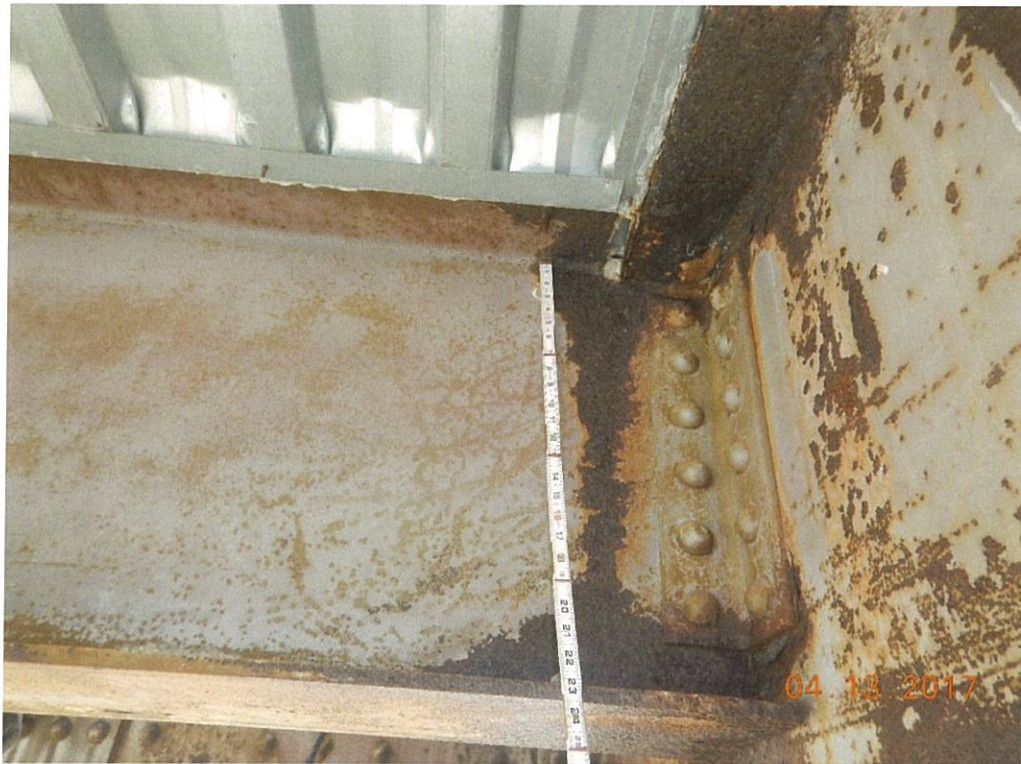
Photo 97: The thru truss stringers are in fair condition with corrosion typically occurring at their end support connections to floorbeams.

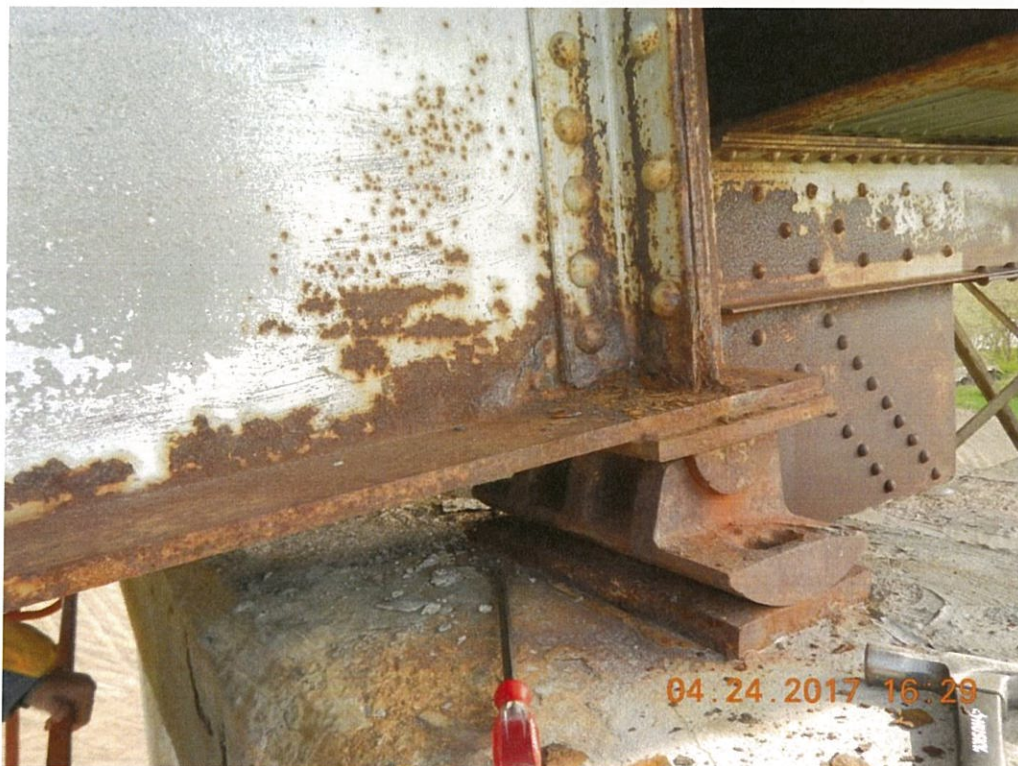
Photo 98: The leaking joints at above the ends of the girders have caused heavy rust with some section loss in the girder webs. Girder 1 exterior face at Pier 8 shown – exterior anchor bolt is sheared off).

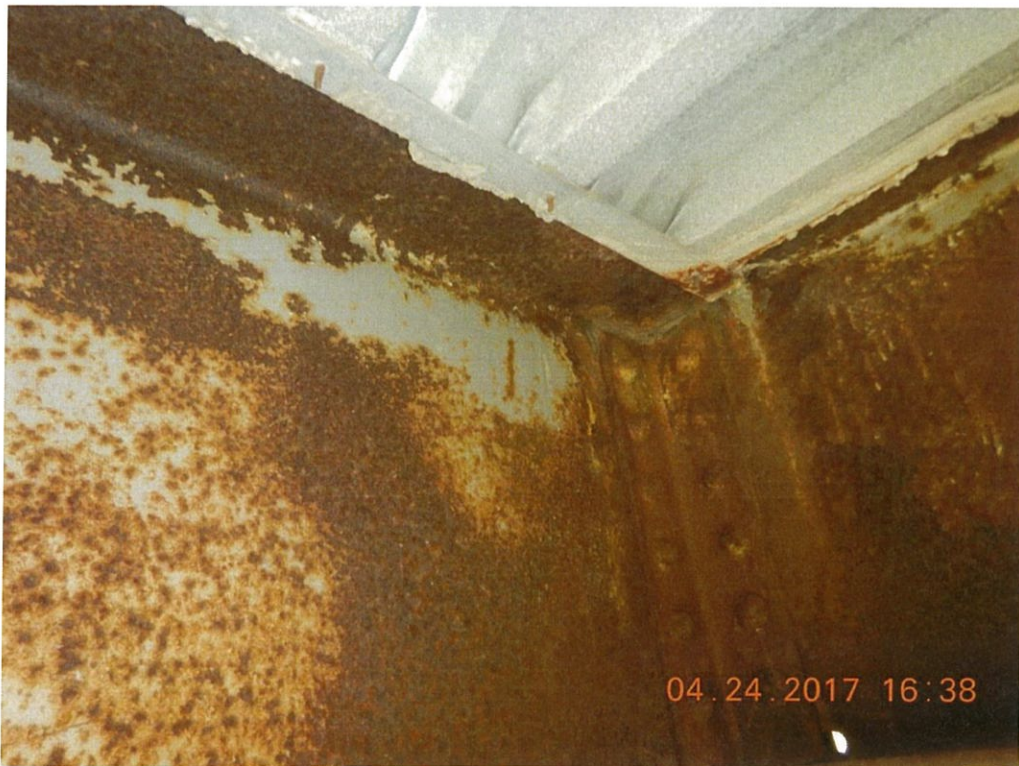
Photo 100: The leaking joints at above the ends of the girders have caused heavy rust with some section loss in the girder webs. Girder 4 interior face at Pier 8 shown.

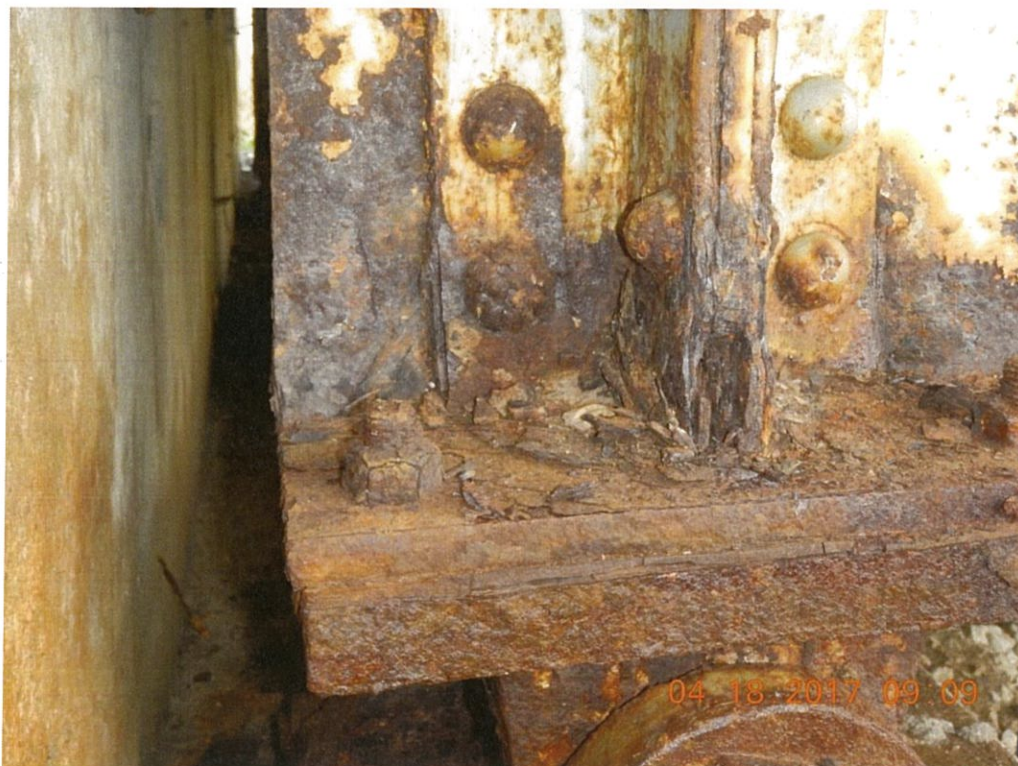
Photo 102: The leaking joints at above the ends of the girders have caused heavy rust with some section loss in the girder webs. Girder 1 exterior face at Abutment 2 shown.

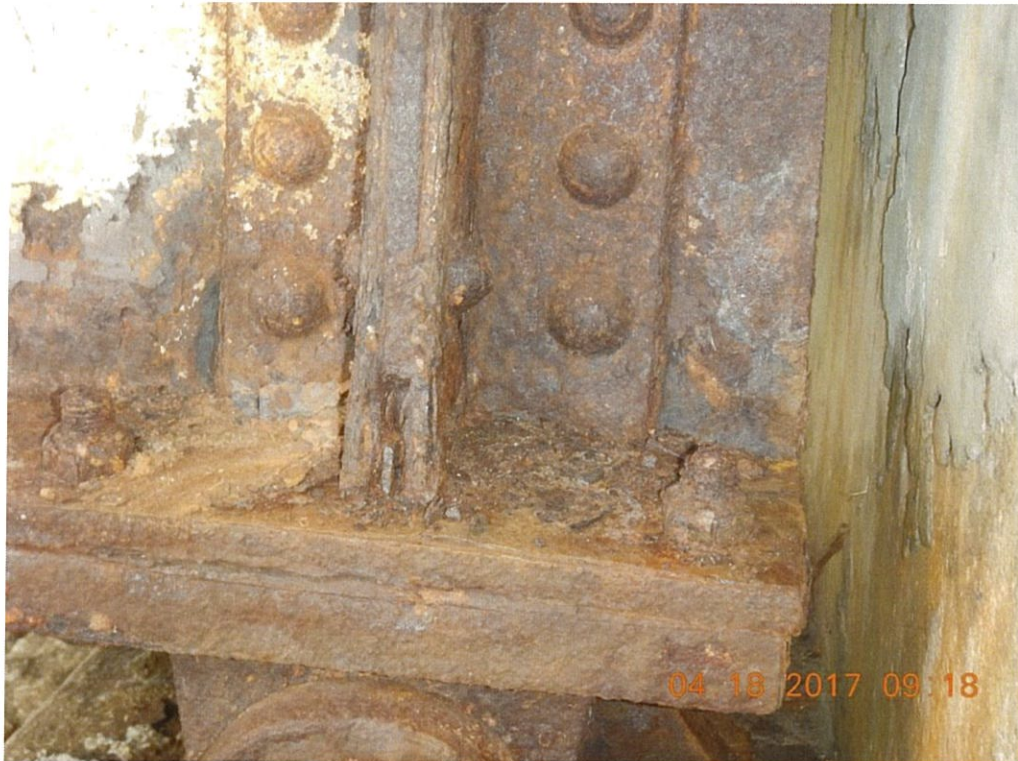
Photo 103: The leaking joints at above the ends of the girders have caused heavy rust with some section loss in the girder webs. Girder 4 exterior face at Abutment 2 shown.

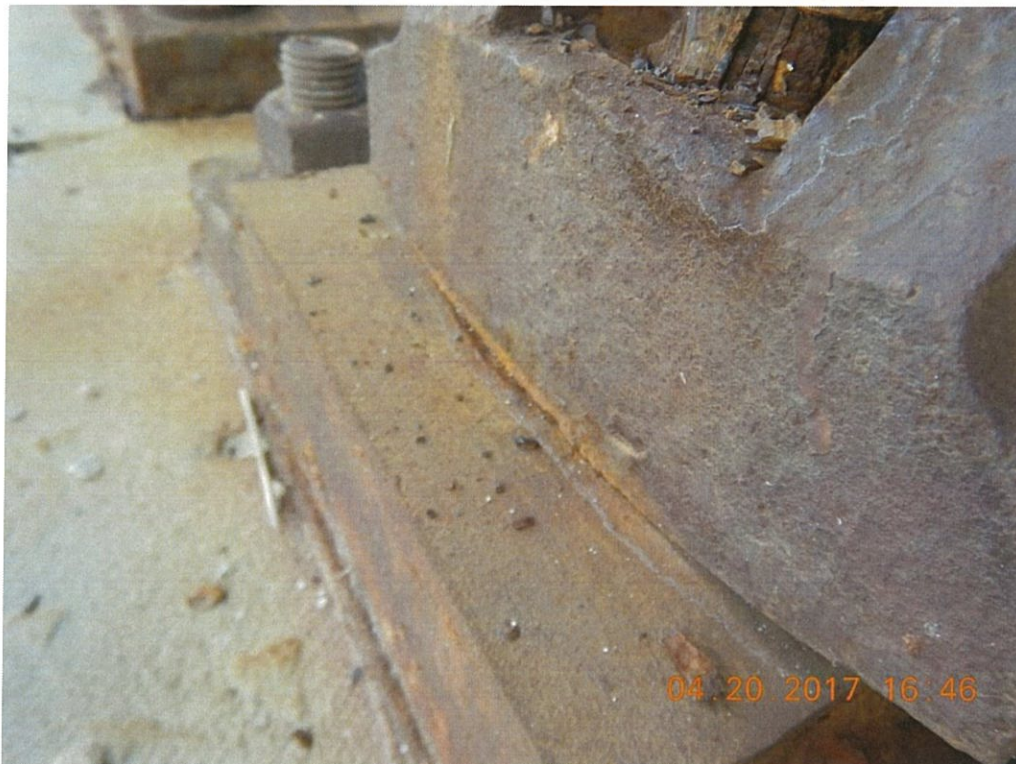
Photo 104: All the expansion bearings have wearing marks indicating movement through the temperature range. Span 3 L0 Rt. shown.

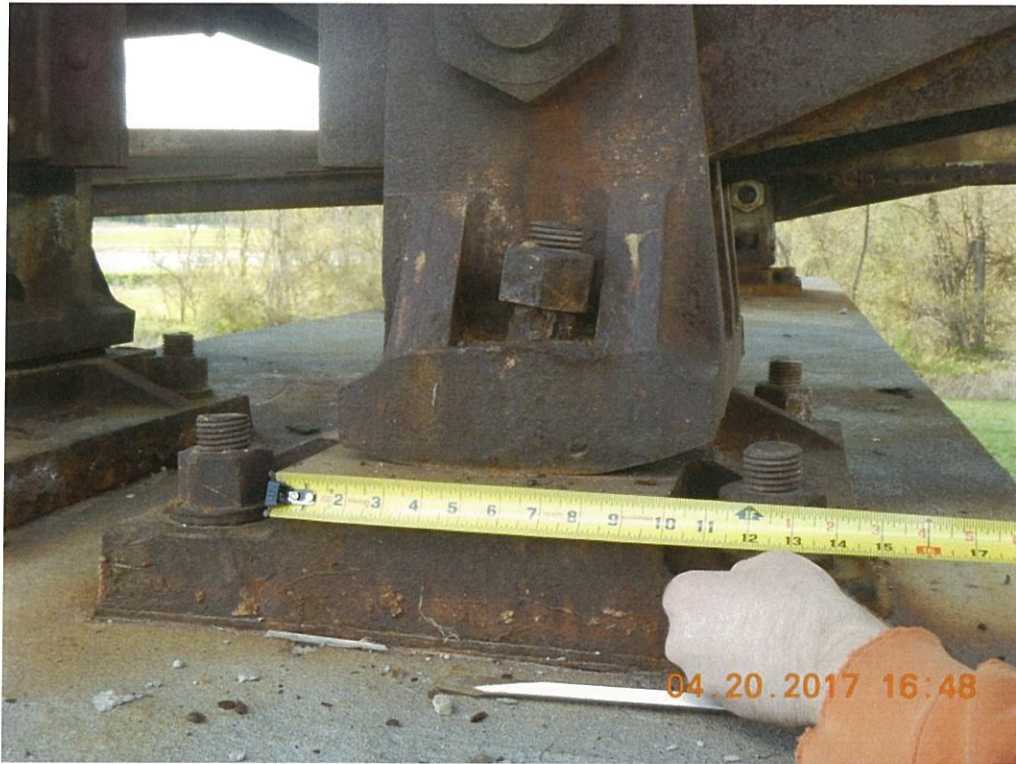
Photo 105: The Span 3 bearings at Pier 2 are no longer centered on the bearing plate and have slide in towards the span approximately $\frac{3}{4}$ ". L0 Rt. shown.

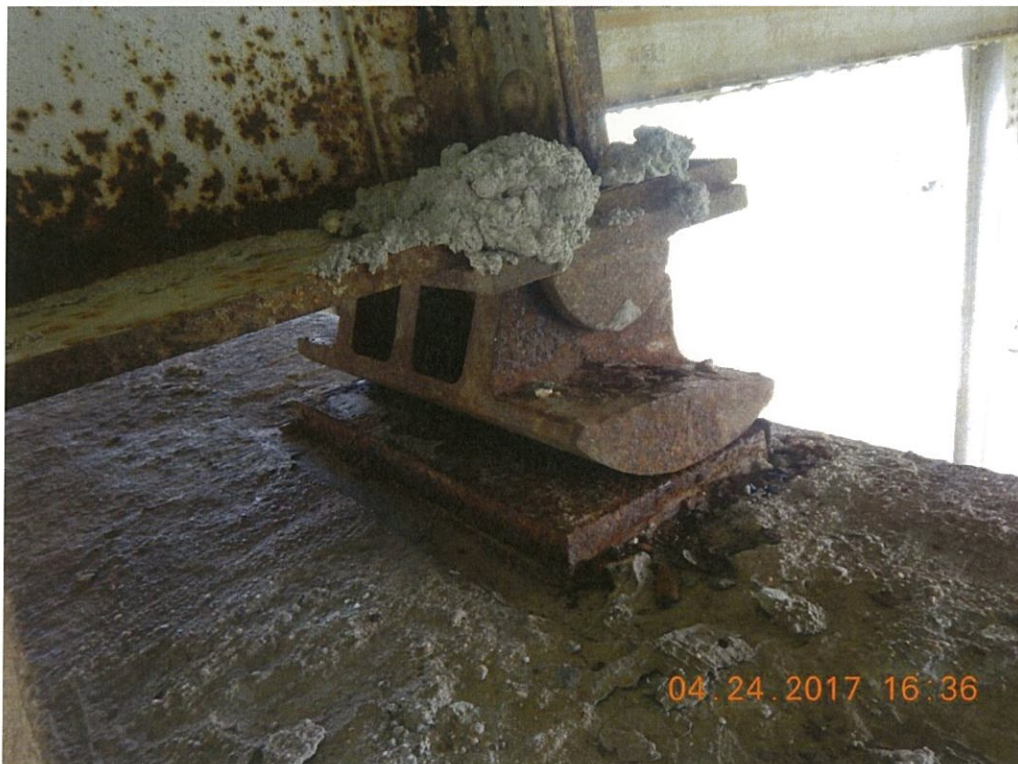
Photo 112: Both anchor bolts at Span 9 Girder 3 are sheared at the top of the slot at the Pier 8 bearing.

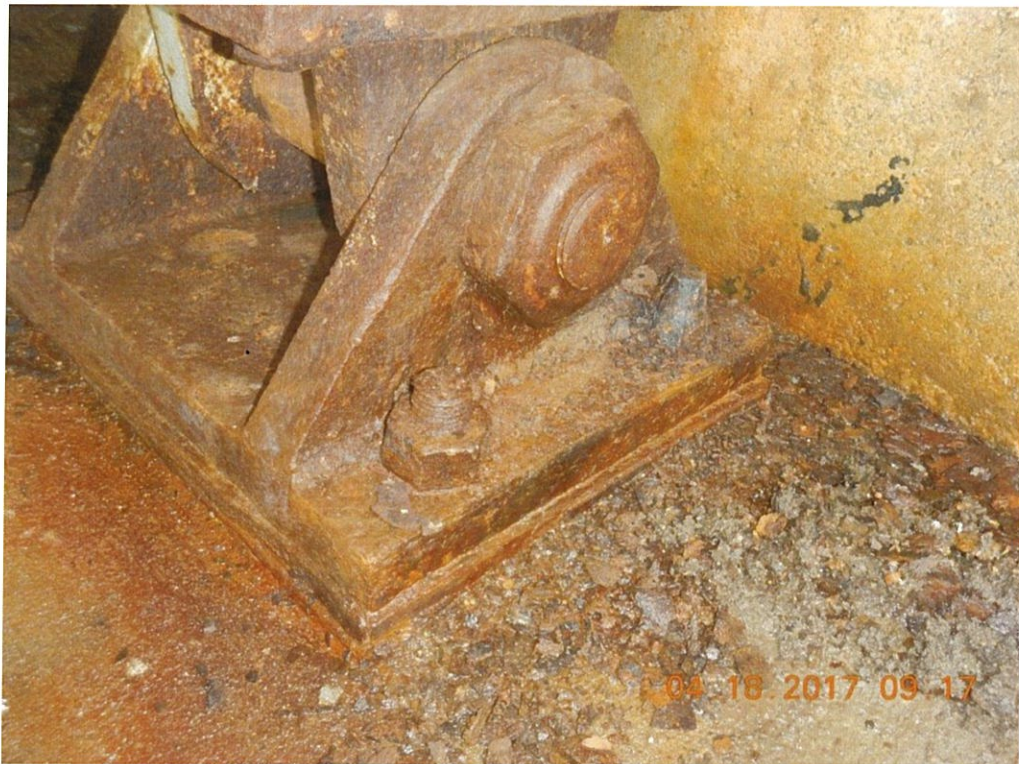
Photo 113: The southeast anchor bolt at Abutment 2 for Span 11 Girder 4 is deteriorated to the point no threads are distinguishable and the nut is almost completely gone.

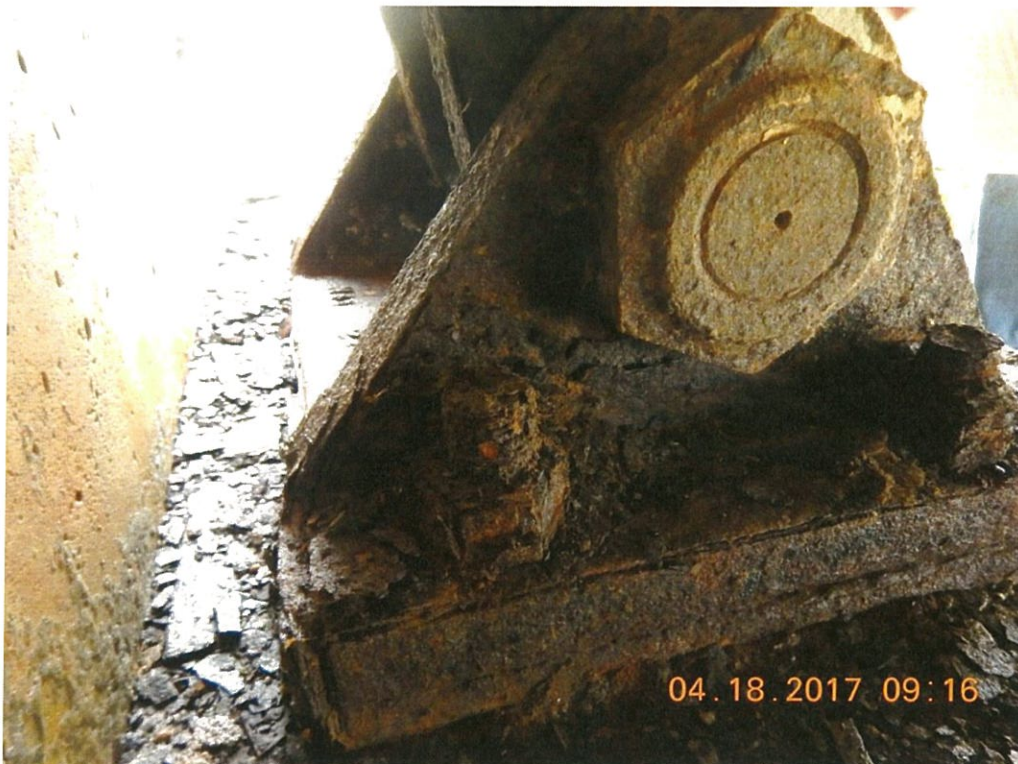
Photo 114: The north bolts at Abutment 2 for Span 11 Girder 4 are starting to deteriorated in a similar manner as shown in Photo 113. This is typical at all four bolts of Girders 1 and 2.

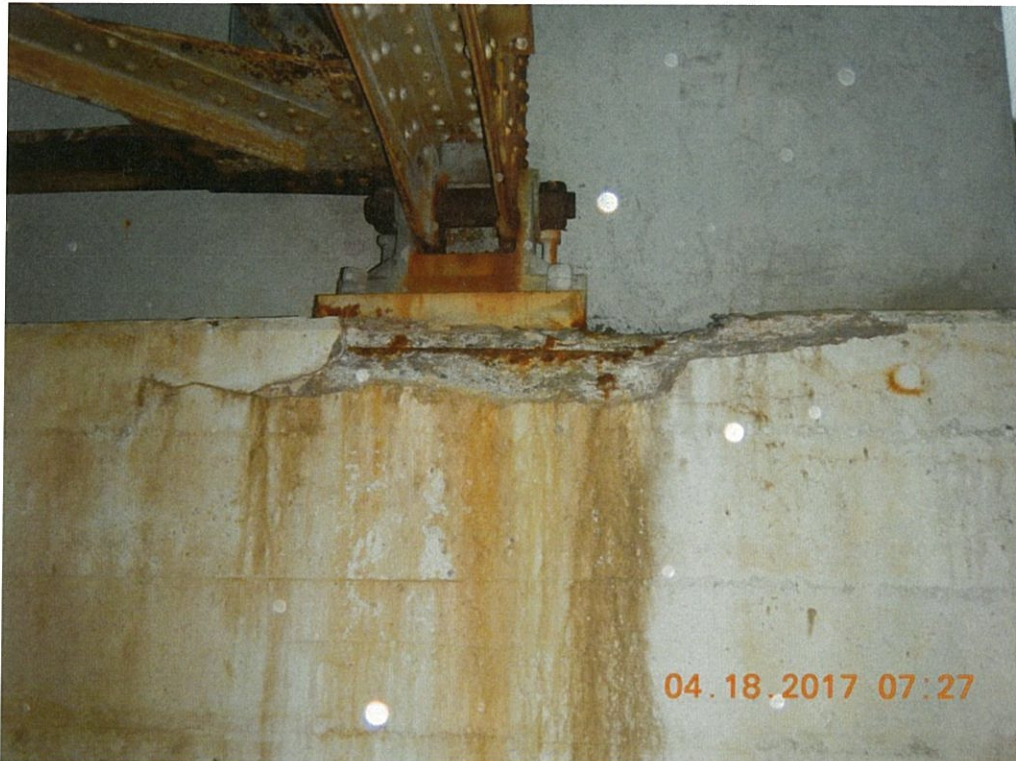
The substructures are typically in the same condition as the previous inspection with spalls, cracking, and delamination that has minimal effect on the capacity of the bridge. The concrete in front of the bearings at Abutment 1 has gotten worse since the previous inspection; it has spalled at the north bearing and is delaminating at the south bearing.

Photo 115: The front edge of Abutment 1 under the north bearing is spalled approximately 6" by 6" for nearly 3' – back edge of spall is at front edge of the bearing.

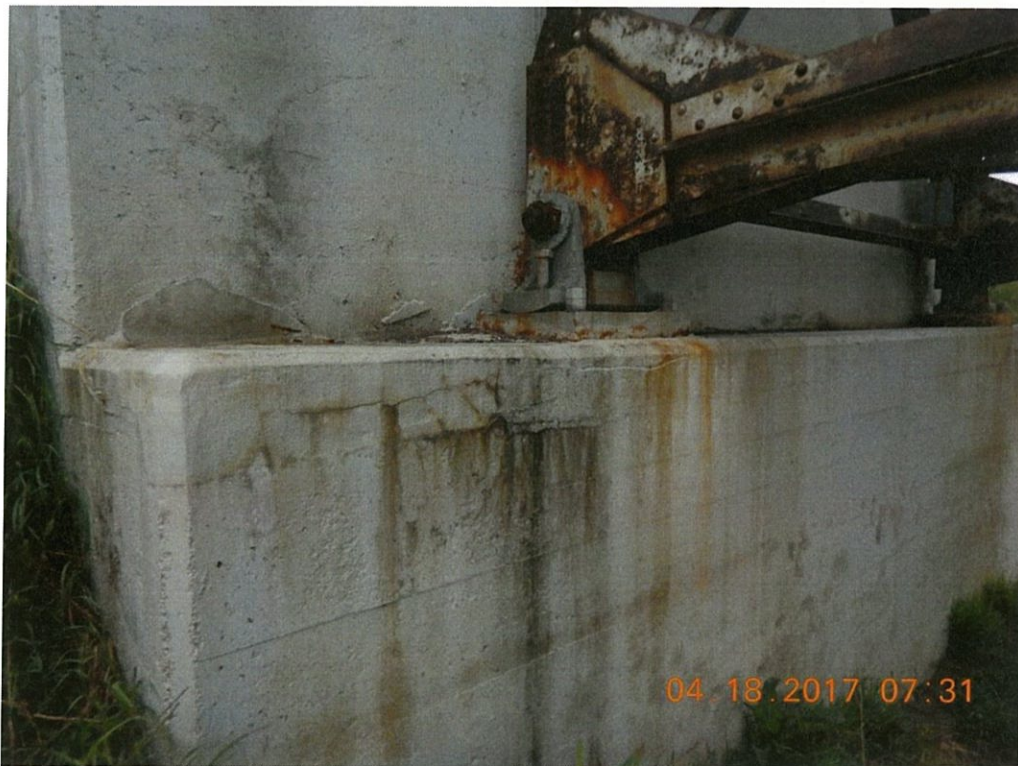
Photo 116: The front edge of Abutment 1 under the south bearing is delaminating from the south corner to the bearing 2.

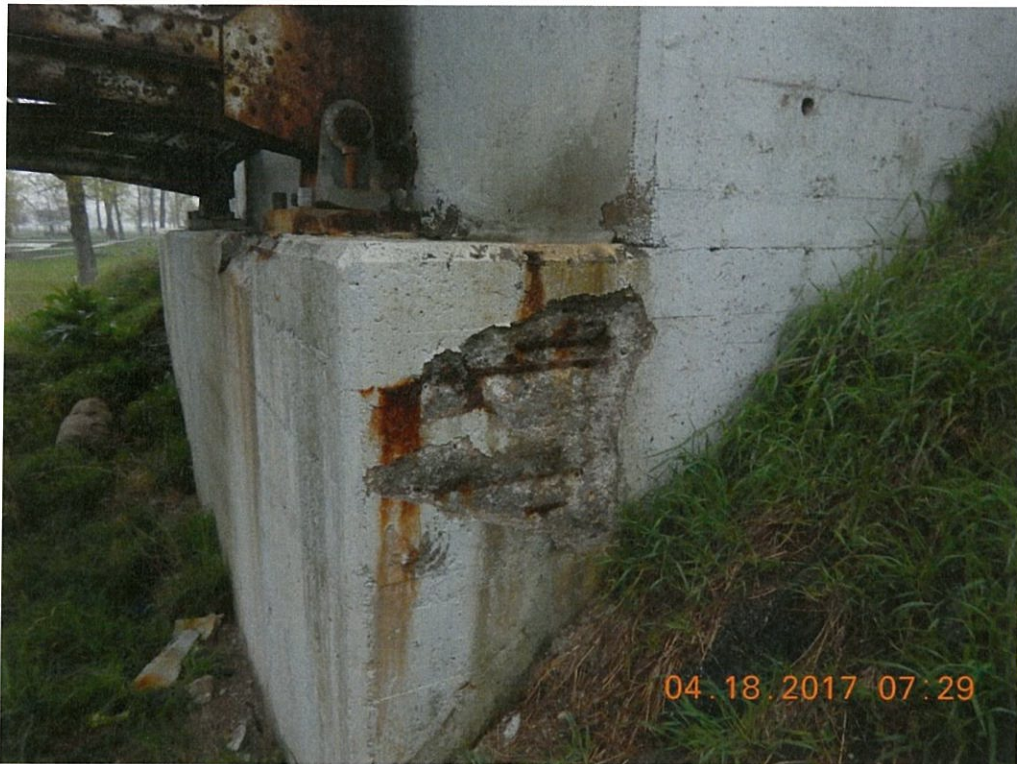
Photo 117: The north vertical face of the Abutment 1 cap is spalled 2" deep for approximately 2' by 2'.

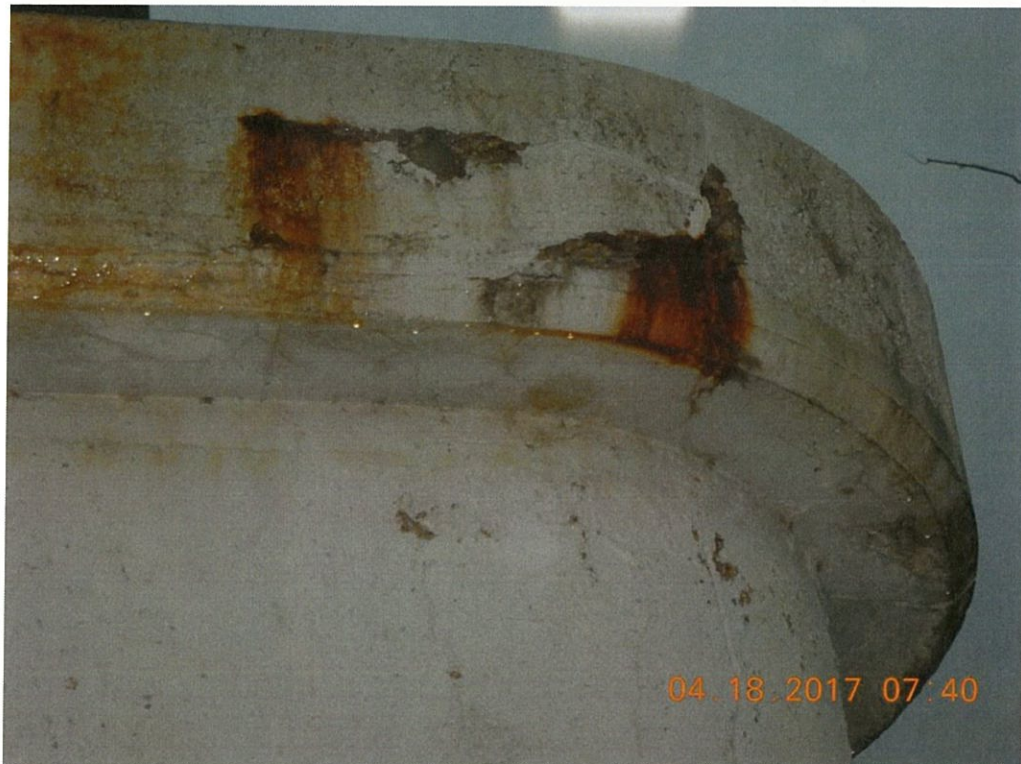
Photo 118: Spalling with heavy rust staining on the vertical face of the Pier 1 cap at the north and south ends. Northeast corner shown.

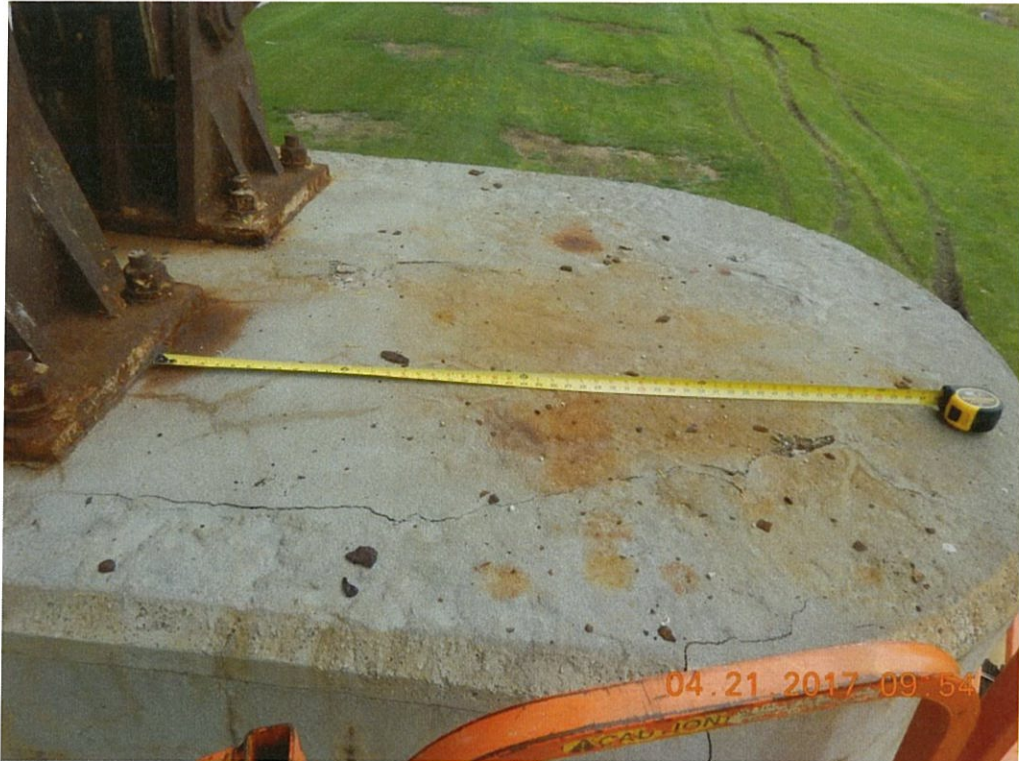
Photo 119: The top of the Pier 1 cap has minor sealant coat deterioration with plain sand underneath it near the center; similar at the south end with cracks forming - shown.

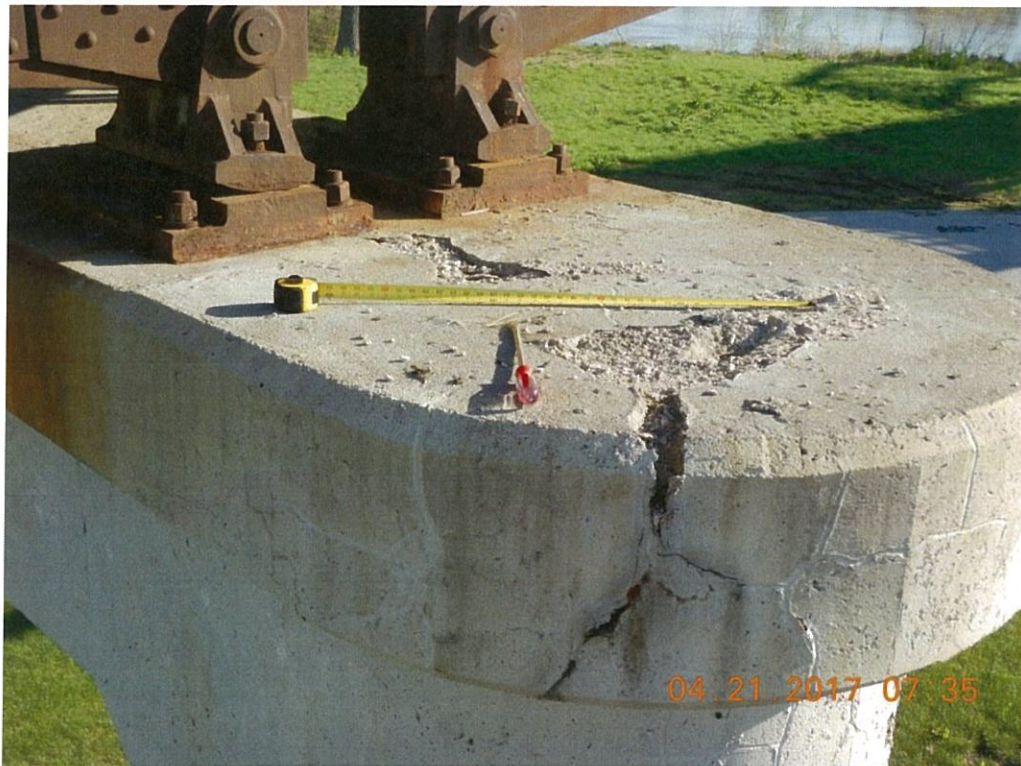
Photo 120: The top of the Pier 2 cap has sealant coat deterioration with sand and aggregate underneath it at two locations on the south.

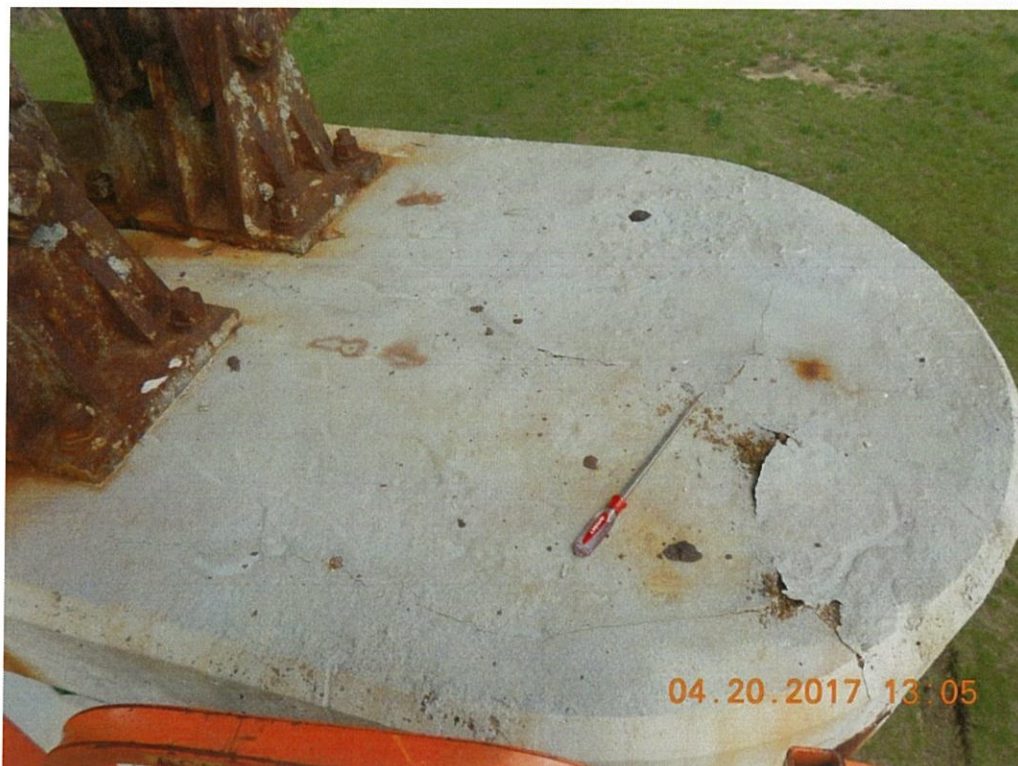
Photo 122: The top of the Pier 3 cap has minor sealant coat deterioration with plain sand and aggregate underneath it at the south end.
