APPENDIX E. STRUCTURAL DOCUMENTS

**Bellevue Toll Bridge
East Mission Avenue over the Missouri River
Bellevue, Nebraska**

**Structure No. S370 01918
Fracture Critical and Routine NBIS Bridge Inspection
April 2017**

Prepared for:
Bellevue Bridge Commission

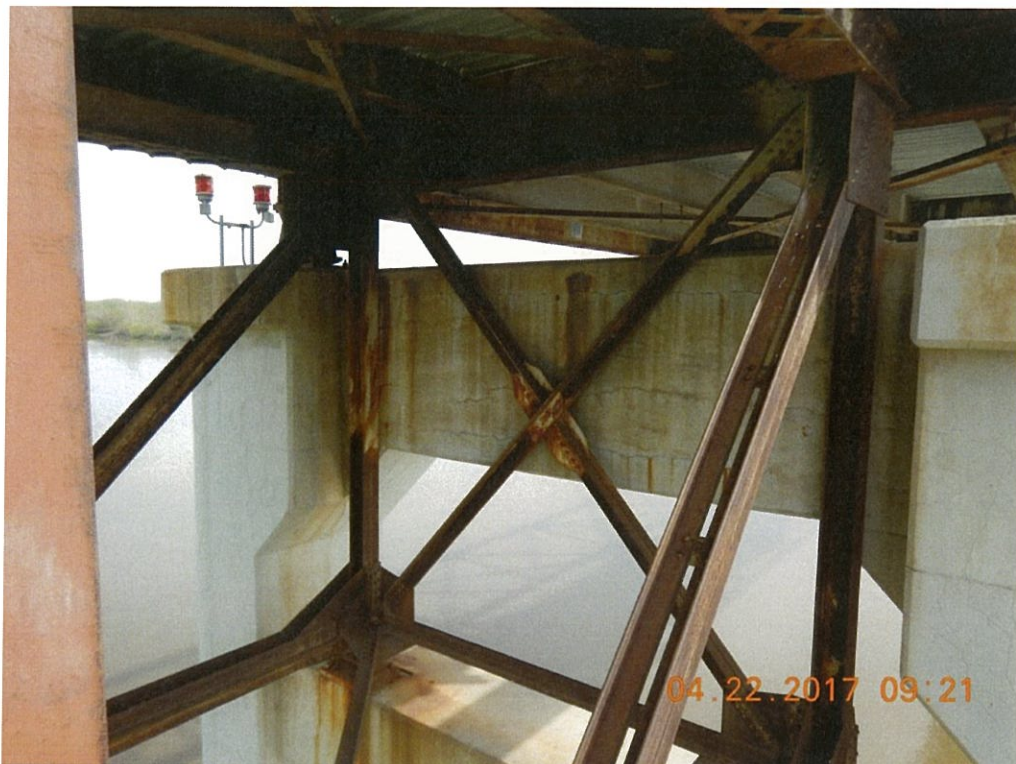
Photo 123: The faces of the top cap of Pier 4 have heavier longitudinal cracking. The west face is shown. This is similar to Piers 6 and 8 where superstructure type changes.

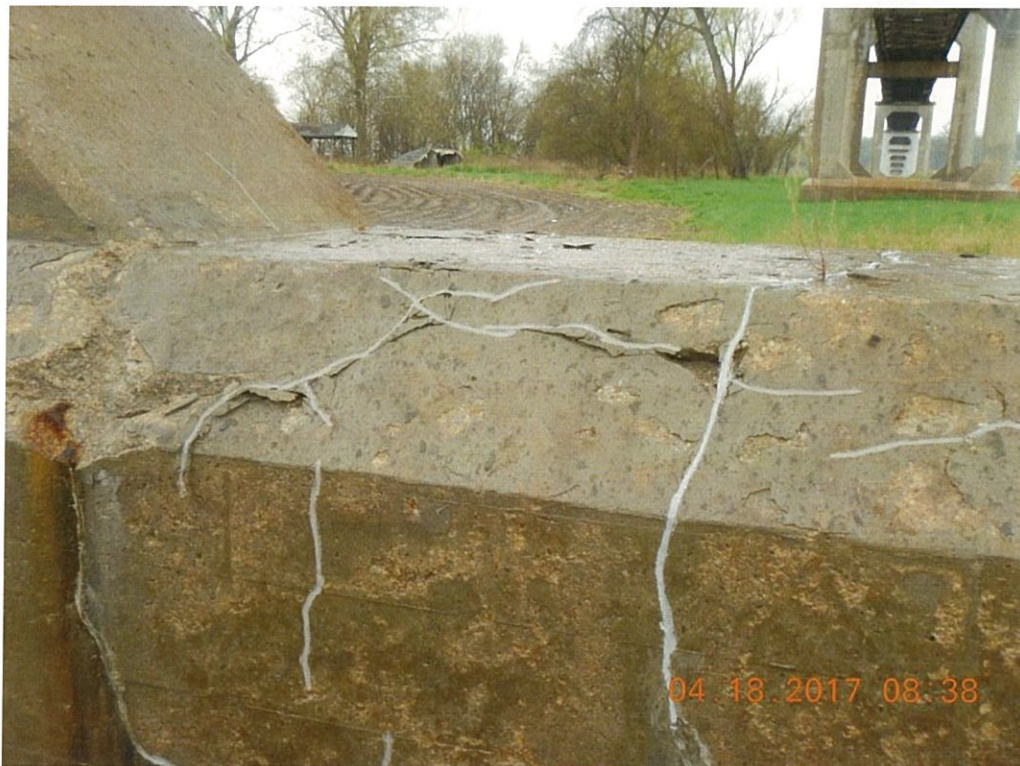
Photo 128: The top of the Pier 8 bottom wall is scaling which is creating spalls around some of the cracks; larger spalls are present at the southwest corner and east faces of the wall. East face shown.

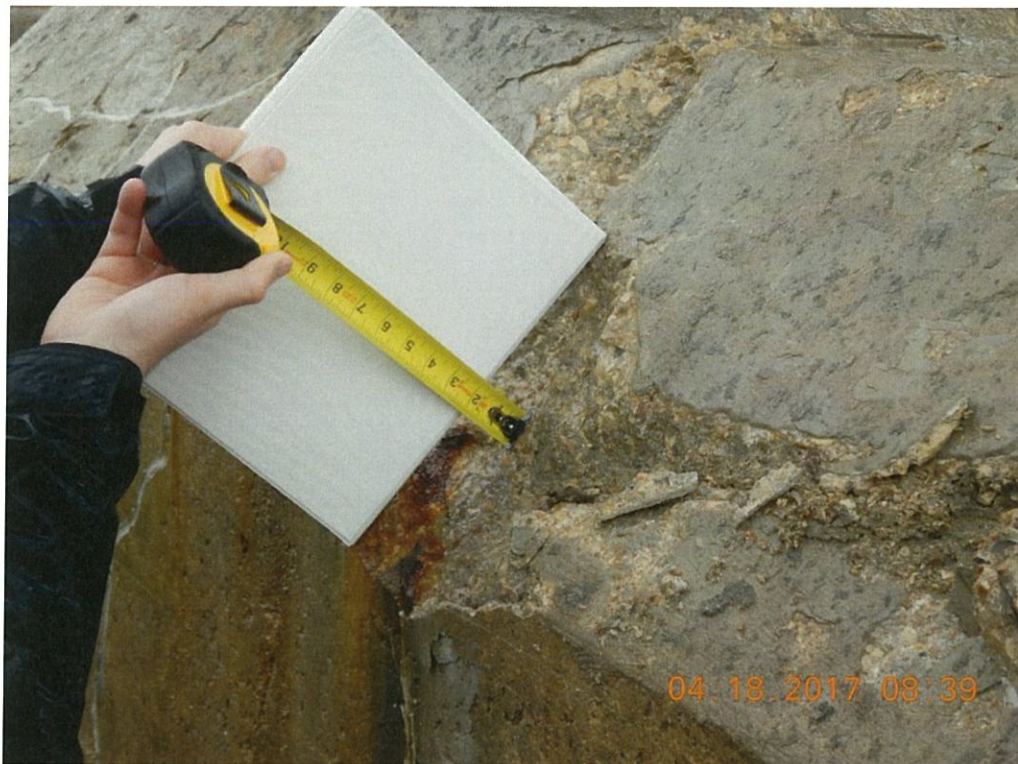
Photo 129: The top of the Pier 8 bottom wall is scaling which is creating spalls around some of the cracks; larger spalls are present at the southwest corner and east faces of the wall.
Close up of largest spall on east face shown.

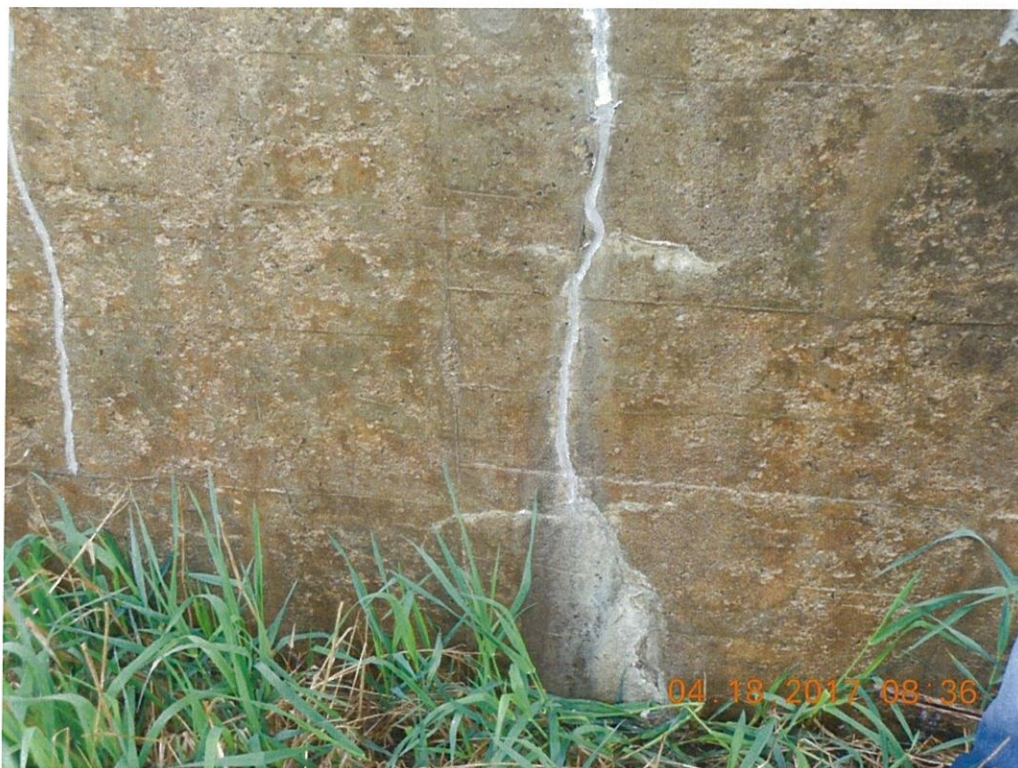
Photo 130: Efflorescence is present at the west face of the Pier 8 bottom wall.

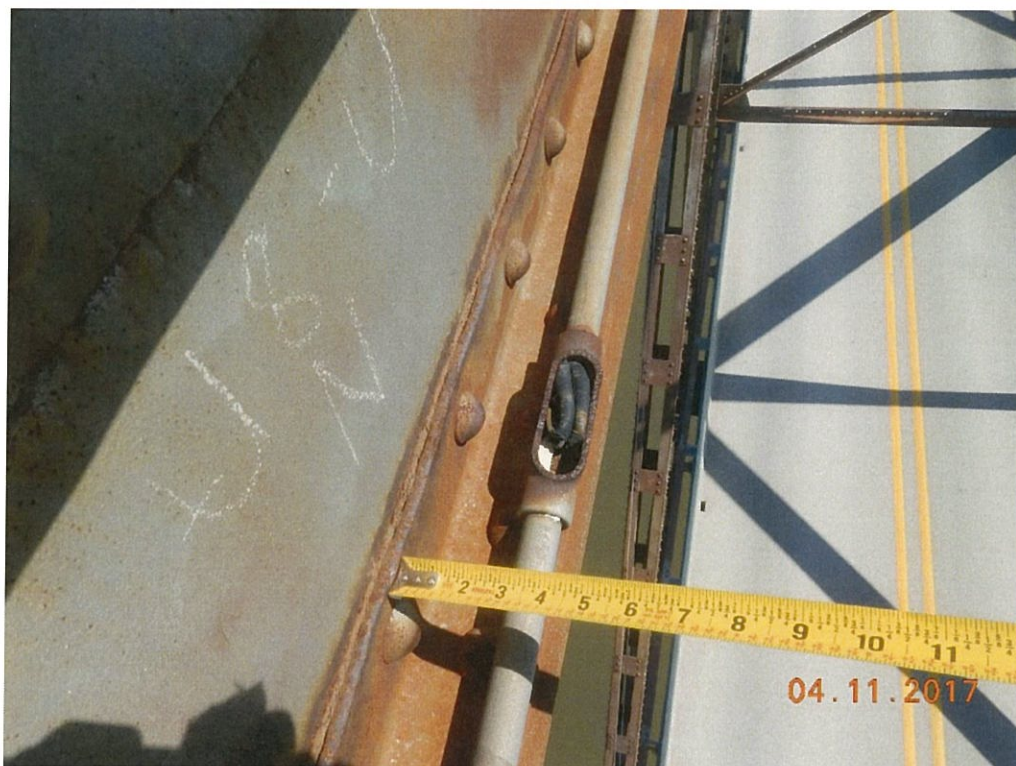
Photo 137: There is a missing conduit junction box cover on top of the Pier 4 cap at the north end and in Span 5 along the inside of U8U9 Lt. – shown.

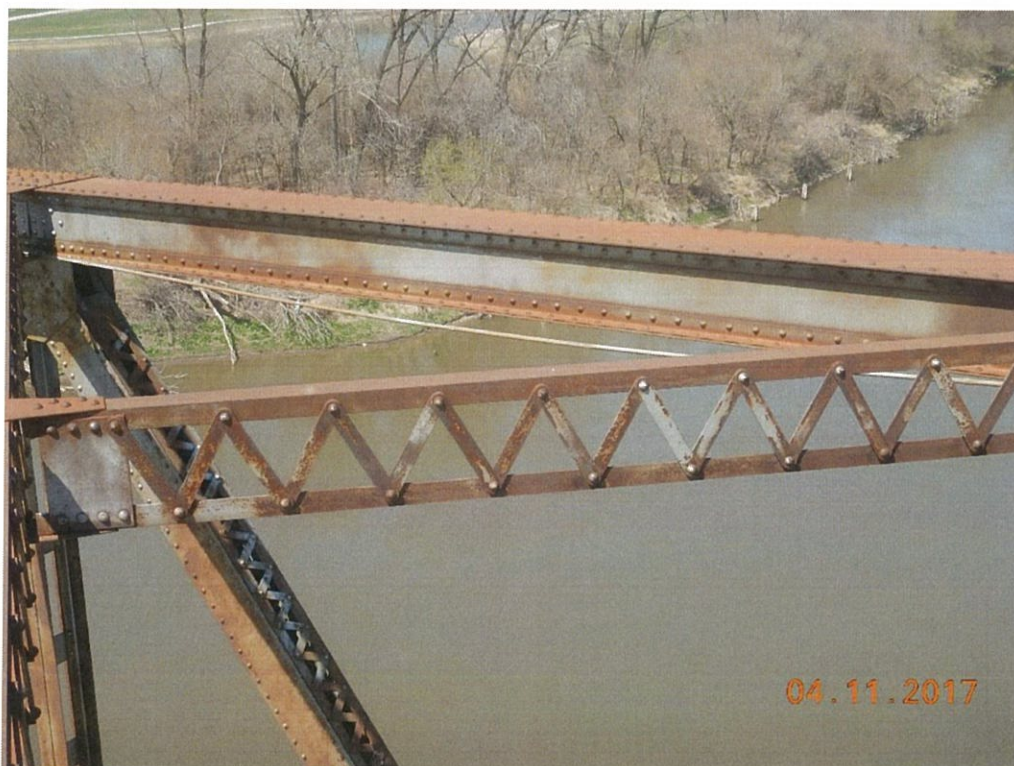
Photo 138: The conduit in Span 5 is unsupported along the inside U7U8 Lt.

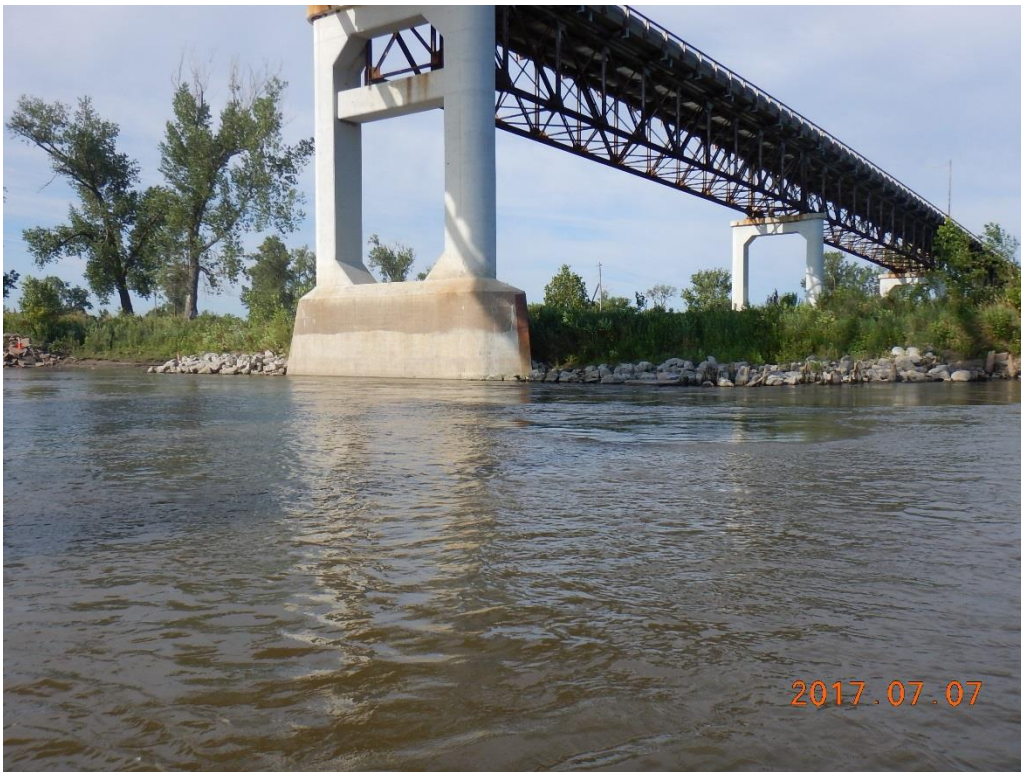
Pier 4 – Riprap Placed to Repair Scour

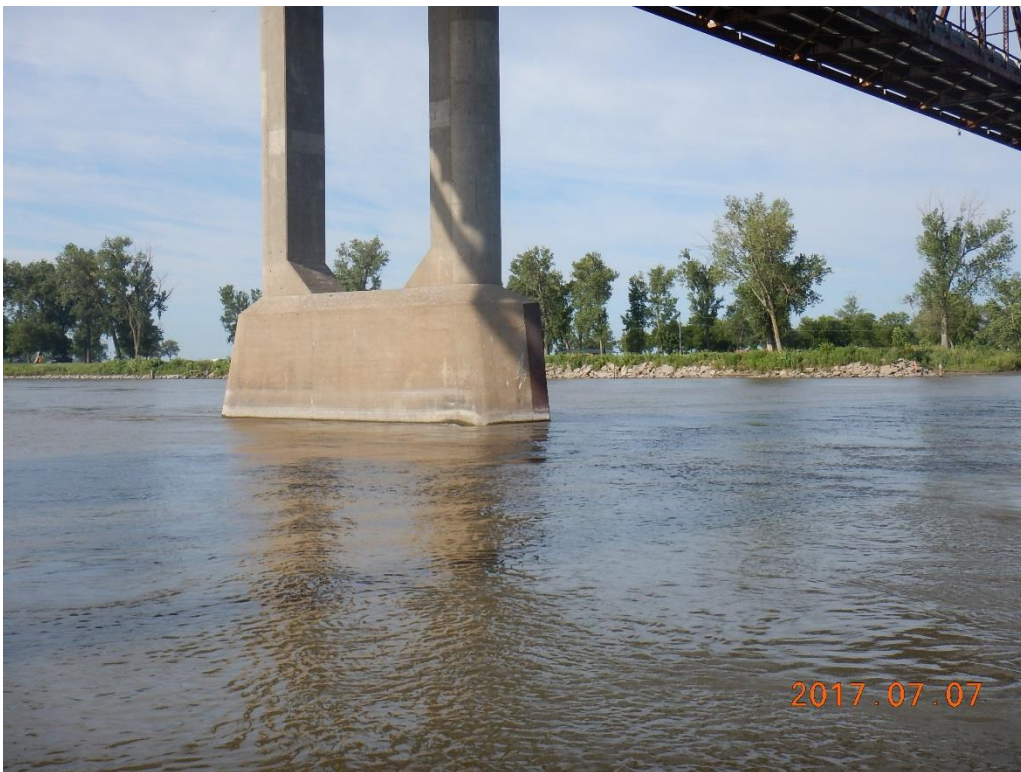
Pier 5 – No Debris at Upstream Nose
