## **APPENDIX H. ENVIRONMENTAL REVIEW DOCUMENTS**

## **Bellevue Bridge Alternatives Study**

### **List of Potential Permits and Other Applicable Regulations**

Figure 2 - Index Map  
**Resource Map**  
 Bellevue Bridge Alternatives Study  
 Sarpy County, NE; Mills County, IA

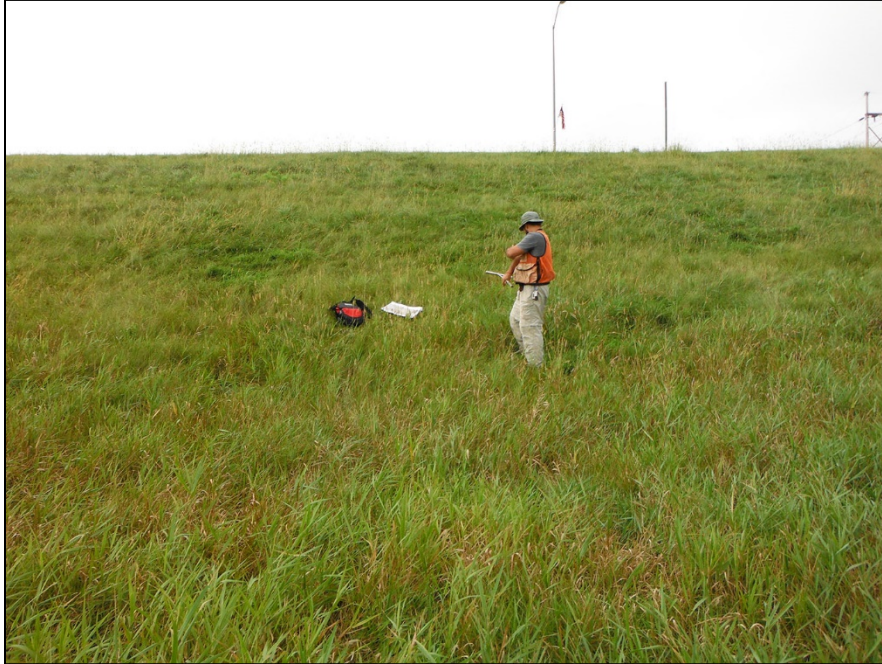
**Photograph 1.** View south toward sample point S-1, the upland outpost for Wetland 2, located on slope leading up to East Mission Avenue. This area is dominated by *Poa pratensis* and *Setaria pumila*.

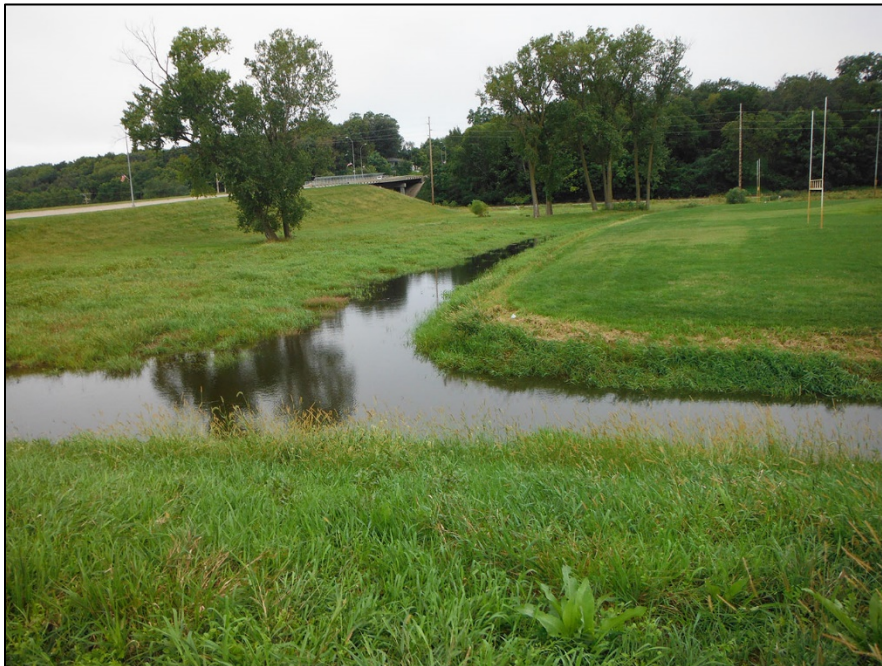
**Photograph 2a.** View west toward sample point S-2 and Wetland 2, a PEMA/PEMC wetland located between a soccer field and East Mission Avenue. Drainage swales within the wetland contained standing water; dominants included *Cyperus esculentus* and *Persicaria maculosa*. Areas above the swales were dominated by *Phalaris arundinacea*.

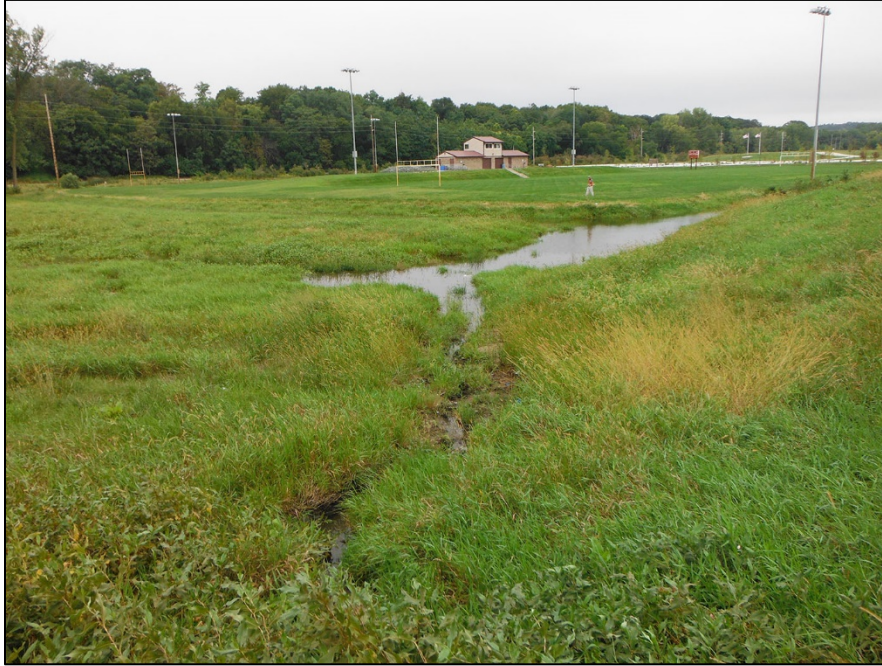
**Photograph 2b.** View northwest toward Wetland 2, overlooking the ditch/drainage swale. The ditch drains into a culvert under 15<sup>th</sup> Street and ultimately leading to the Missouri River.

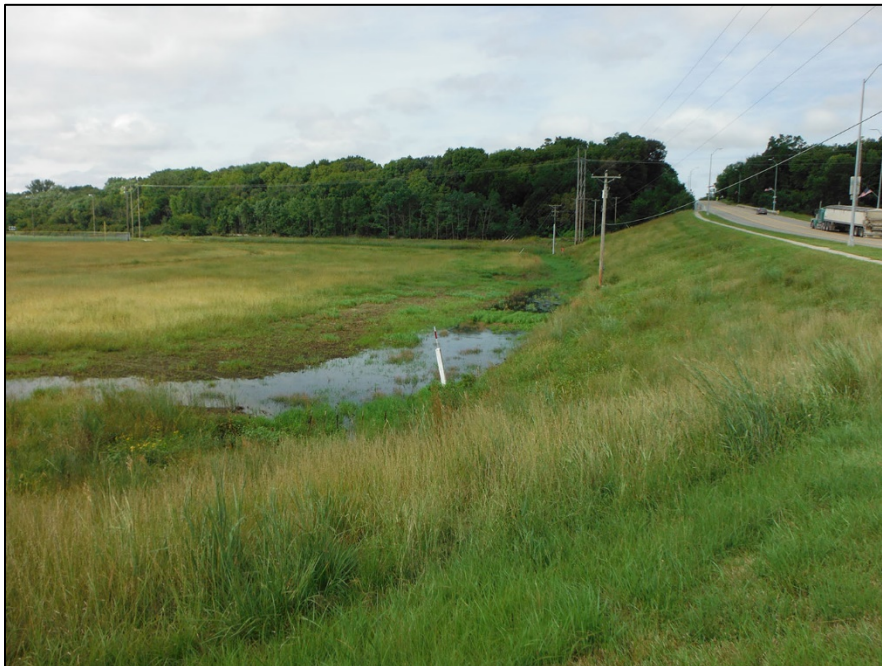
**Photograph 3.** View west toward sample point S-3 and Wetland 3, a PEMA/PEMC wetland dominated by *Phalaris arundinacea* and *Persicaria maculosa*. Standing water was present throughout much of the wetland.

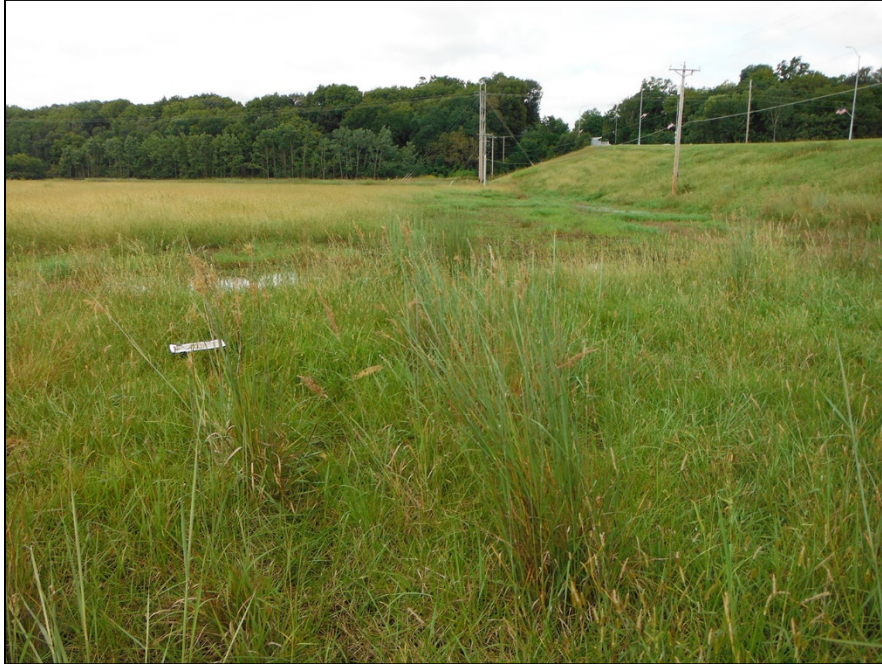
**Photograph 4.** View west toward sample point S-4, the upland outpost for Wetland 3, located above the wetland. This area is dominated by *Sorghastrum nutans*, *Schedonorus arundinaceus*, and *Poa pratensis*.

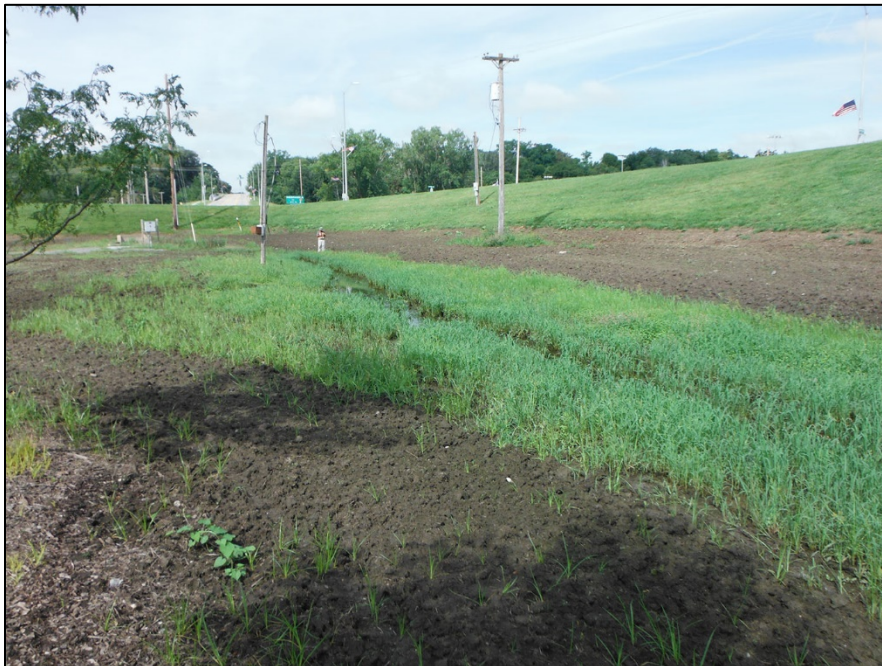
**Photograph 5a.** View west toward Wetland 5, a PEMA/PEMC wetland located in a drainage ditch leading to the Missouri River. The wetland is dominated by *Echinochloa crus-galli* and *Cyperus esculentus*. The surrounding area was recently inundated from high river levels, but waters had since receded. At the time of the site visit, standing water remained only within the ditch containing the wetland. The area surrounding the wetland had been tilled.

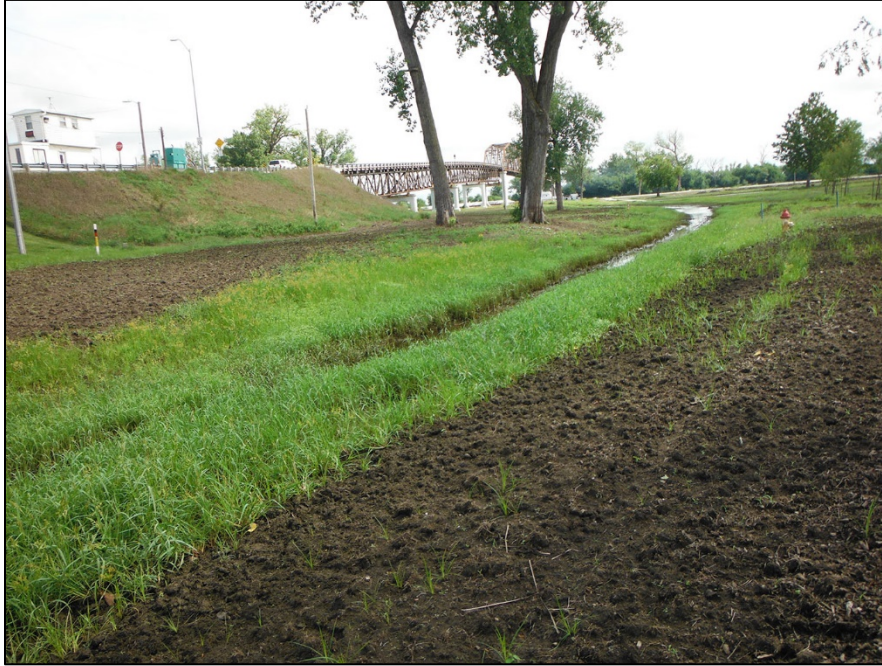
**Photograph 5b.** View northeast toward the drainage ditch associated with Wetland 5. This portion of the ditch was not delineated due to being outside the ESA; however, Wetland 5 appears to continue outside the ESA along the drainage ditch until it enters a culvert under River Drive and then drains into the Missouri River.

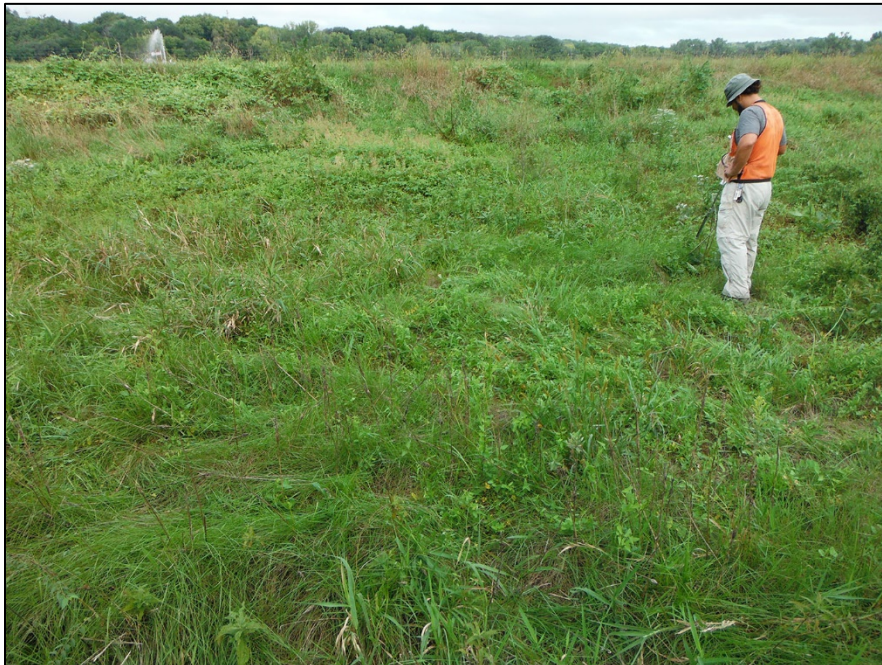
**Photograph 6.** View northwest toward sample point S-6, the upland outpost for Wetlands 7, 8, and 9. This area is dominated by *Poa pratensis* and *Convolvulus arvensis*.

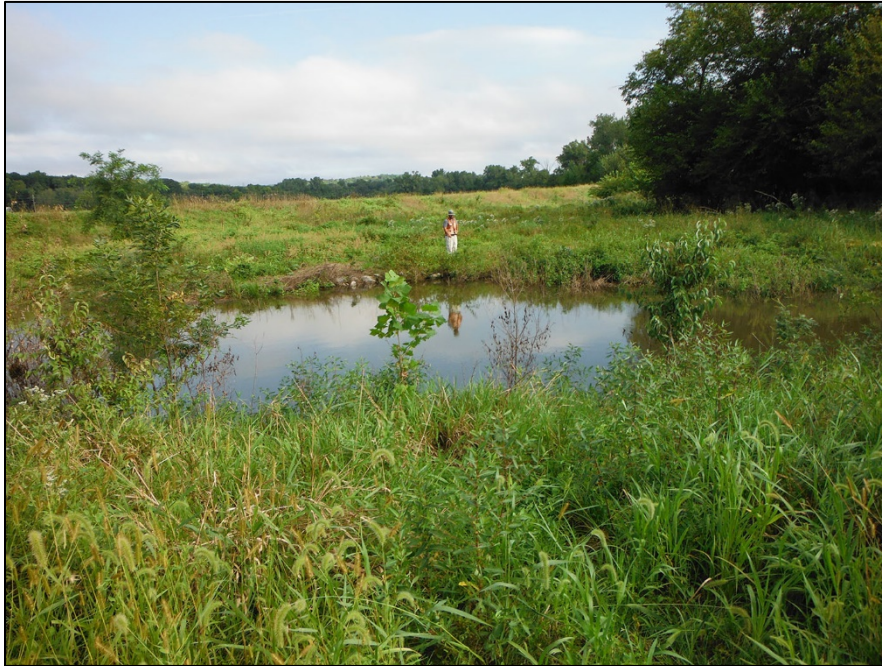
**Photograph 7.** View north toward sample point S-7, Channel 7, and Wetland 7. Wetland 7 is a PEMA/PEMC wetland located along the fringes of Channel 7, which is an intermittent tributary ditch leading to the Missouri River. The wetland is dominated *Phalaris arundinacea* and *Apocynum cannabinum*. The channel is the outlet from the drainage ditches on the west side of 15<sup>th</sup> Street, and also from the pond and the parking lot at American Heroes Park.

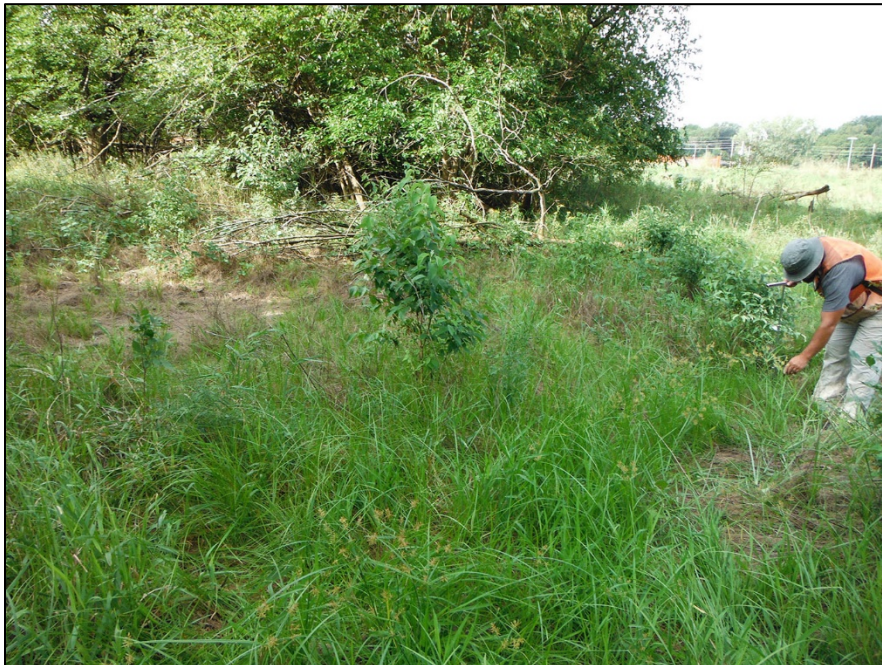
**Photograph 8.** View south toward sample point S-8 and Wetland 8, a PEMA/PEMC wetland located in a floodplain depression. Dominant species include *Fraxinus pennsylvanica*, *Cornus drummondii*, *Cyperus esculentus*, and *Phalaris arundinacea*.

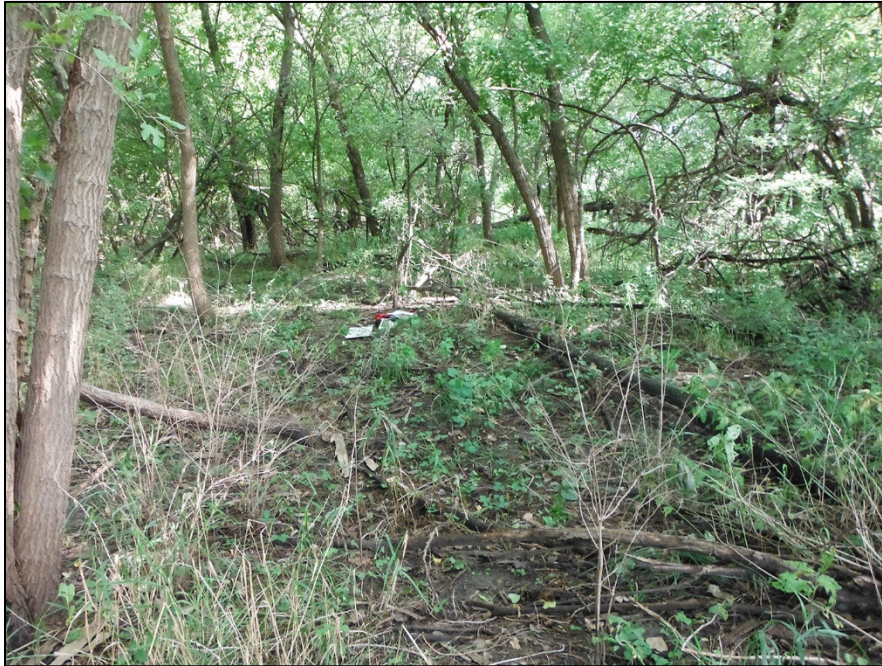
**Photograph 9.** View north toward sample point S-9 and Wetland 9, a PFOA wetland located in the riparian corridor along the west bank of the Missouri River. Dominant species included *Cornus alternifolia*, *Morus alba*, *Populus deltoides*, *Fraxinus pennsylvanica*, and *Teucrium canadense*.

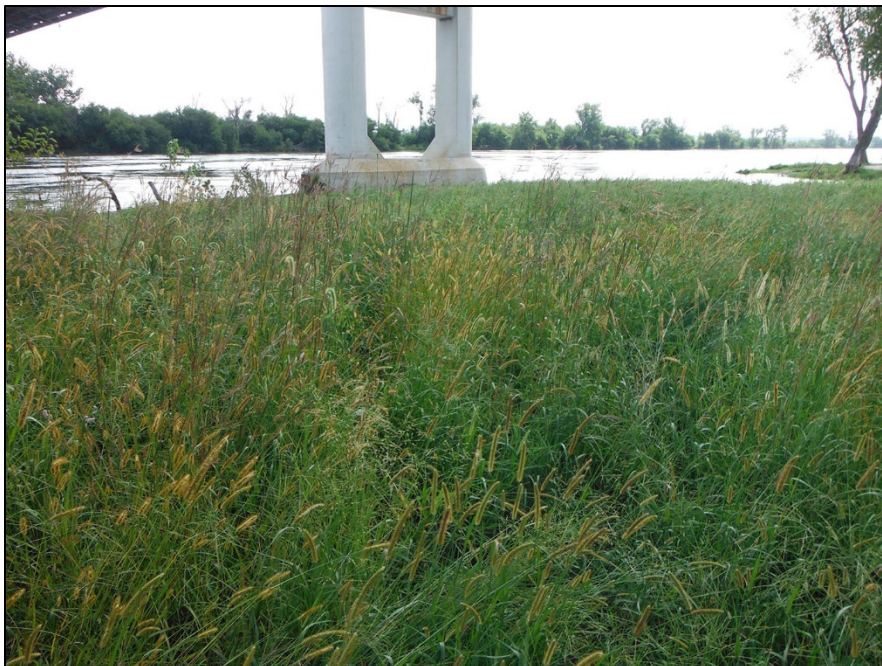
**Photograph 10.** View east toward sample point S-10, the upland outpost for Wetland 11. This area is dominated by *Setaria viridis*. The Missouri River (Channel 11) is present in the background.

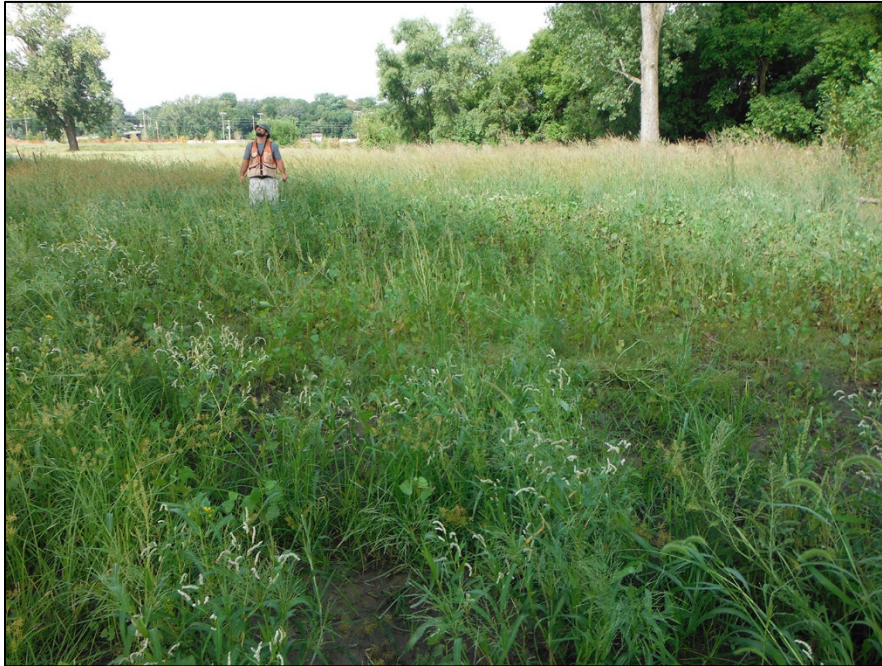
**Photograph 11.** View west toward sample point S-11 and Wetland 11, a PEMA/PEMC wetland located under the Bellevue Bridge along the west bank of the Missouri River (Channel 11). Dominant species are *Populus deltoides*, *Cyperus esculentus*, *Panicum dichotomiflorum*, and *Persicaria lapathifolia*.

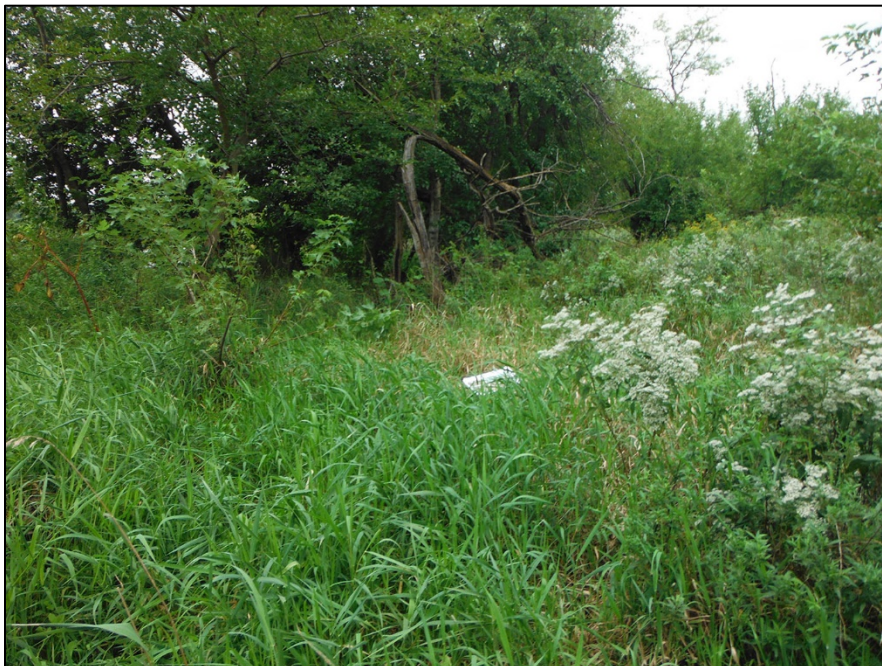
**Photograph 12.** View northwest toward sample point S-12 and Wetland 12, a PFOA wetland located in the riparian corridor along the east bank of the Missouri River. Dominant species are *Acer saccharinum*, *Morus alba*, and *Phalaris arundinacea*.

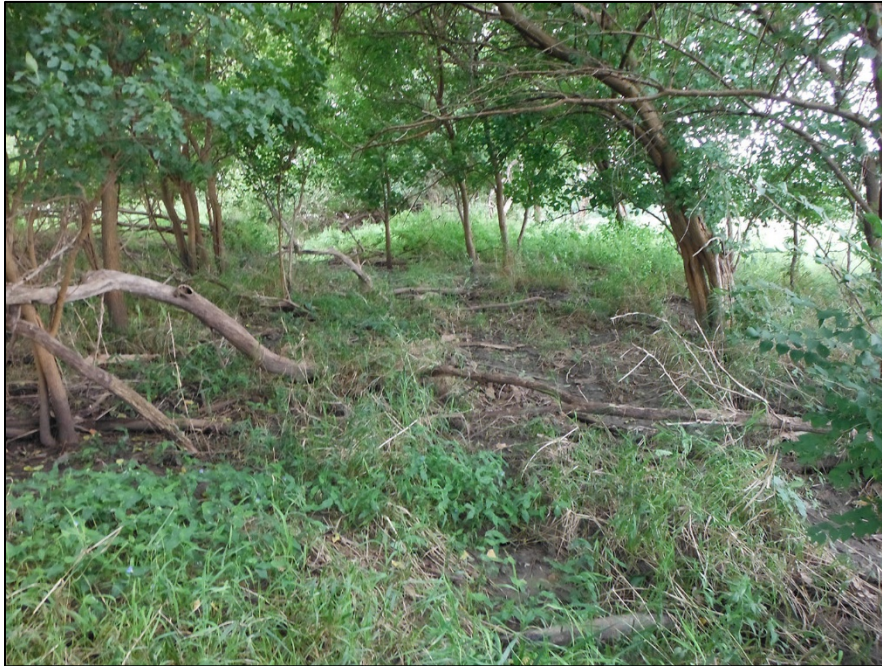
**Photograph 13.** View west toward sample point S-13 and Wetland 13, a PFOA wetland located in the riparian corridor along the east bank of the Missouri River. There is evidence of overland flow through the area, but no channel or erosional features. Dominant species are *Morus alba*, *Populus deltoides*, and *Phalaris arundinacea*.

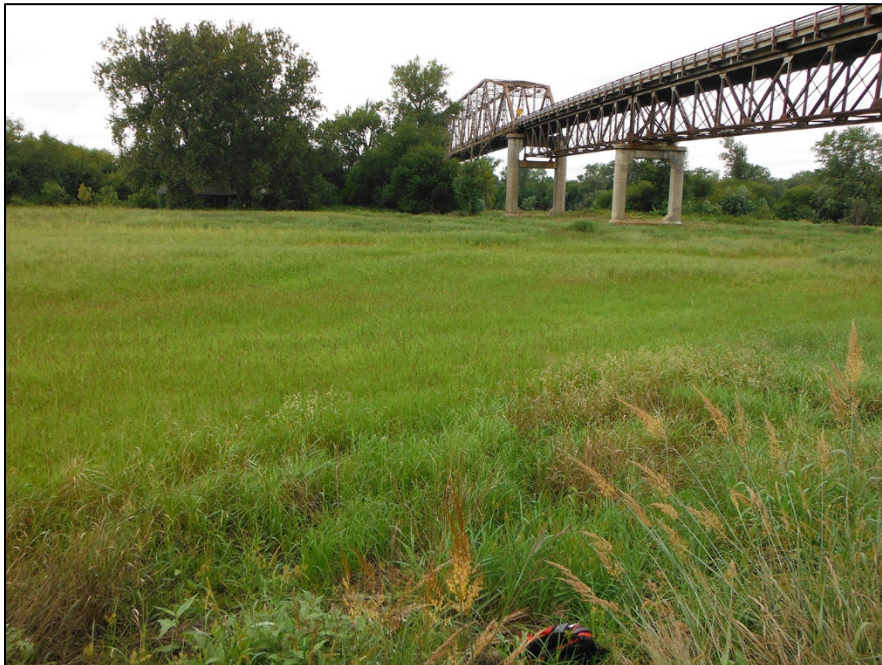
**Photograph 14.** View west toward sample point S-14 and Wetland 14, a PEMA/PEMC wetland located in the floodplain of the Missouri River. Dominant species are *Echinochloa crus-galli* and *Panicum dichotomiflorum*.

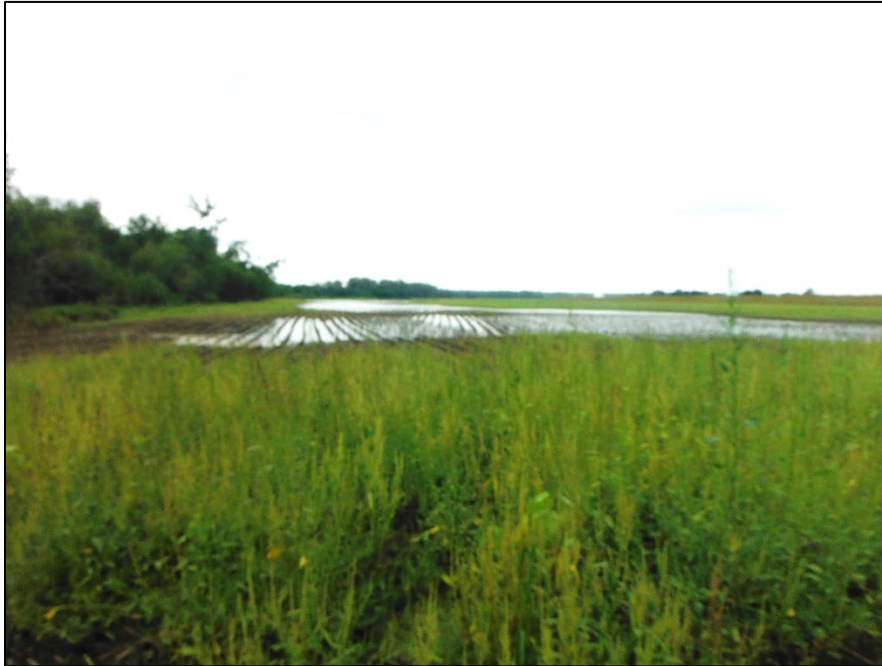
**Photograph 15.** View north toward sample point S-15 and Wetland 15, a farmed PEMA/PEMC wetland that appears to have been planted in soybeans earlier in the year. The area has since been colonized by weedy annuals, including *Amaranthus tuberculatus* and *Xanthium strumarium*.

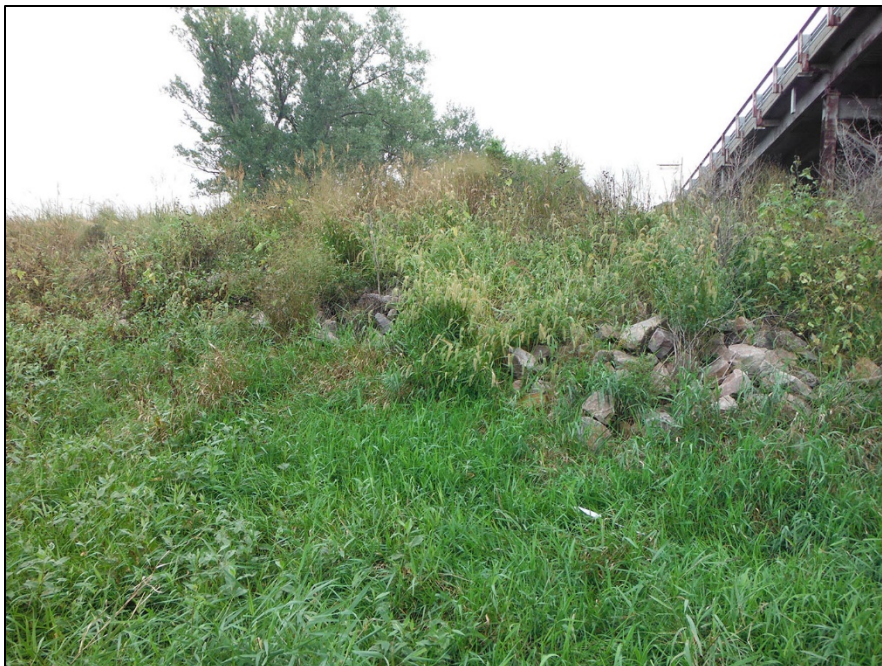
**Photograph 16.** View northeast toward sample point S-16, the upland outpost for Wetlands 12, 13, 14, and 15. The point is located on the riverside slope of the levee and is dominated by *Setaria faberi* and *Sorghastrum nutans*.

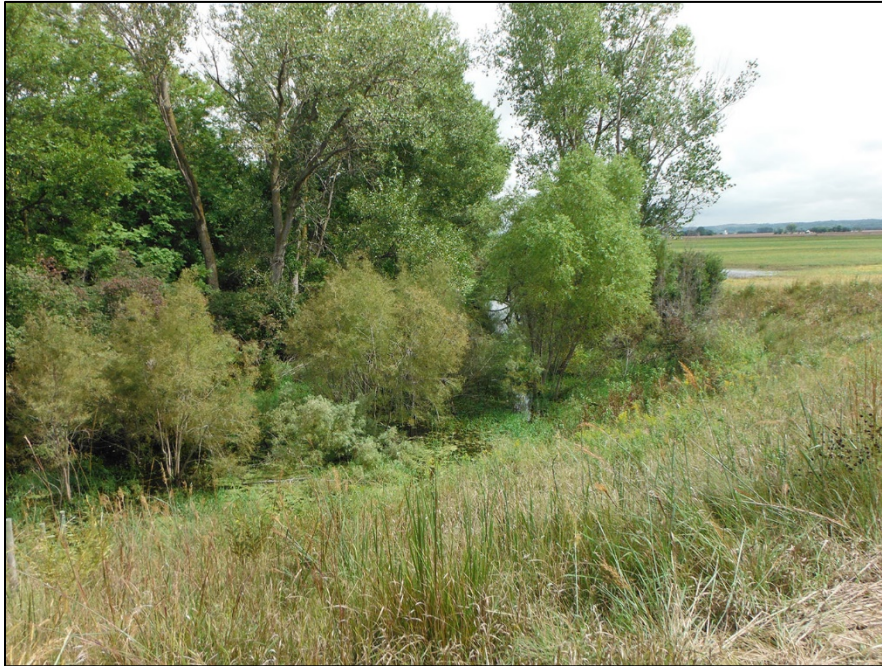
**Photograph 17a.** View northeast toward the edge of Wetland 17, a PFOA wetland located on the south side of H10 and the Bellevue Bridge embankment. Dominant species are *Populus deltoides*, *Salix amygdaloides*, *Salix interior*, *Cornus drummondii*, and *Phalaris arundinacea*.

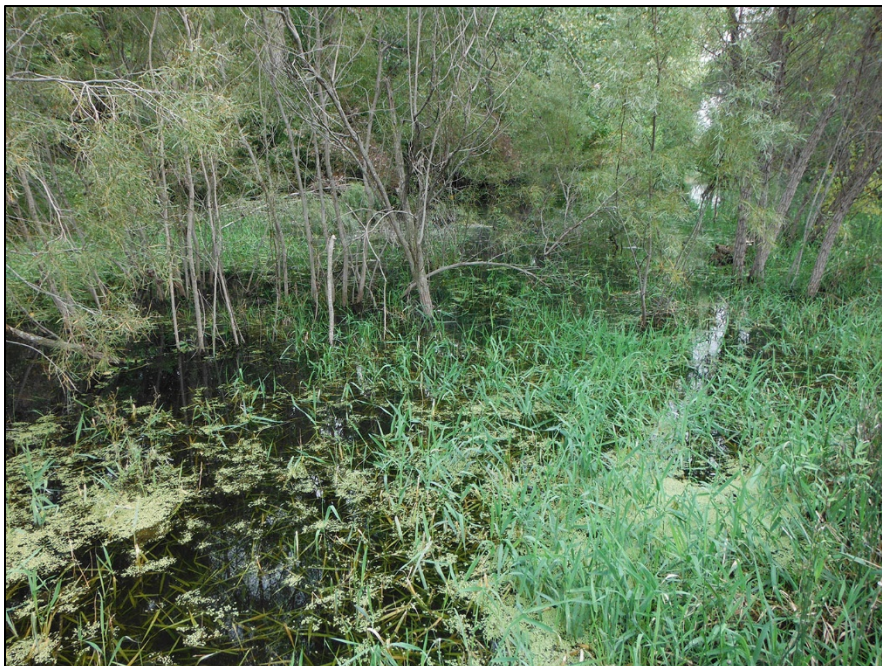
**Photograph 17b.** View northeast toward sample point S-17 and the center of Wetland 17. Much of the wetland was inundated during the site visit.

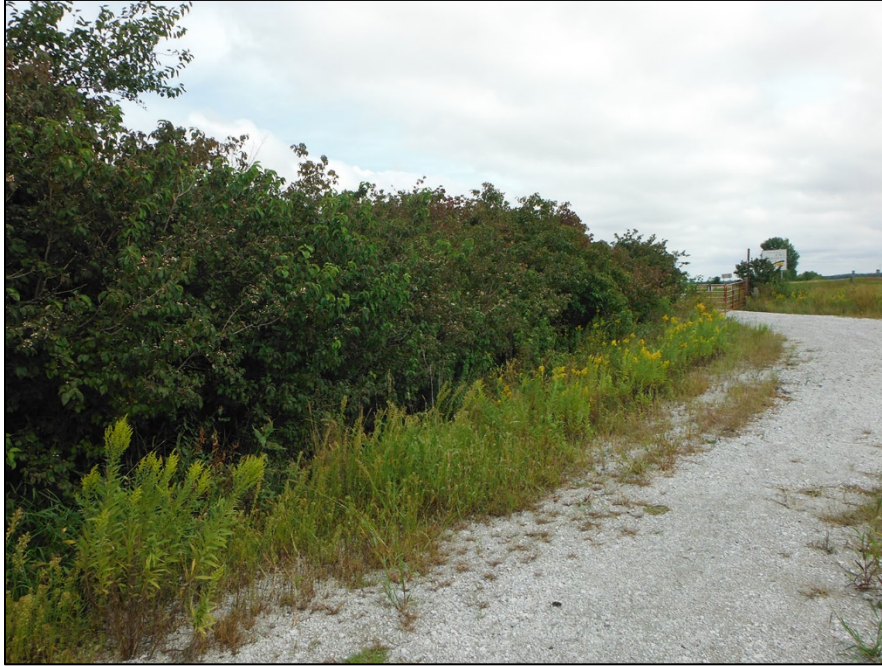
**Photograph 18a.** View north toward Wetland 18, a PSSA wetland located in the ditch between County Road H10 and a gravel levee access road. Dominant species are *Cornus drummondii*, *Morus alba*, *Phalaris arundinacea*, and *Solidago gigantea*.

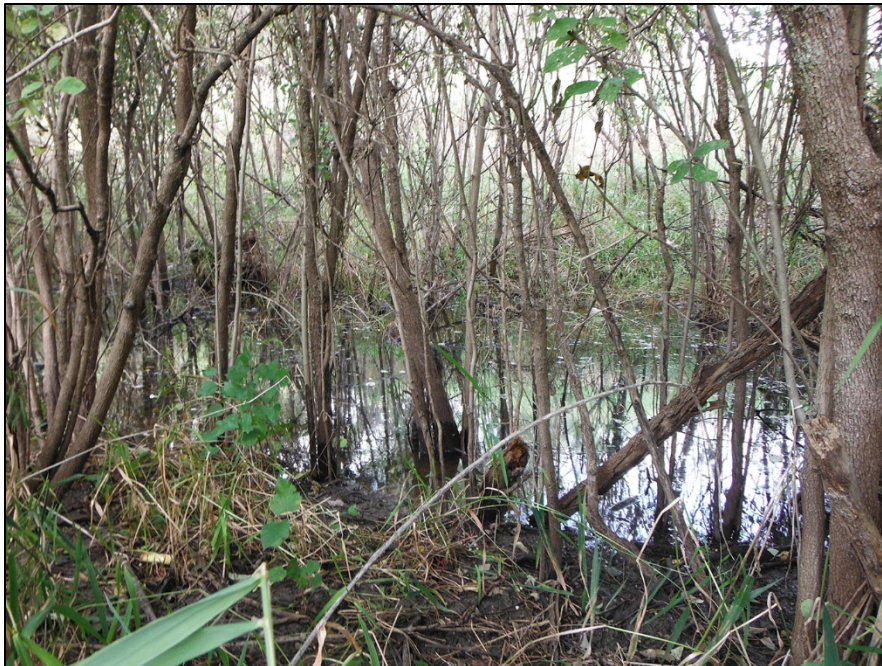
**Photograph 18b.** View northwest toward sample point S-18 and Wetland 18. Standing water was present in the bottom of the ditch. Most herbaceous vegetation was restricted to the fringes of the water.

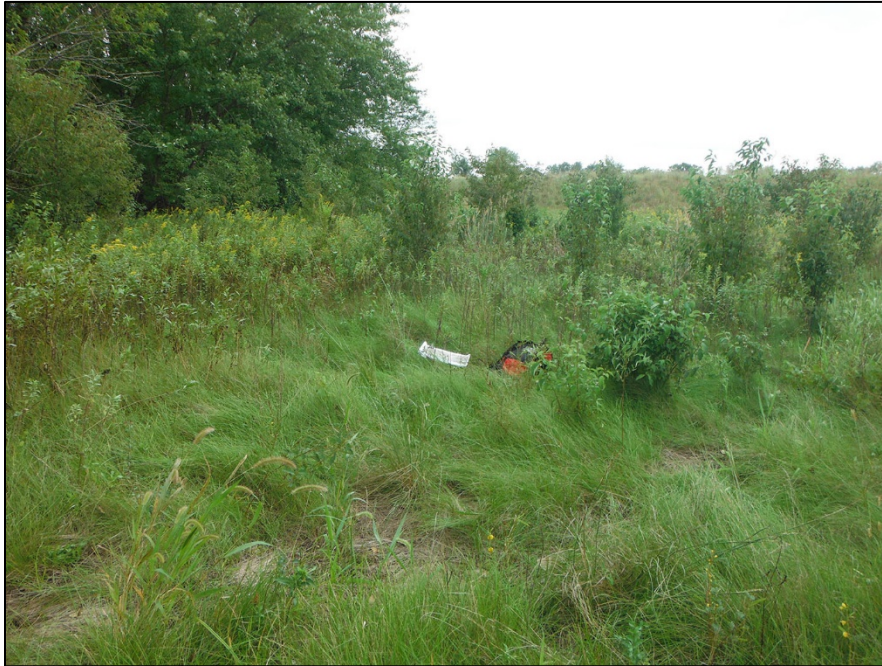
**Photograph 19.** View southwest toward sample point S-19, the upland outpost for Wetlands 20, 21 and 22, located on a flat area that is at a higher elevation than the adjacent wetlands. This area is dominated by *Poa pratensis* and *Cornus drummondii*.

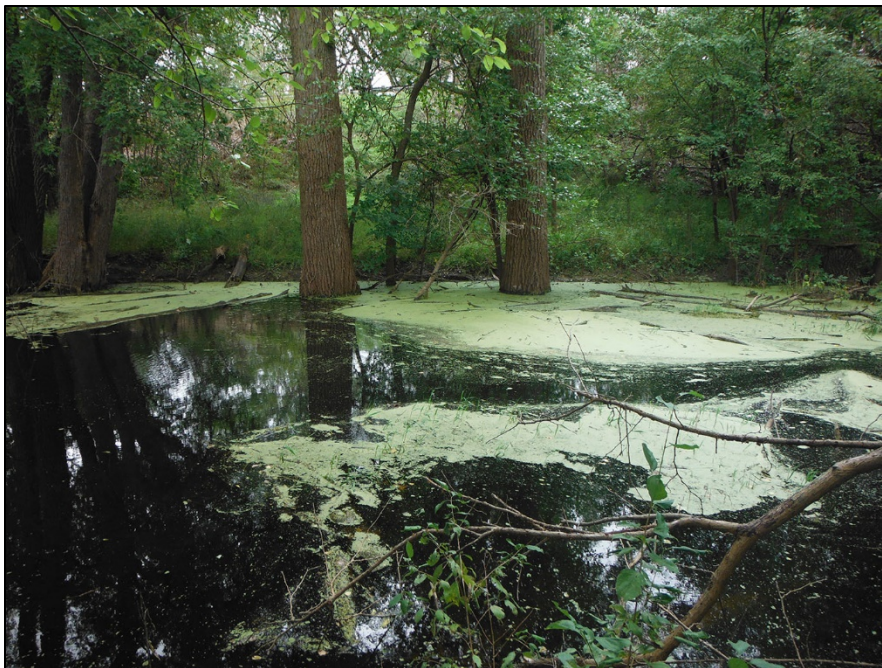
**Photograph 20.** View southeast toward sample point S-20 and Wetland 20. This PFOA wetland is dominated by *Morus alba*, *Populus deltoides*, *Cornus drummondii*, *Phalaris arundinacea*, *Solidago canadensis* and *Toxicodendron radicans*.

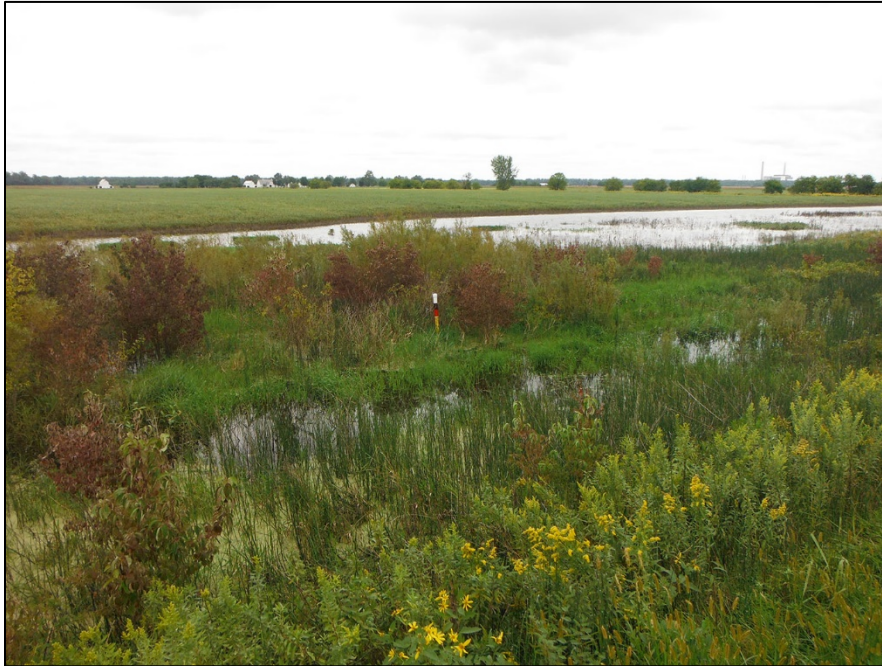
**Photograph 21.** View north toward sample point S-21 and Wetland 21, a PSSA wetland located in the ditch on the north side of County Road H10. Dominant species include *Morus alba*, *Cornus drummondii*, *Salix interior*, *Phalaris arundinacea*, *Equisetum arvense*, and *Lemna minor*.

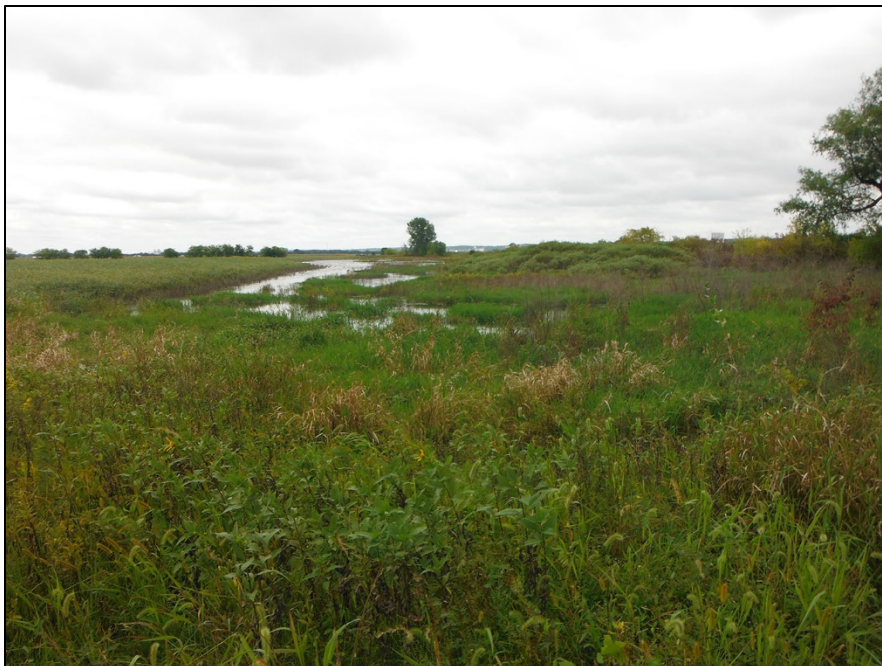
**Photograph 22.** View east toward sample point S-22 and Wetland 22, a PEMA/PEMC wetland located between an agricultural field on the north and County Road H10 on the south. Dominant species include *Phalaris arundinacea*, *Polygonum coccineum*, and *Cornus drummondii*.

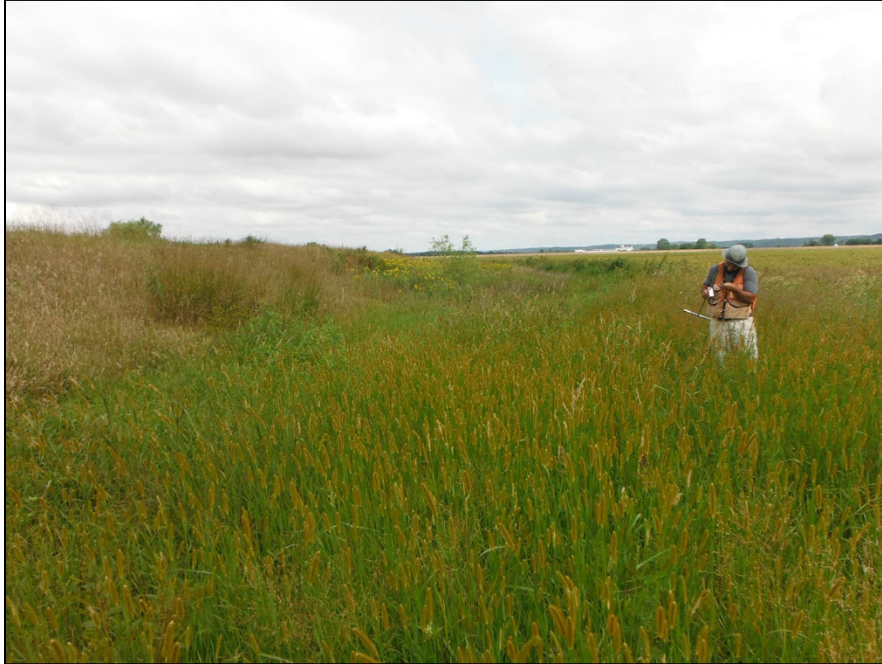
**Photograph 23.** View northeast toward sample point S-23, the upland outpost for Wetland 24. This area is dominated by *Setaria viridis*.

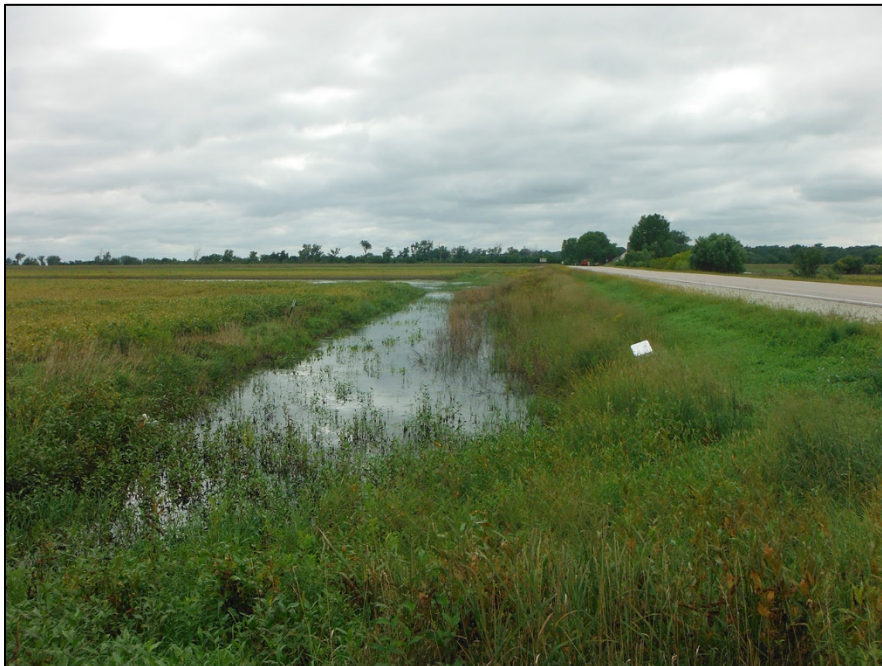
**Photograph 24.** View southwest toward sample point S-24 and Wetland 24, a PEMA/PEMC wetland located in the ditch on the south side of County Road H10. Dominant species include *Polygonum coccineum*, *Echinodorus berteroi*, and *Apocynum cannabinum*.

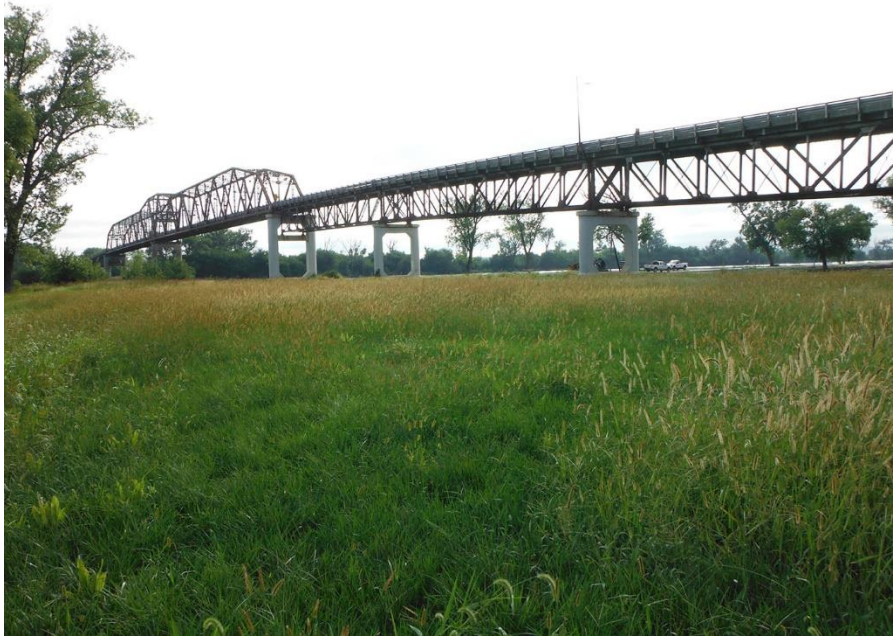
**Photograph 3.** View southeast toward the Bellevue Bridge. Bellevue Bridge is a continuous truss bridge over the Missouri River connecting Mills County, Iowa and Sarpy County, Nebraska near the city of Bellevue, Nebraska.

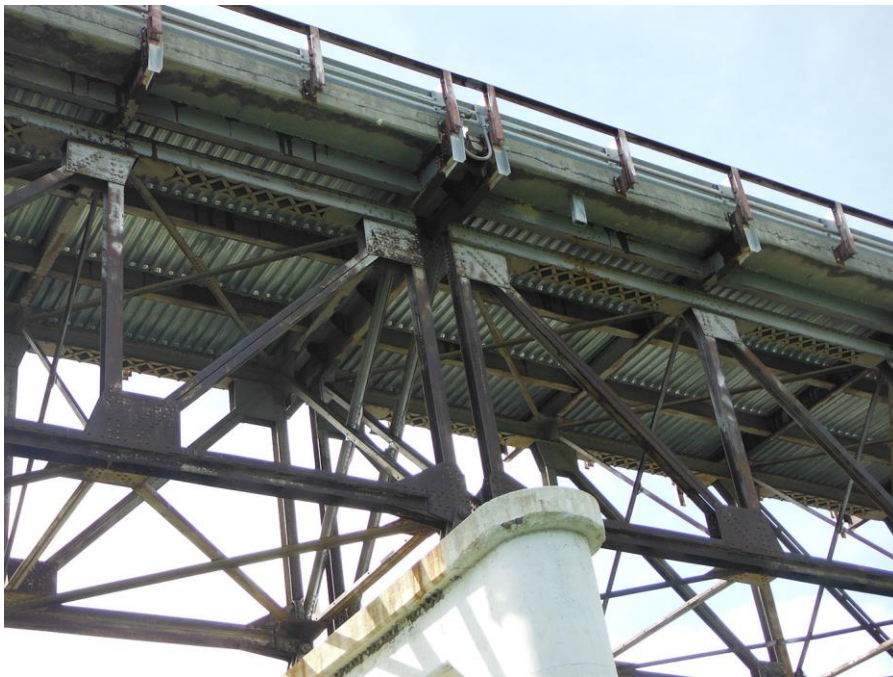
**Photograph 4.** View toward the bridge support substructure, which are painted. Paint on the materials used during the time of the bridge's construction may have contained lead-based materials. A lead inspection may be needed if paint removal or disposal is necessary.

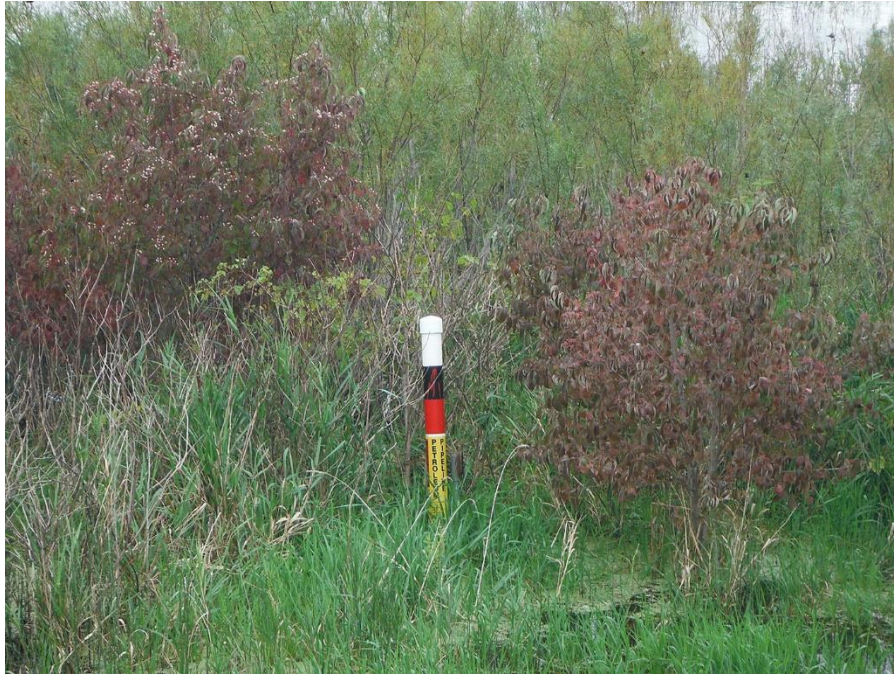
**Photograph 5.** View north toward a petroleum pipeline marker located north of Highway 370, in Iowa. Several utility markers such as this are present within the study area.
