APPENDIX E. STRUCTURAL DOCUMENTS

**Bellevue Toll Bridge
East Mission Avenue over the Missouri River
Bellevue, Nebraska**

**Structure No. S370 01918
Fracture Critical and Routine NBIS Bridge Inspection
April 2017**

Prepared for:
Bellevue Bridge Commission

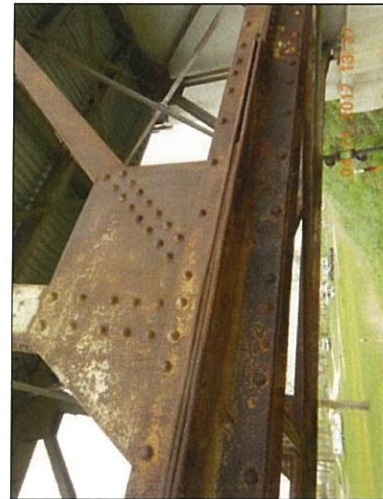
Span 1 L1L2 Lt middle batten plate hole

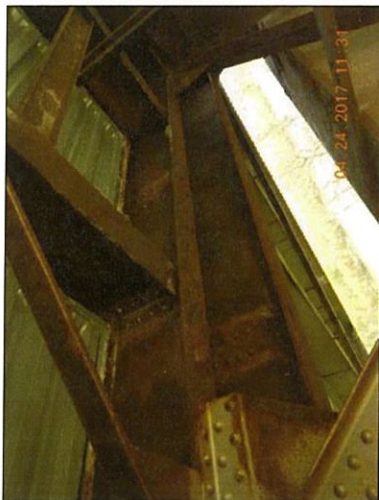
Span 7 Floorbeam 0 interior deterioration (3)

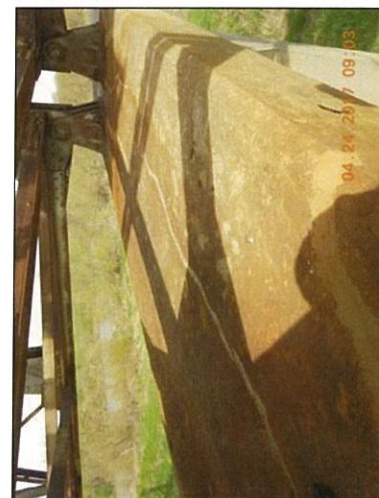
Pier 7 South top deterioration
