APPENDIX E. STRUCTURAL DOCUMENTS

**Bellevue Toll Bridge
East Mission Avenue over the Missouri River
Bellevue, Nebraska**

**Structure No. S370 01918
Fracture Critical and Routine NBIS Bridge Inspection
April 2017**

Prepared for:
Bellevue Bridge Commission

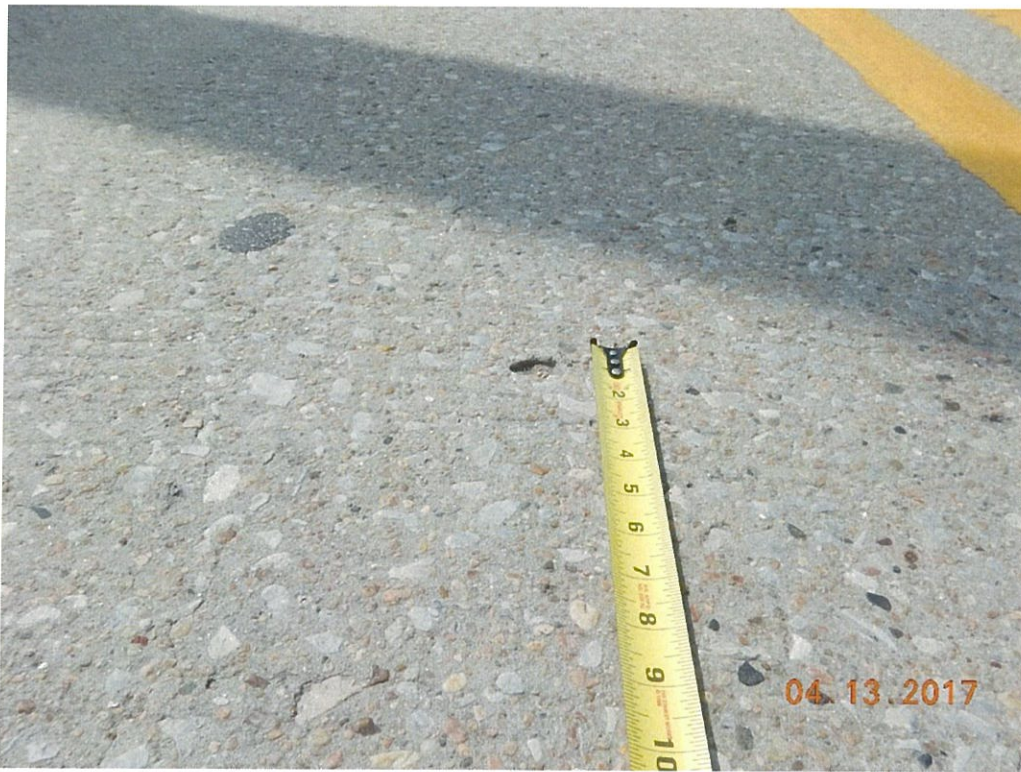
The area within 2' of each curb is showing light scaling, 1/16" to 1/8". There are several small aggregate popouts, 1/4" to 1", (Photo 5) and other snow plow markings (Photo 6) scattered throughout the deck surface. Where the deck is continuous over a floorbeam there is transverse cracking (Photo 7). Other areas of heavier map cracking, higher concentration of transverse cracking over the floorbeams, and areas of wear are identified in deck deficiency drawings in Figures 7 through 10 on the following pages – note there are no changes in the drawing from the last inspection.

Photo 5: There are several small aggregate popouts, ¼" to 1", scattered throughout the deck surface.

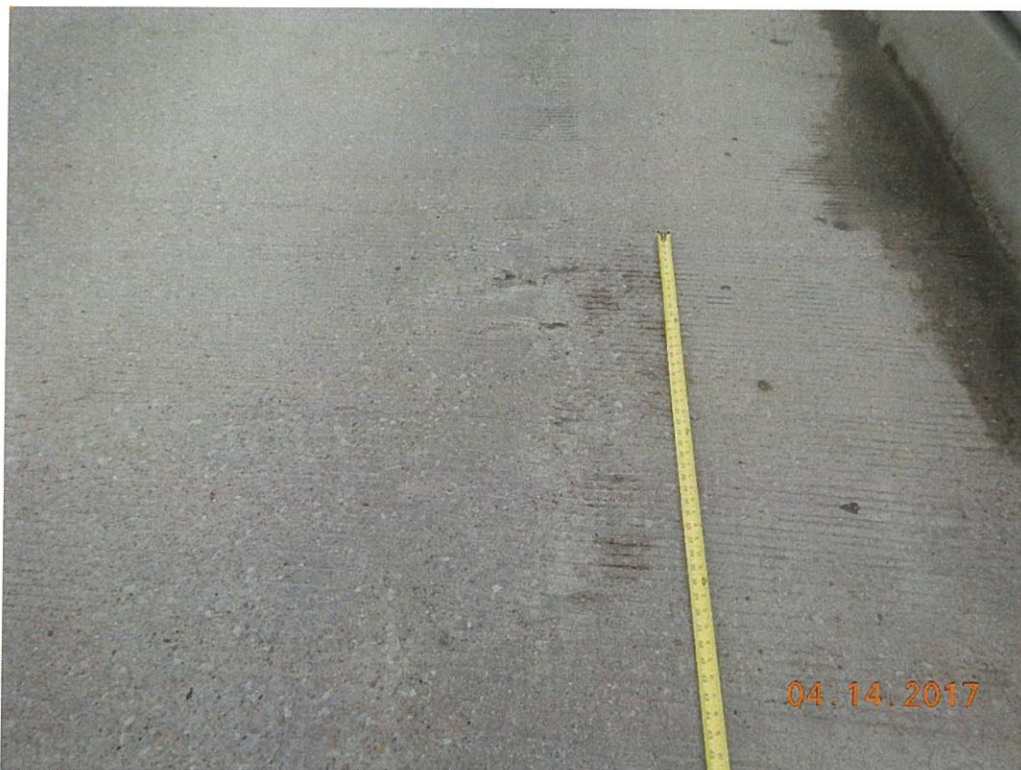
Photo 6: There are several snow plow markings scattered throughout the deck surface.

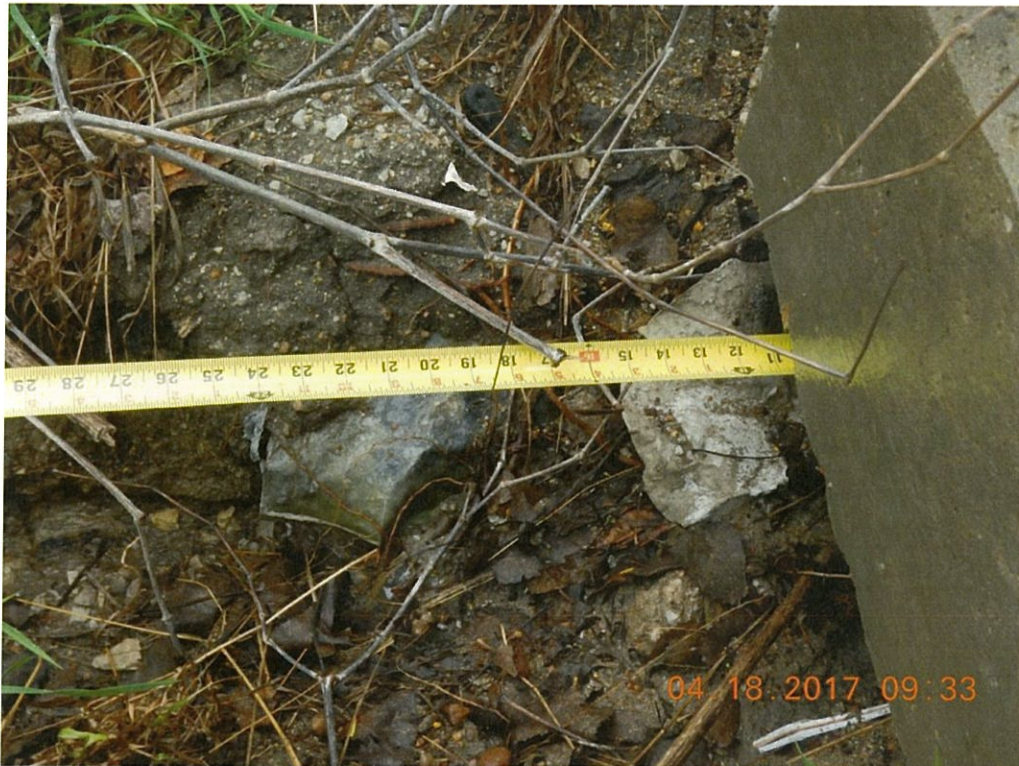
Both concrete approach slabs have transverse cracks and hairline longitudinal cracks; some of the cracks have previously been sealed. The east approach slab is undermined adjacent to the north barrier wall in two spots. At the abutment the penetration is approximately 6" tall by 4' wide x 3' below the slab (Photo 12). At the end of the slab where the ditch is eroding the penetration is approximately 6" tall by 2' wide by 2' below the slab (Photo 13). There is minor undermining along the south edge of the slab at the abutment. The undermining is causing some distress on the surrounding slab evident by diagonal cracking.

Photo 13: The east approach slab is undermined adjacent to the north barrier wall in two spots. Shown is at the end of the slab where the ditch is eroding is the penetration is approximately 6" tall by 2' wide by 2' below the slab.

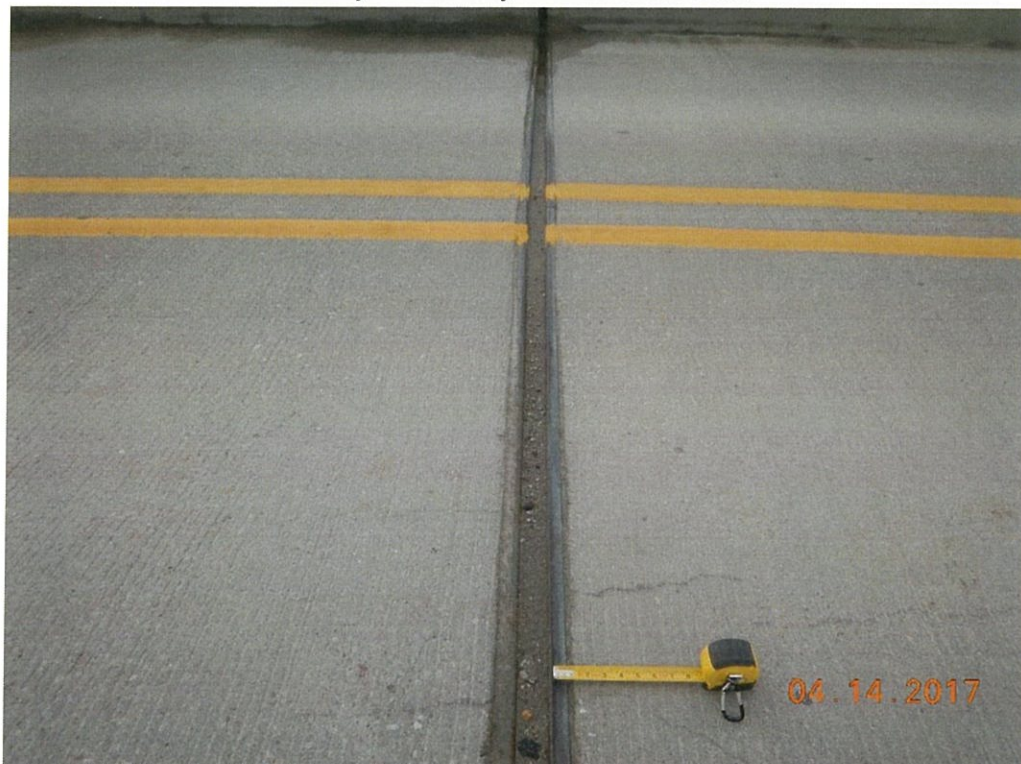
Strip seal joints are present at the abutments, Piers 1 through 3, Pier 5, and Piers 7 through 10, and also L7 and L7' of the thru truss spans. All of these joints are full of debris but appear to be functioning properly (Photo 14). The steel armoring on several of these joints have evidence of plow damage. Each of these joints has evidence of water leakage below. At the inspection it was noted water was dripping from one of the joint ends. Further investigation indicated there are typically two small holes in each joint end, at all strip seal joints (Photo 15). The consistency of the hole size, shape, and location indicates this may have occurred during installation.

Photo 14: All of the strip seal joints are full of debris.

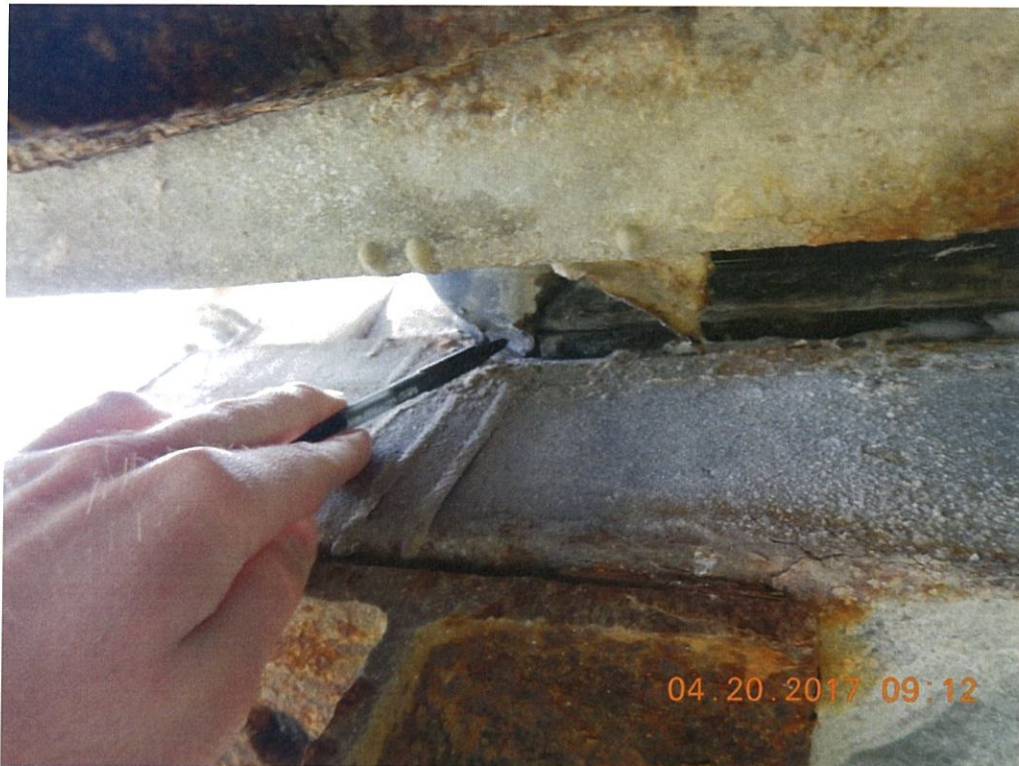
Various cracking is present throughout the deck but has not changed since the last inspection. Each strip seal joint has evidence of water leakage below. There are typically two small holes in each end of each of these joints.

Photo 15: There are typically two small holes in each end of the joint, at all strip seal joints. The north end of the joint above Pier 2 is shown and water is visibly coming out of the hole.

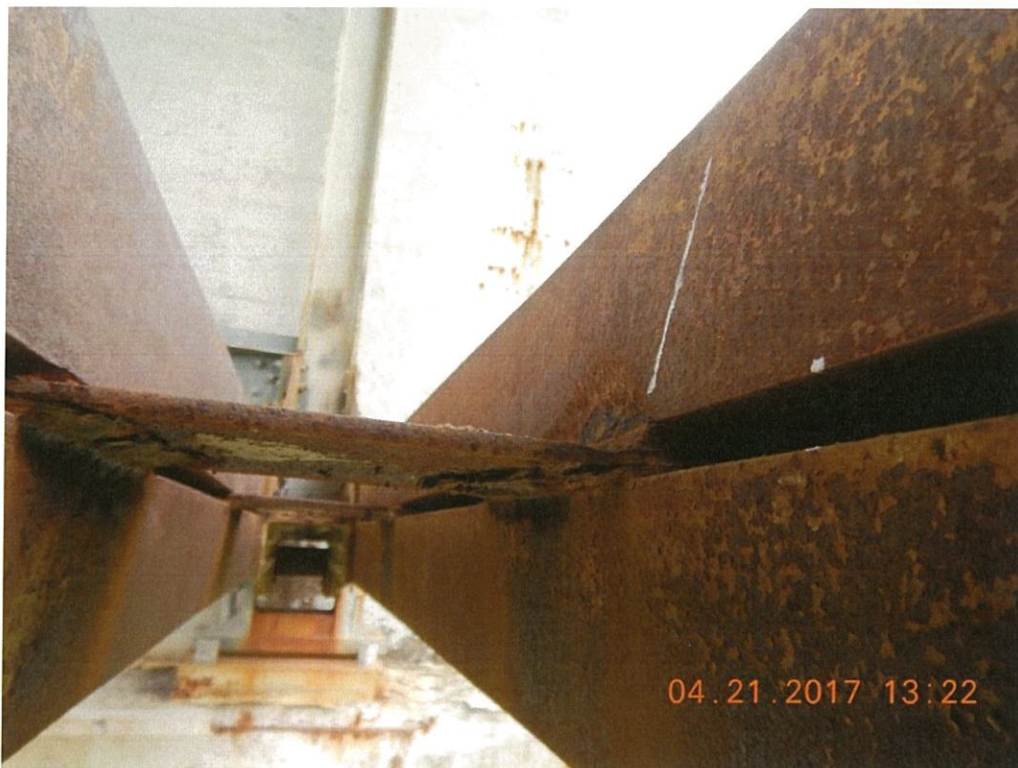
The section loss at the batten plates of the lower chords is typically on the inside of the lower chord angle above and below the batten plate. Most of these areas have some form of section loss in the angles. Typically this loss is minimal and does range to approximately 1/8" depth for 1" to 2" above and below the batten plate (Photos 21 and 22). This loss does also go into some batten plates with holes having formed in the middle batten plates of Span 1 L0L1 Lt. (Photo 23) and Span 1 L1L2 Lt. (Photo 24) and the west batten plate in Span 2 L0L1 Lt. (Photo 25).

Photo 22: The section loss at the batten plates of the deck truss lower chords is typically on the inside of the lower chord angle above and below the batten plate. Span 1 L0L1 Lt. shown.

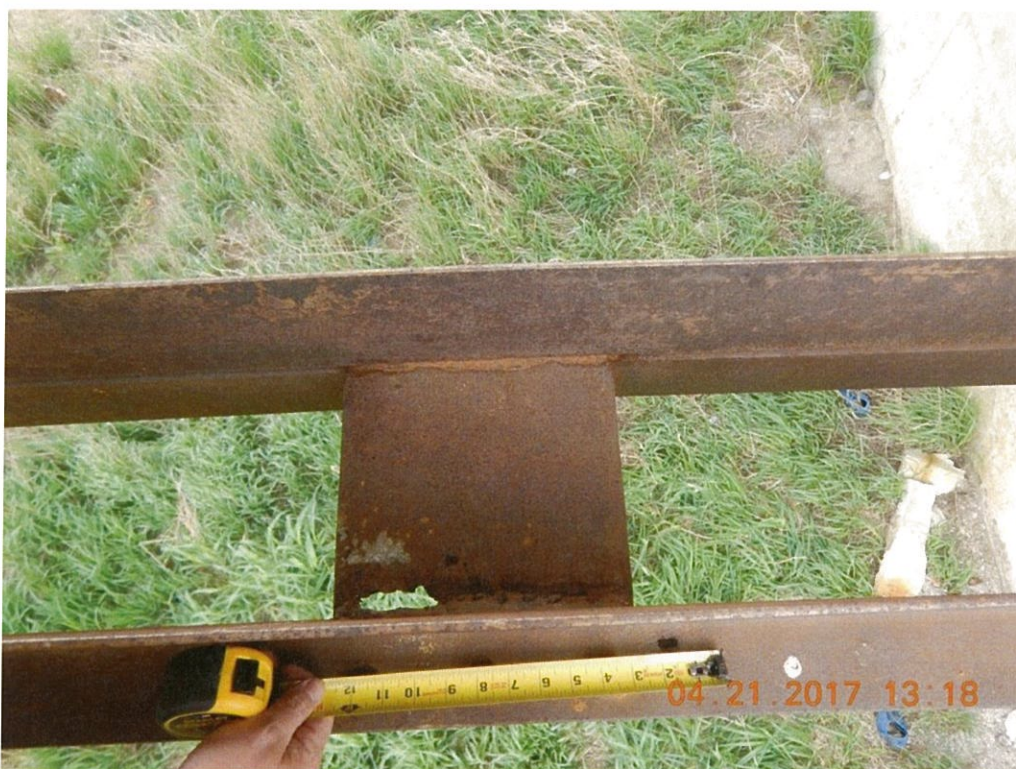
Photo 23: The loss shown in Photos 21 and 22 does also go into some batten plates with holes having formed in the middle batten plates of Span 1 L0L1 Lt.

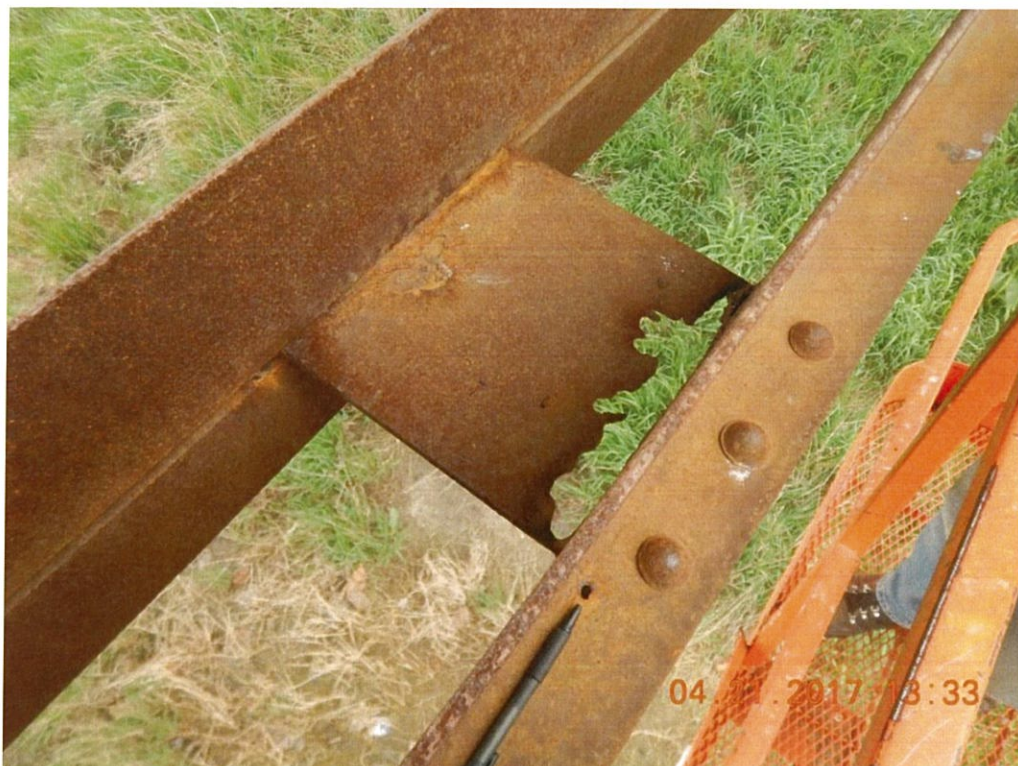
Photo 24: Similar loss in Span 1 L1L2 Lt. middle batten plate as shown in Photo 23. There is also a small $\frac{1}{4}$ " diameter hole in the horizontal leg of the top exterior angle of this member.

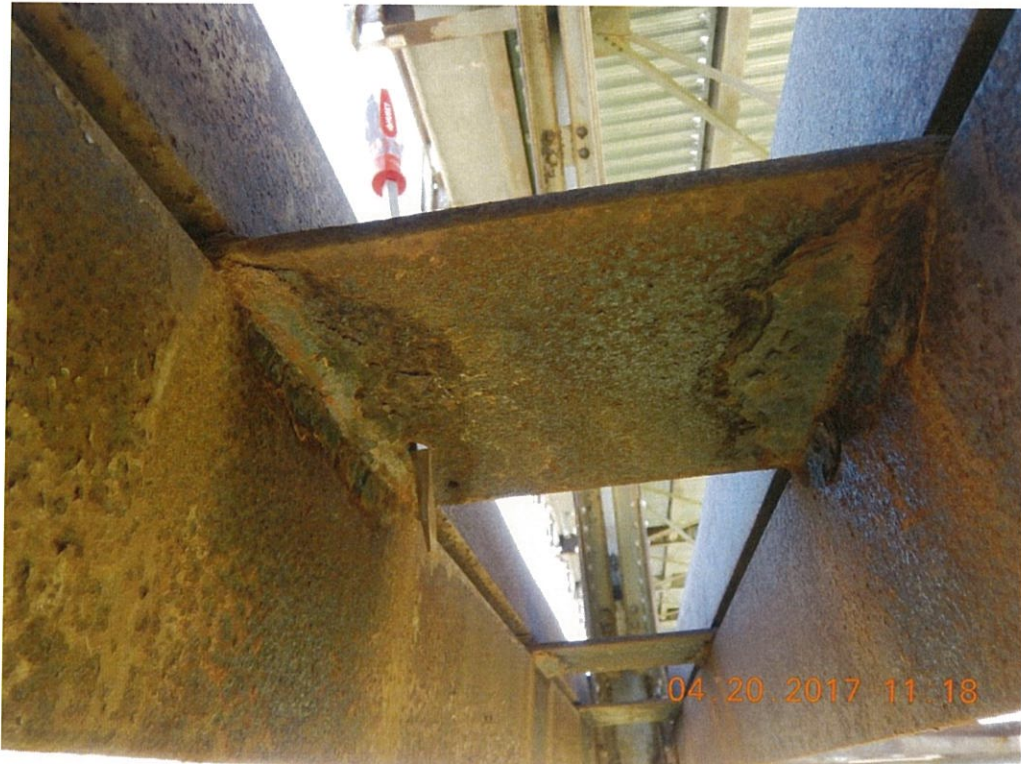
Photo 25: Similar loss in Span 2 L0L1 Lt. west batten plate as shown in Photos 22 and 23.

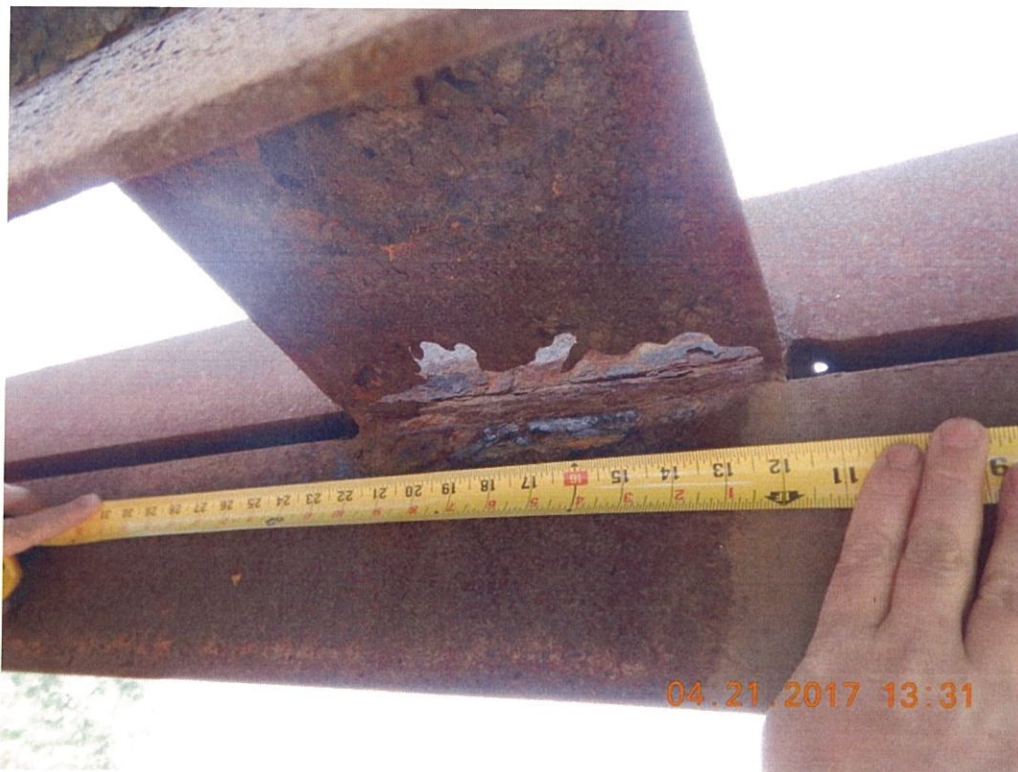
The worst case of lower chord loss is at the middle batten plate of Span 1 L1L2 Lt. There is complete section loss in both bottom angles for approximately 5" in length and 1" in depth (Photos 26 and 27). There is also a small 1/4" diameter hole in the horizontal leg of the top exterior angle just east of the middle batten plate rivets (Photo 24). This deterioration was not noted as being fully through the angle leg at the 2015 inspection but was noted as being fully through at the 2016 Coatings Inspection indicating possible accelerated section loss. A 1/2" diameter hole in the horizontal leg of the top exterior angle just west of the middle batten plate rivets in Span 1 L0L1 Lt. was also noted at this inspection that wasn't previously noted (Photo 23). Minor amounts of concrete are sitting on the lower chords at some locations; the worst is below the deck blowout.

Photo 26: The worst case of the deck truss lower chord loss is at the middle batten plate of Span 1 L1L2 Lt. Complete section loss in the exterior angle for approx. 5" in length and 1" in depth.

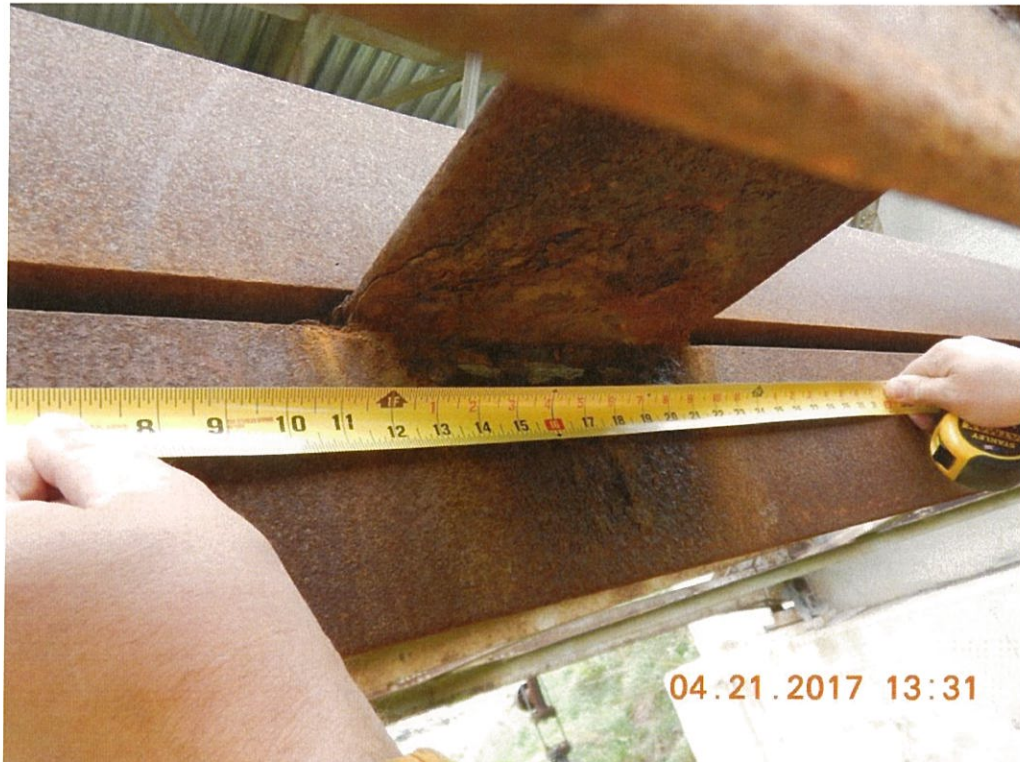
Photo 27: The worst case of the deck truss lower chord loss is at the middle batten plate of Span 1 L1L2 Lt. Complete section loss in the interior angle for approx. 5" in length and 1" in depth.

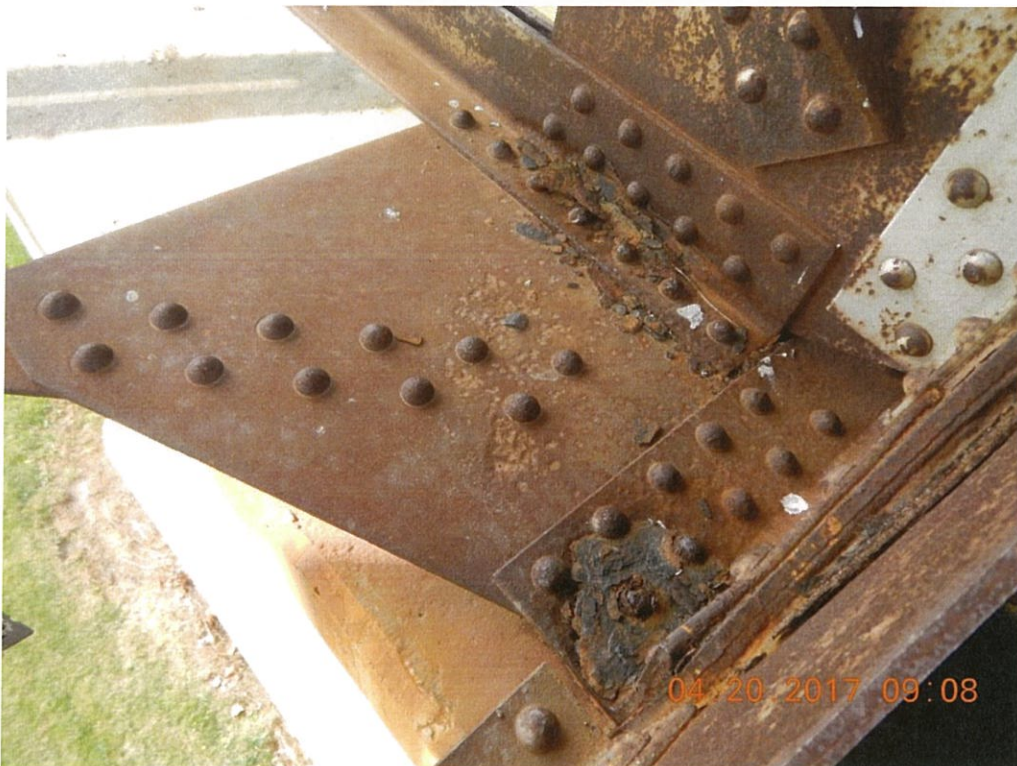
Section loss has occurred in several of the horizontal gusset plates from water previously sitting on the plates (Photo 28). The worst is typically at the horizontal gusset plates above the truss bearings with rivet heads deteriorated at some locations. The horizontal plates between the lower chord members at these locations have similar deterioration with rivet head deterioration.

Photo 28: Section loss has occurred in several of the deck truss horizontal gusset plates from water previously sitting on the plates. Span 3 L0 Lt. shown.

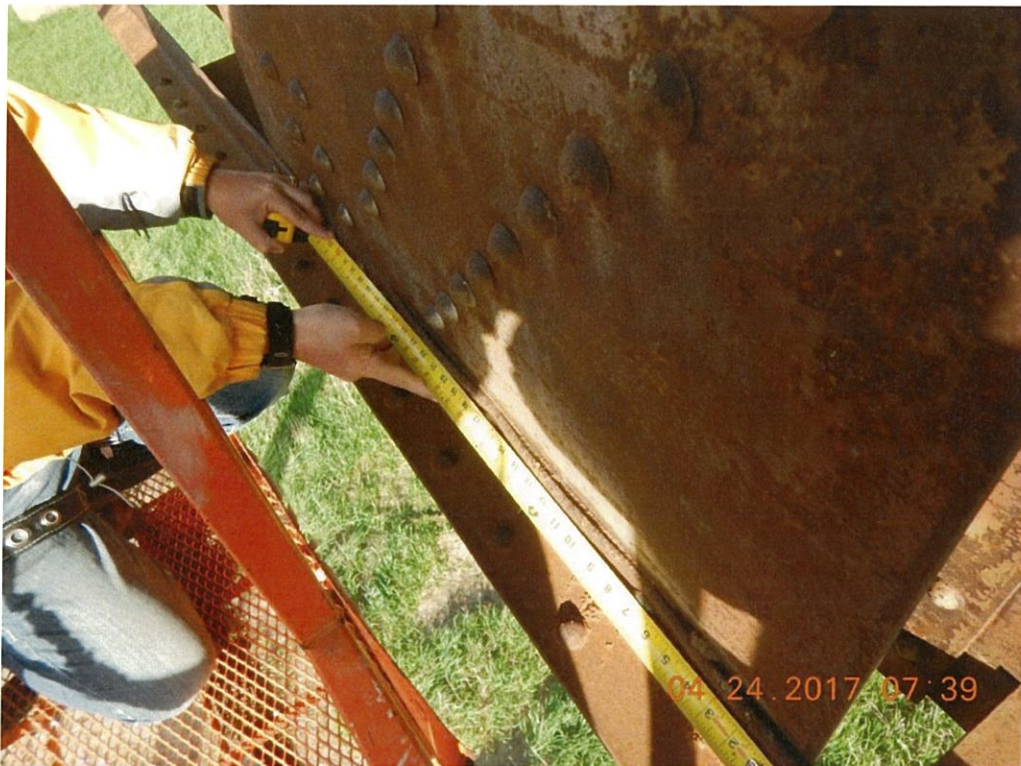
- Members coming into the lower connection gusset plates, both on the interior and exterior (Photos 29, 30, and 31), excluding the span's end connections.
- Lower chord splices (Photo 32).
- Cover plate of the upper chords which produces a ripple distortion along the rivets (Photo 33).
- Batten plates of the diagonals consisting of two angles (Photo 34).
- Continuous plates of the diagonals consisting of four angles; this produces similar ripple distortion along the rivets as seen in the upper chords (Photo 35).
- The upper connections below the deck joints (Photos 36 and 37).

Photo 29: Minor packrust up to 1/4" is typical at the members coming into the deck truss lower connection gusset plates, excluding end connections. Span 8 L9 Rt. exterior shown.

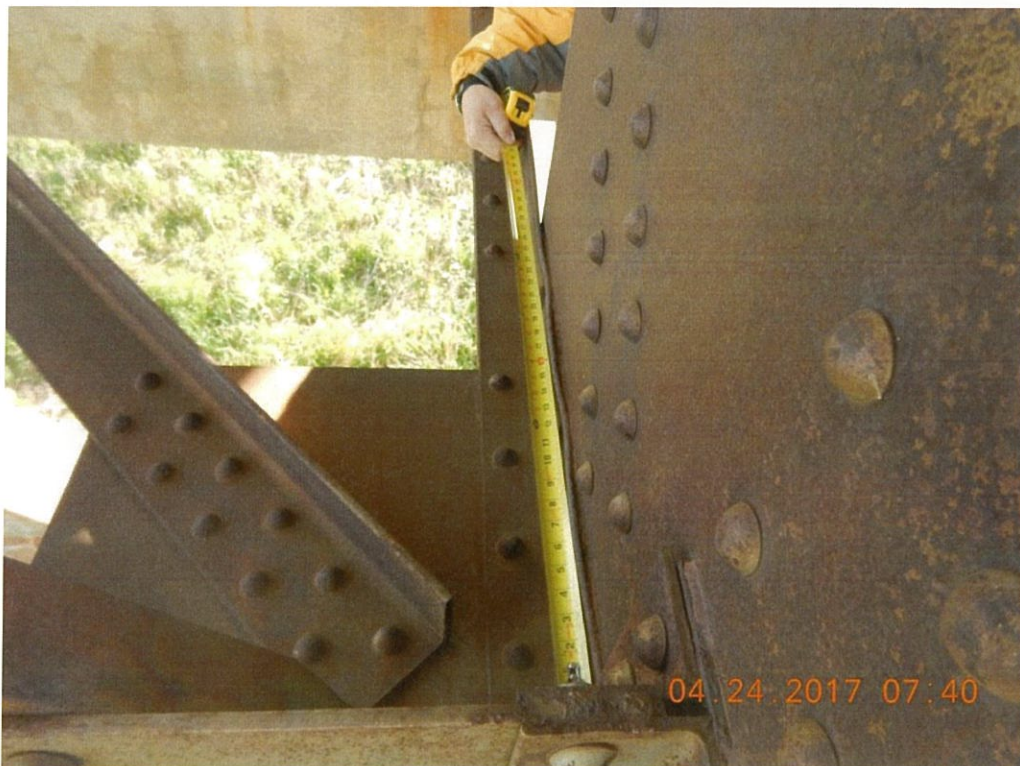
Photo 30: Minor packrust up to 1/4" is typical at the members coming into the deck truss lower connection gusset plates, excluding the end connections. Span 8 L9 Rt. interior shown.

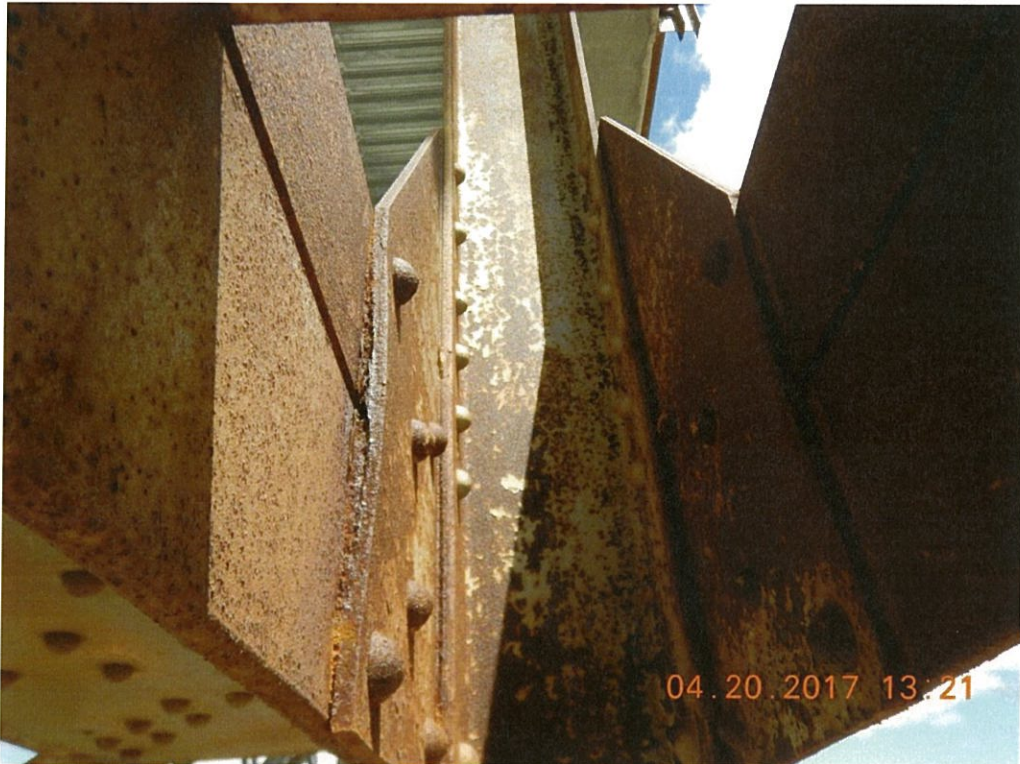
Photo 31: Minor packrust up to 1/4" is typical at the members coming into the deck truss lower connection gusset plates, excluding the end connections. Span 3 L8 Rt. west inside shown.

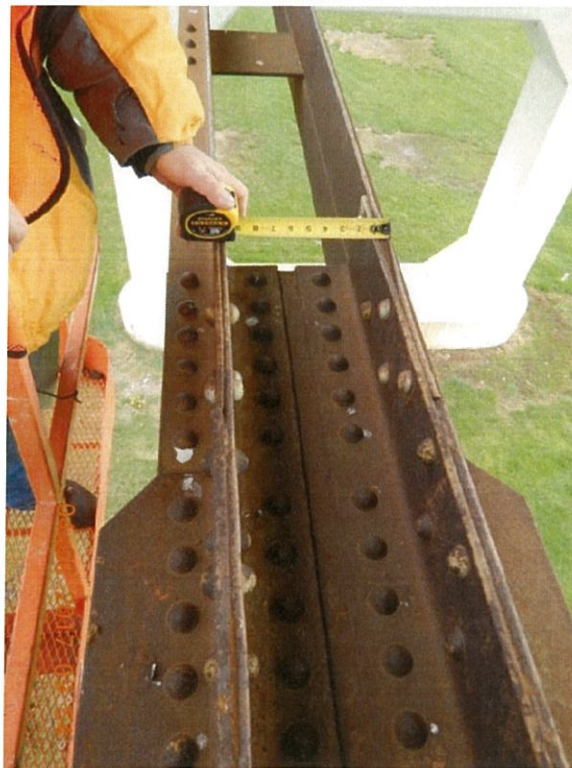
Photo 32: Minor packrust up to 1/4" is typical at the deck truss lower chord splices. Span 2 L8L9 Lt. shown – note this splice has more packrust than typical.

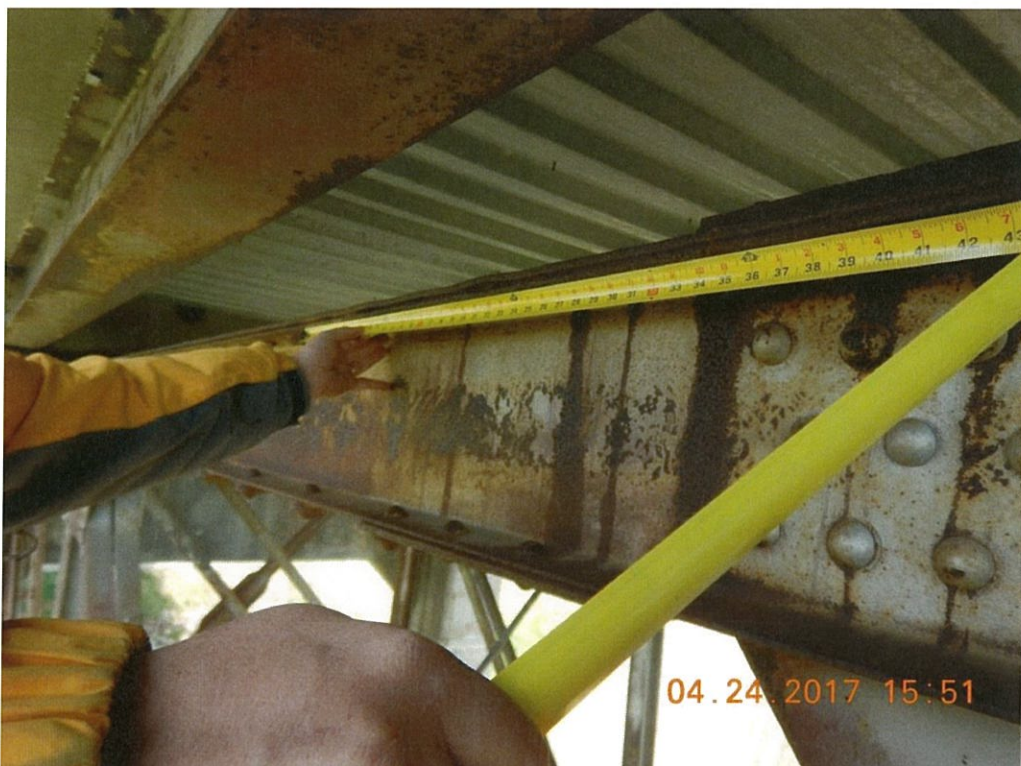
Photo 33: Minor packrust up to 1/4" is typical at the cover plate of the deck truss upper chords which produces a ripple distortion along the rivets. Span 8 U8U9 Lt. shown.

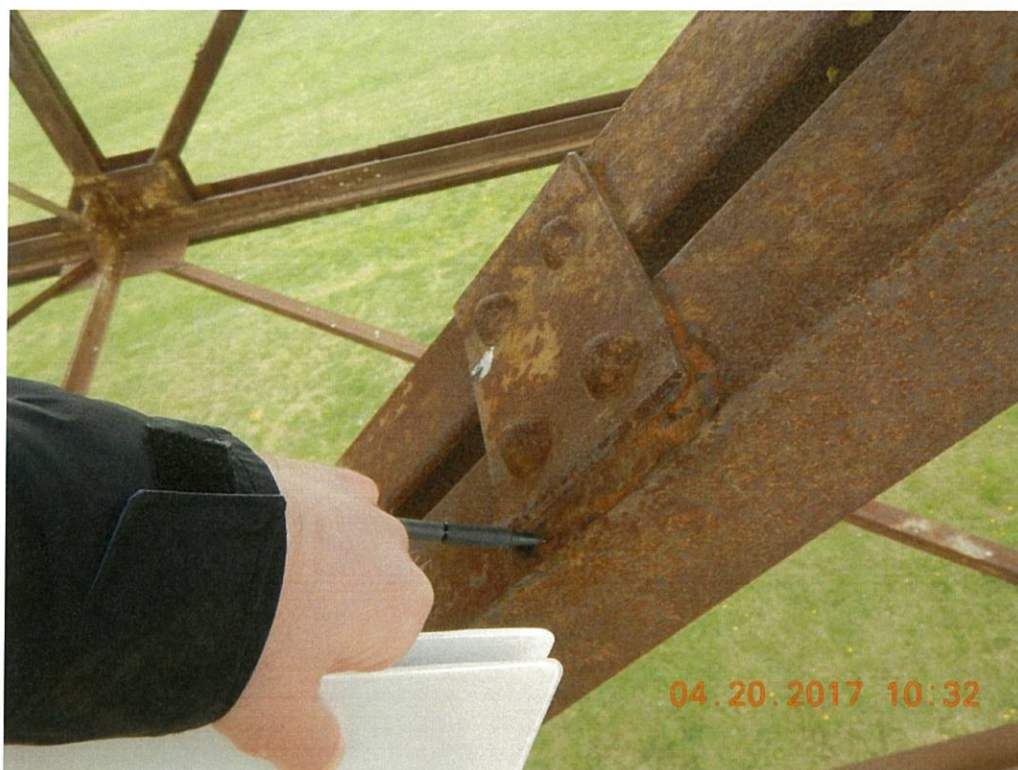
Photo 34: Minor packrust up to 1/4" is typical at the batten plates of the deck truss diagonals consisting of two angles. Span 2 U3L4 Lt. shown.

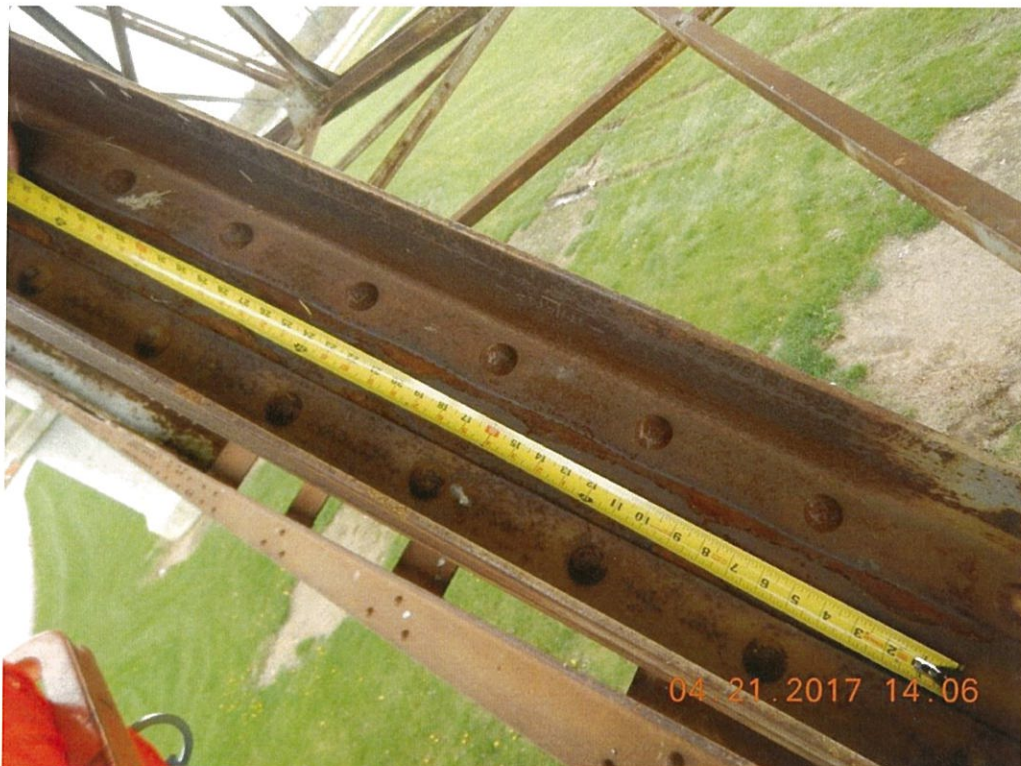
Photo 35: Minor packrust up to 1/4" is typical at the continuous plates of the deck truss diagonals consisting of four angles. Span 1 U6L5 Lt. shown.

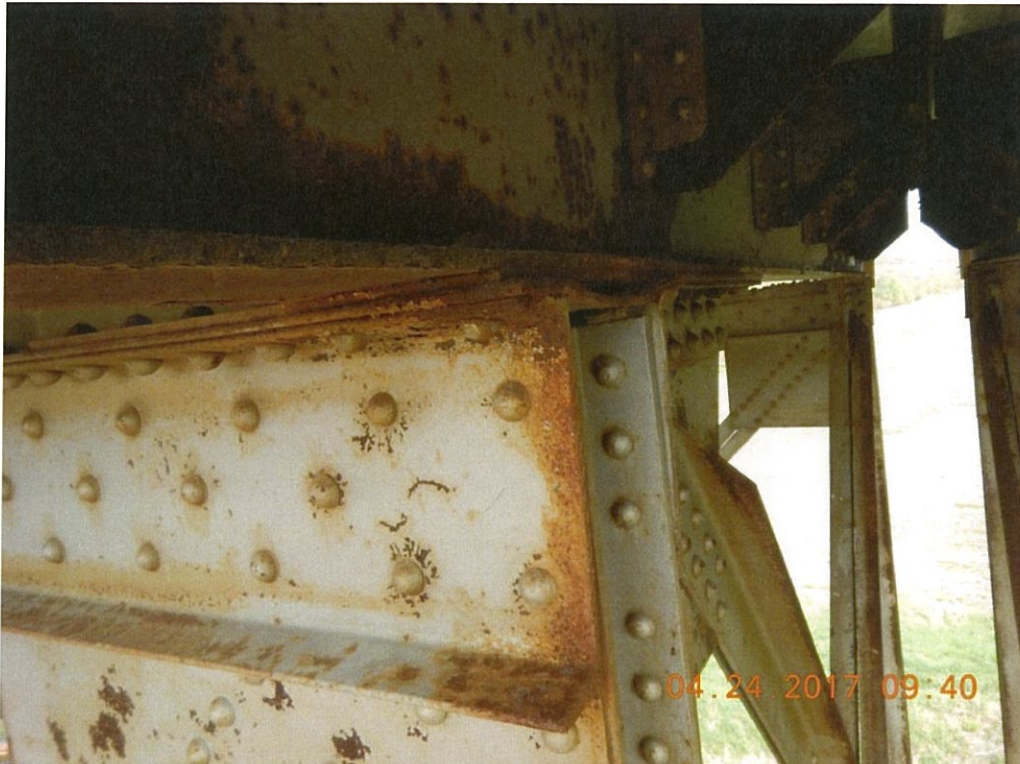
Photo 37: Minor packrust up to 1/4" is typical at the deck truss upper connections below the deck joints. Span 7 U0 Lt. end shown.

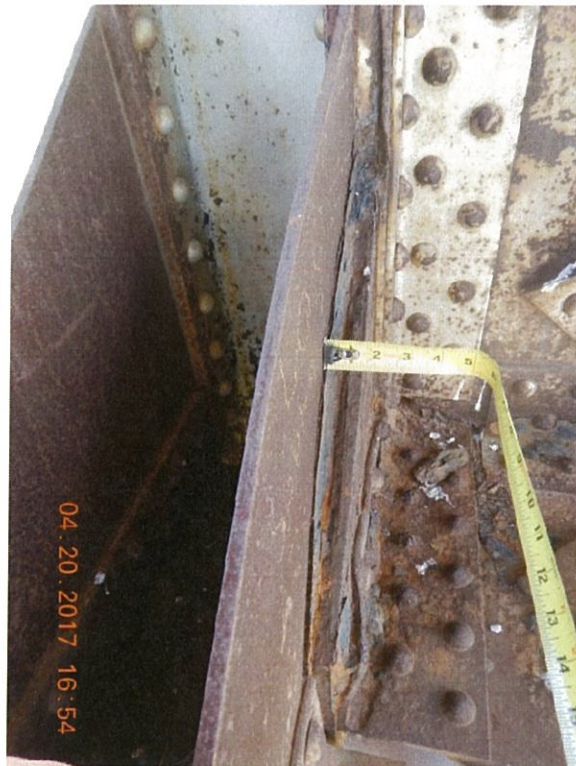
- Gusset plates and plate connections to the bearings at ends of the spans (Photo 38).
- Upper chord cover plates below the floorbeam where only two rivets are present instead of four rivets (Photo 39).

Photo 38: Heavier packrust up to 1" is typical at the deck truss gusset plates and plate connections to the bearings at the ends of the spans. Span 3 L0 Rt. interior top edge shown.

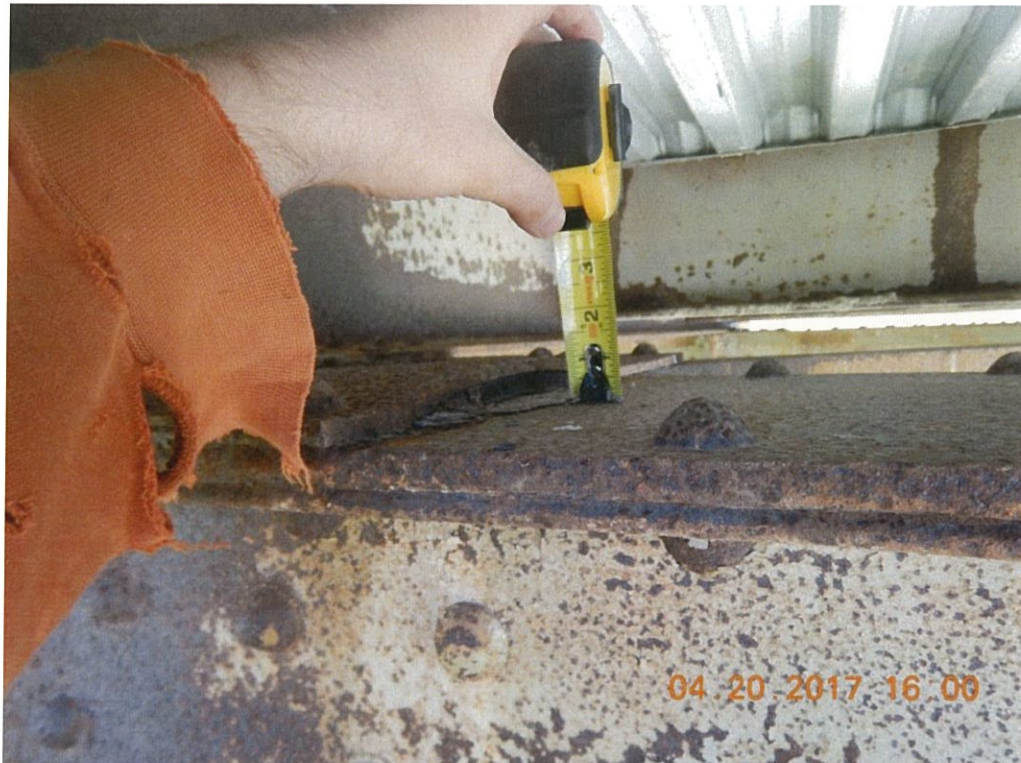
Photo 39: Heavier packrust up to 1" is typical at the deck truss upper chord cover plates below the floorbeam where only two rivets are present instead of four. Span 3 U3 Rt. shown.

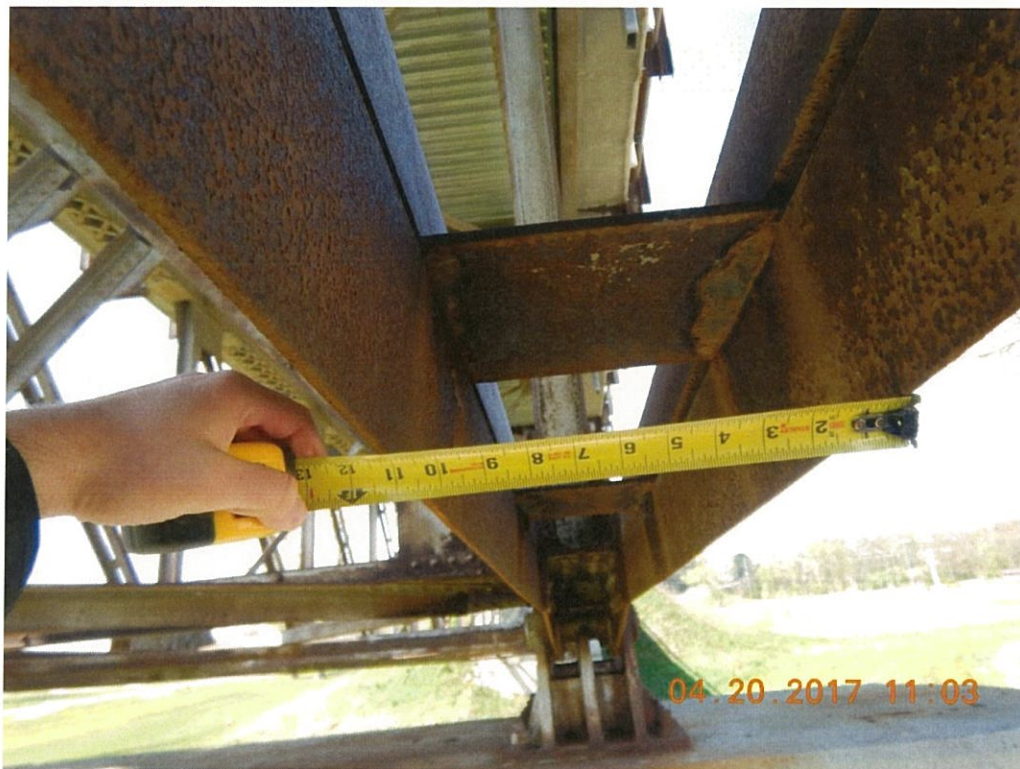
Photo 40: The vertical angles of the deck truss lower chords from L0 to L2 and L8 to L10 were typically bowed outward. Span 2 L0L1 Lt. shown.

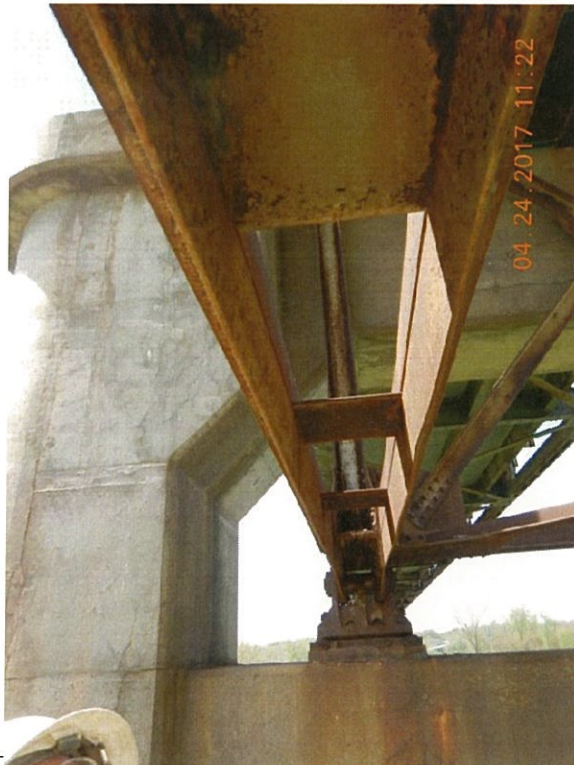
Photo 42: The vertical angles of the deck truss lower chords from L0 to L2 and L8 to L10 were typically bowed outward with the interior leg of Span 7 L0L1 Rt. distorting in a wave pattern.

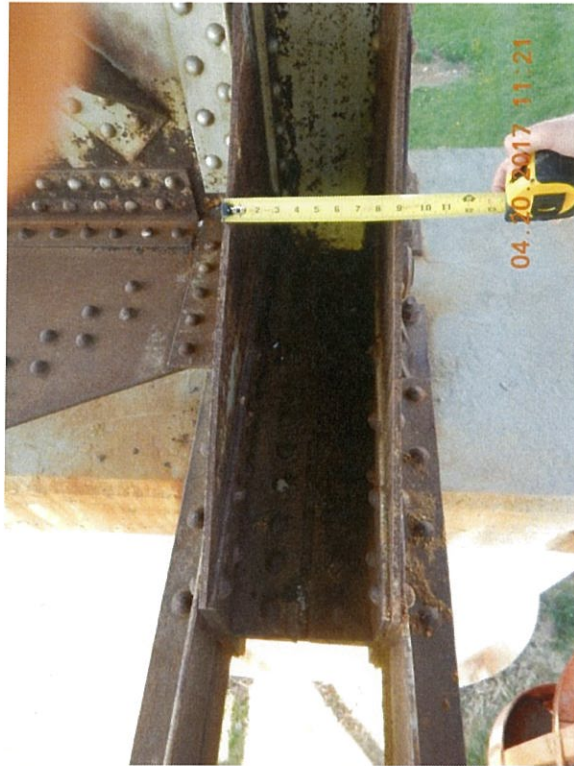
Photo 43: The lower chord gusset plates at the deck truss bearings are typically bowed inward at the top. Span 2 L0 Lt. shown.

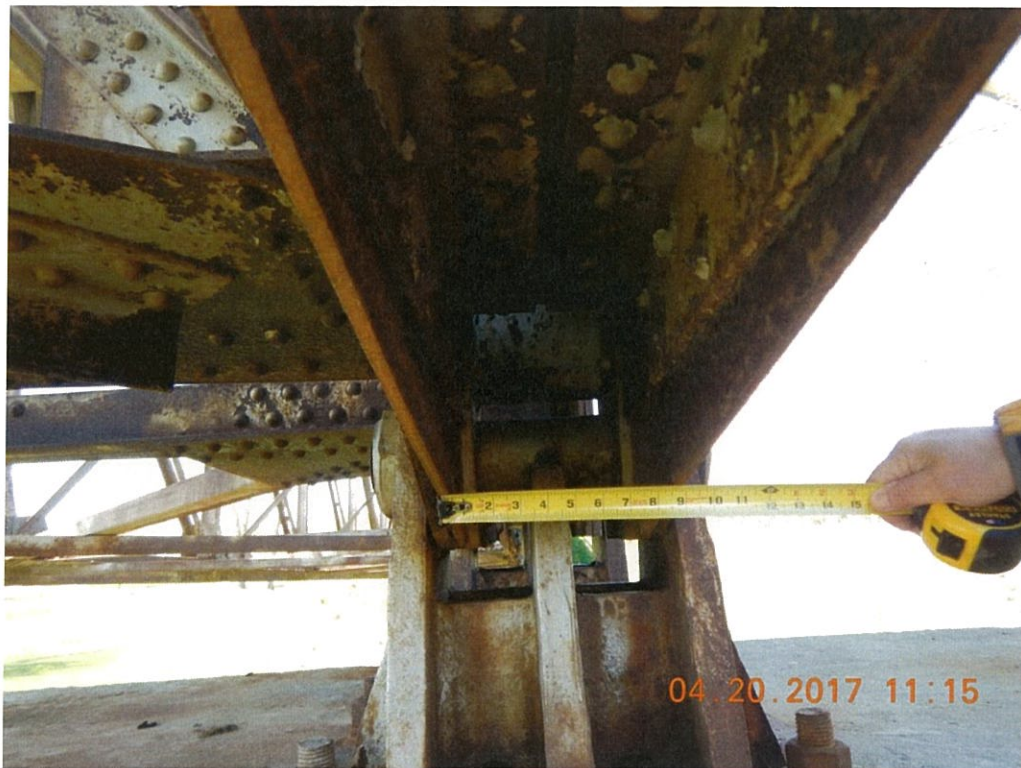
Photo 44: The lower chord gusset plates at the deck truss bearings are typically bowed inward at the bottom. Span 2 L0 Lt. shown.

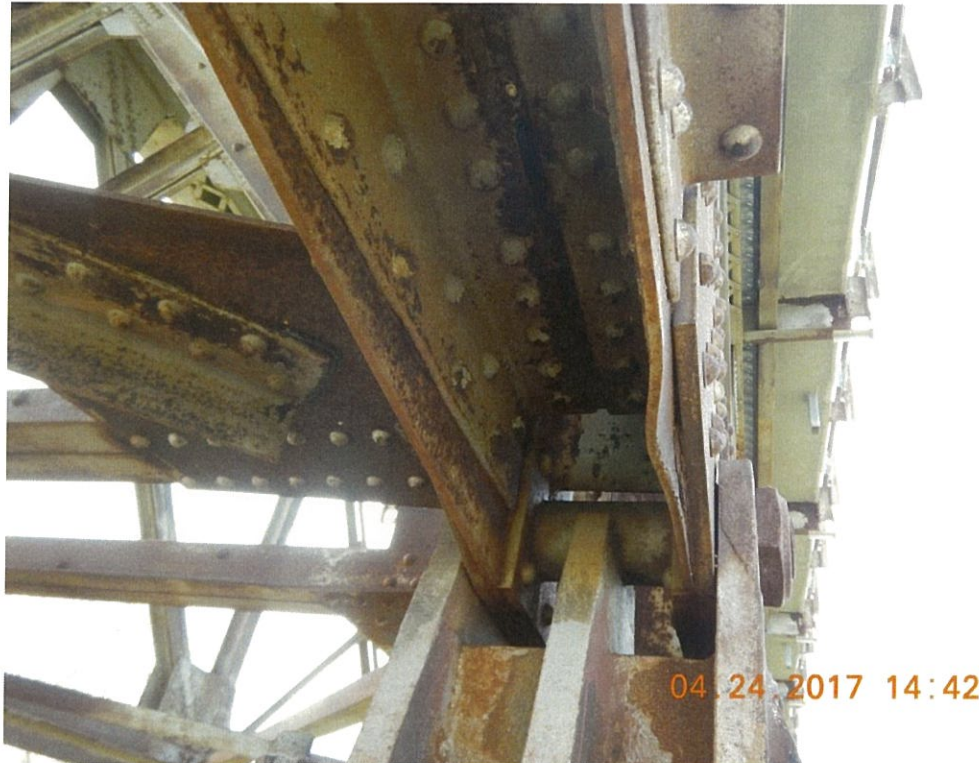
Photo 45: The lower chord gusset plates at the deck truss bearings are typically bowed inward at the bottom. Span 8 L0 Lt. shown, also has a dent on the exterior.
