APPENDIX E. STRUCTURAL DOCUMENTS

**Bellevue Toll Bridge
East Mission Avenue over the Missouri River
Bellevue, Nebraska**

**Structure No. S370 01918
Fracture Critical and Routine NBIS Bridge Inspection
April 2017**

Prepared for:
Bellevue Bridge Commission

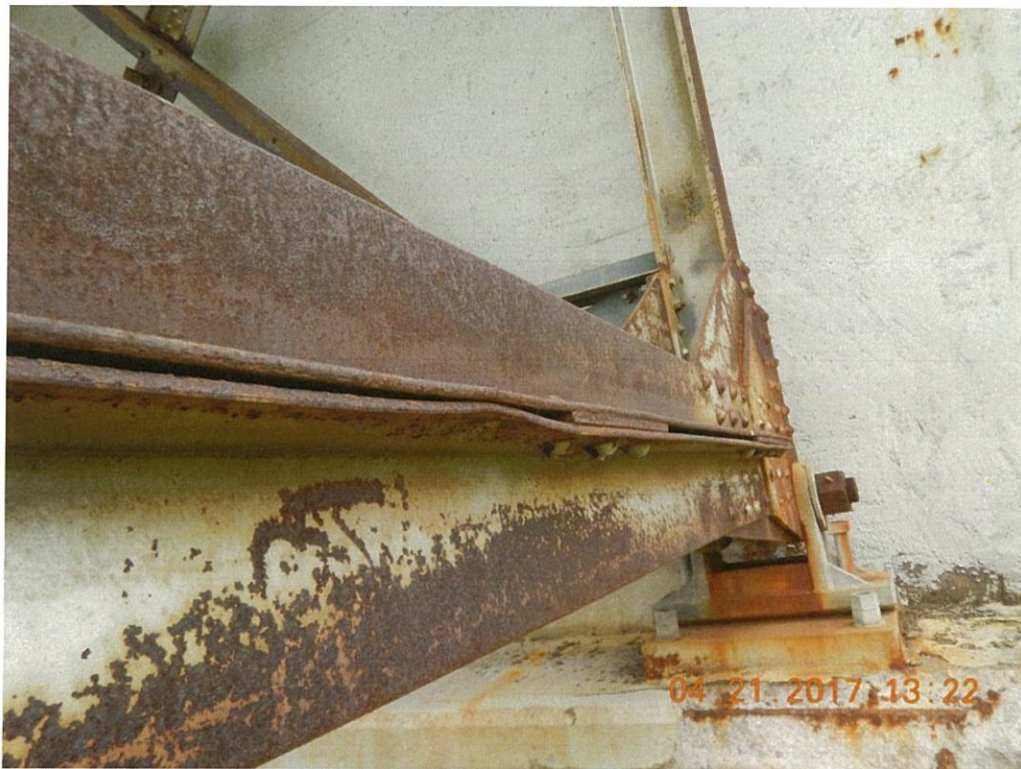
Small dents are present at some locations throughout the truss members: largest are at Span 1 L0L1 Lt. (Photo 46), Span 1 U7U8 Rt. (Photo 47), Span 3 L9L10 Rt. (Photo 48), Span 7 U8L8 Lt., and Span 8 L0L1 Rt. (Photo 49). The Span 4 L7 Lt. exterior gusset plate has a minor tear (Photo 50). The exterior face of Span 3 U4L4 Rt. has a small rolling defect above L4 (Photo 51). These issues were most likely created during construction.

Photo 46: Small dents are present at some locations throughout the deck truss. These dents were most likely created during construction. Span 1 L0L1 Lt. exterior near L0 shown.

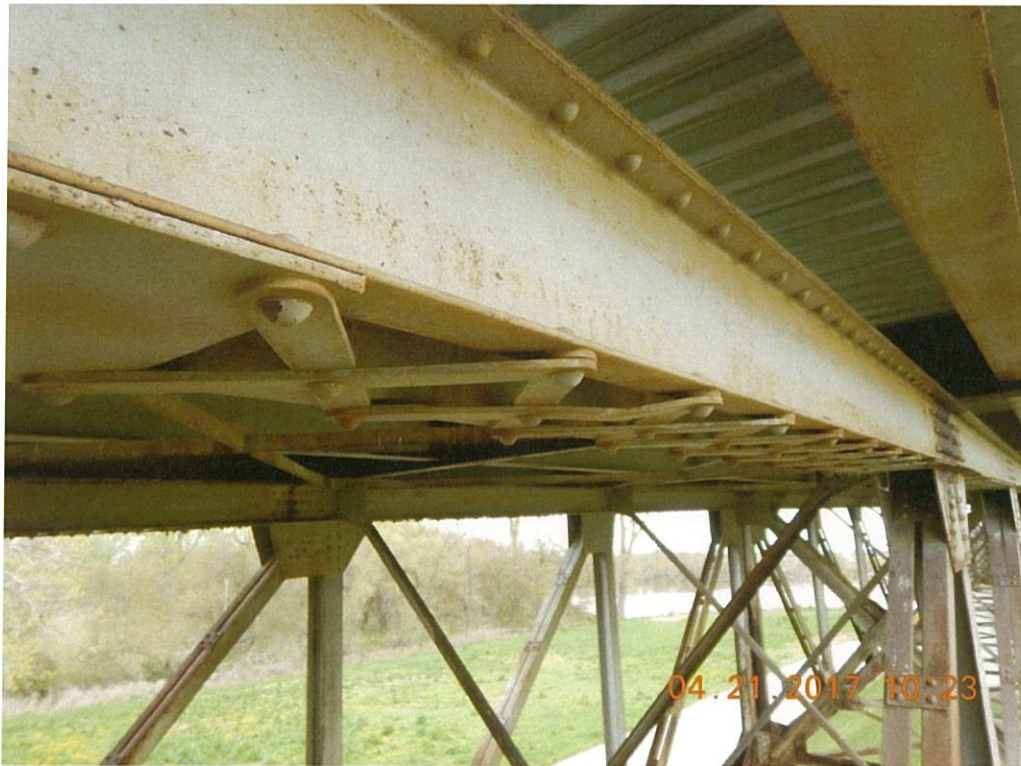
Photo 47: Small dents are present at some locations throughout the deck truss. These dents were most likely created during construction. Span 1 U7U8 Rt. lacing near L7 shown.

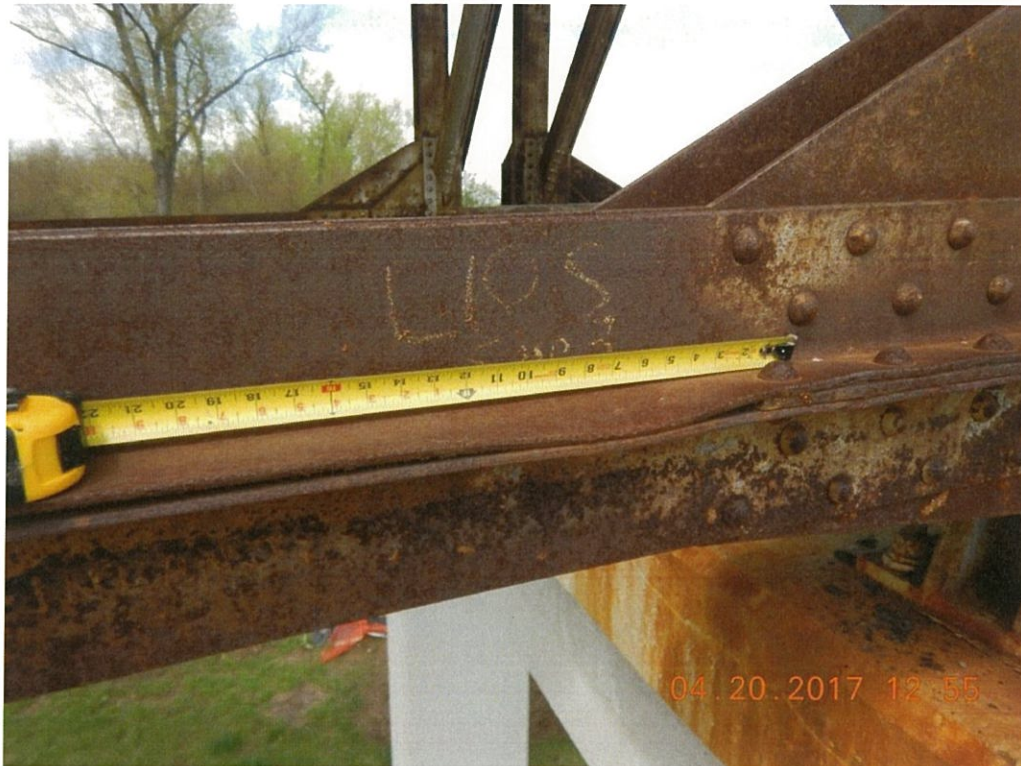
Photo 48: Small dents are present at some locations throughout the deck truss. These dents were most likely created during construction. Span 3 L9L10 Rt. exterior at L10 shown.

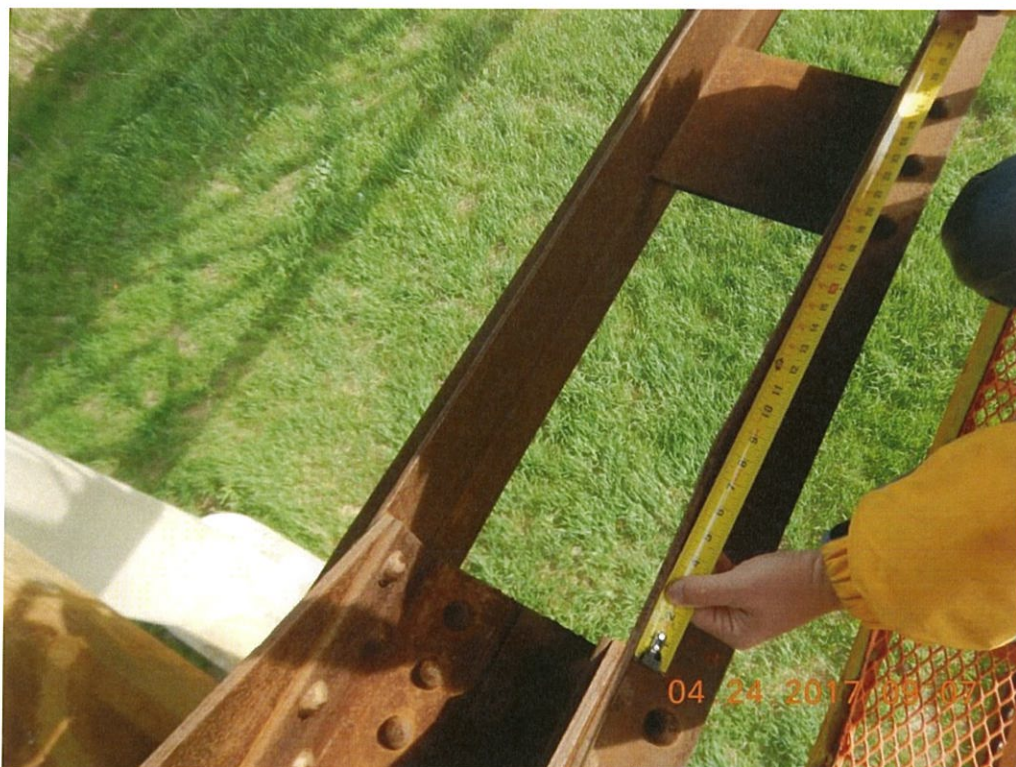
Photo 49: Small dents are present at some locations throughout the deck truss. These dents were most likely created during construction. Span 8 L0L1 Rt. exterior at L0 shown.

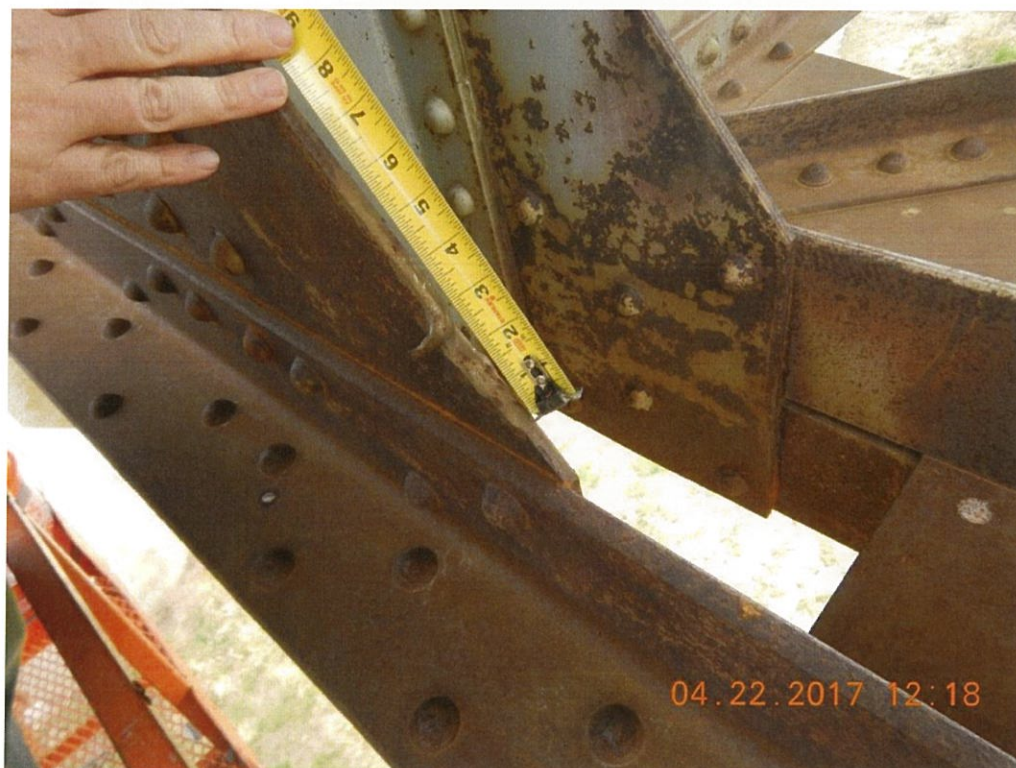
Photo 50: The Span 4 L7 Lt. exterior gusset plate has a minor tear.

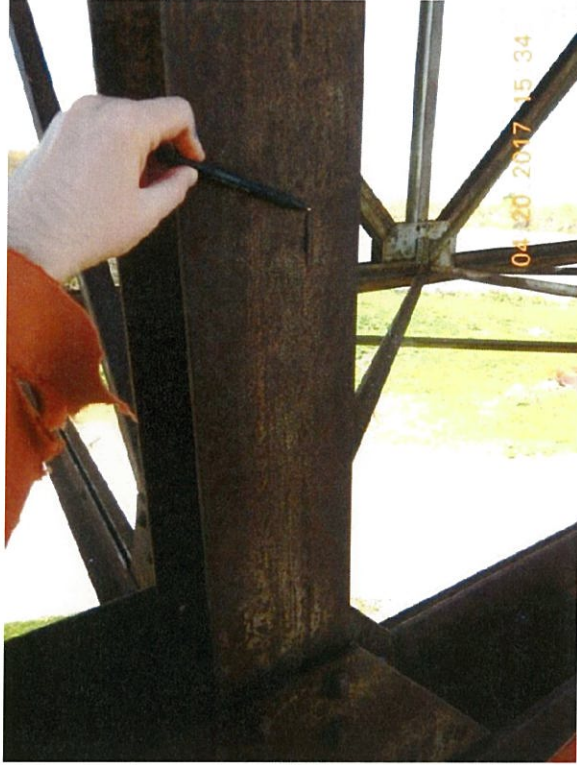
Photo 51: The exterior face of Span 3 U4L4 Rt. has a small rolling defect above L4.

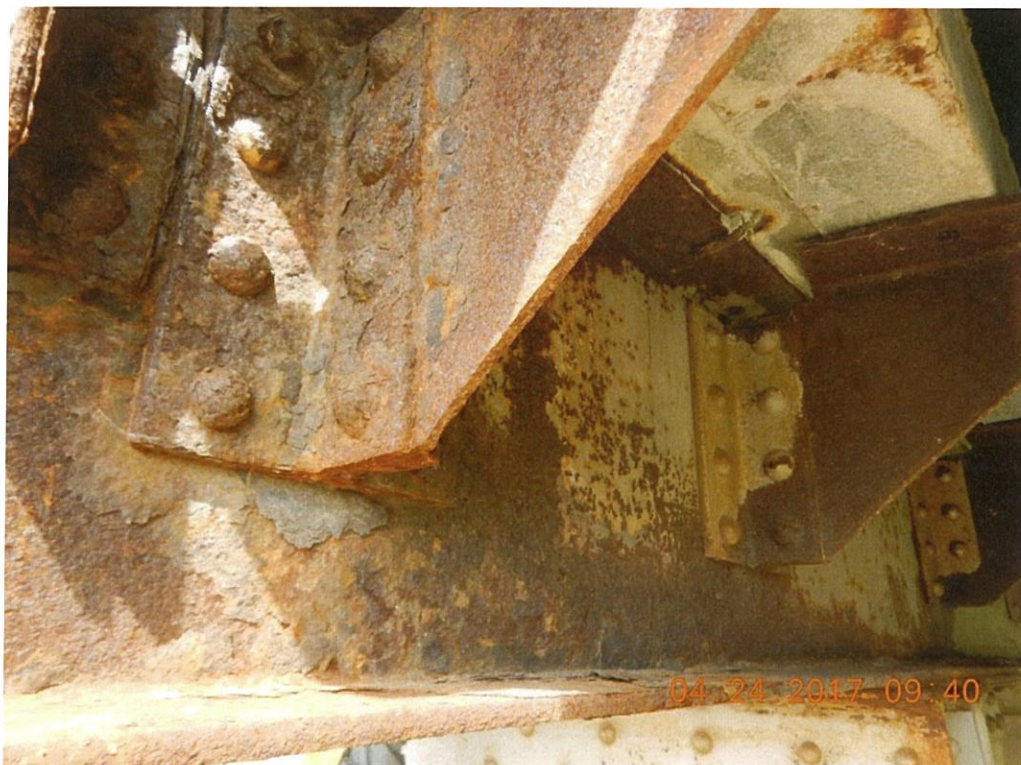
The floorbeams are in fair condition with minor surface rust throughout; heavier rust typically at the floorbeam ends overhanging the truss and at locations below deck joints (Photo 53). There are areas of delamination in the floorbeam faces below the deck joints from previous and continued joint leakage (Photos 54 through 57). The worst is at the ends. The steel cantilever brackets in these areas also have similar issues with holes forming; however, these were made redundant when the deck was replaced. Minor packrust has developed between the web and exterior stringer connection angle at some locations throughout (Photo 58); minimal section loss was noted.

Photo 55: There are areas of delamination in the deck truss floorbeam faces below the deck joints. Span 7 Floorbeam 10 Rt. end shown.

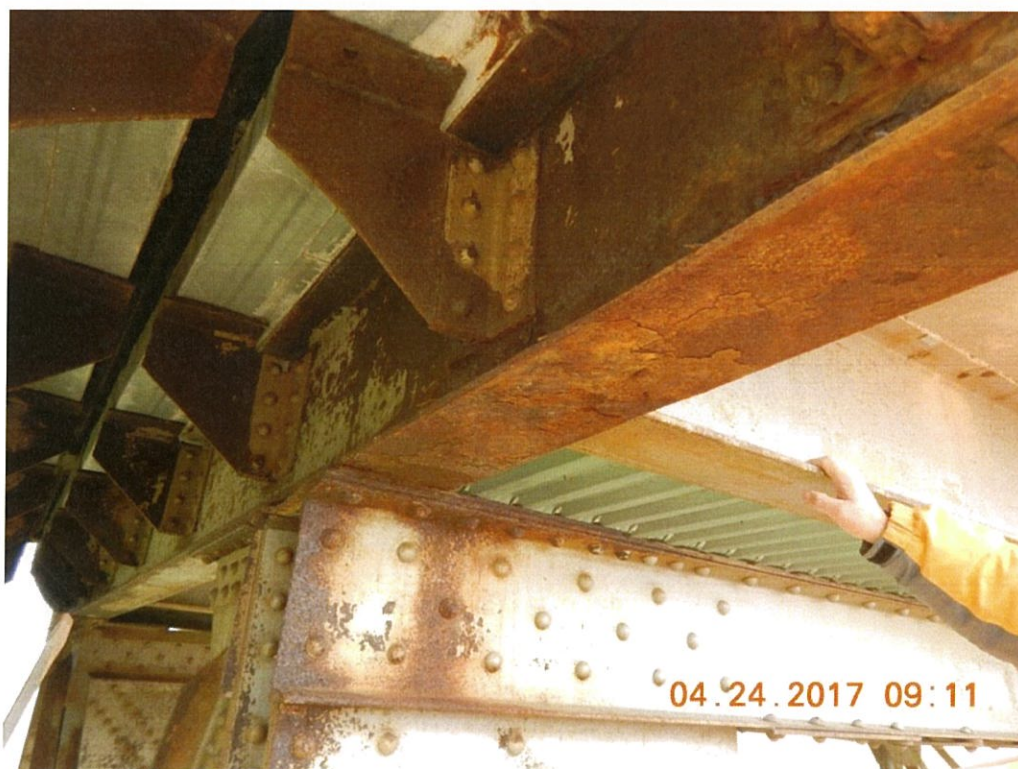
Photo 56: There are areas of delamination in the deck truss floorbeam faces below the deck joints. Span 8 Floorbeam 0 Rt. end shown.

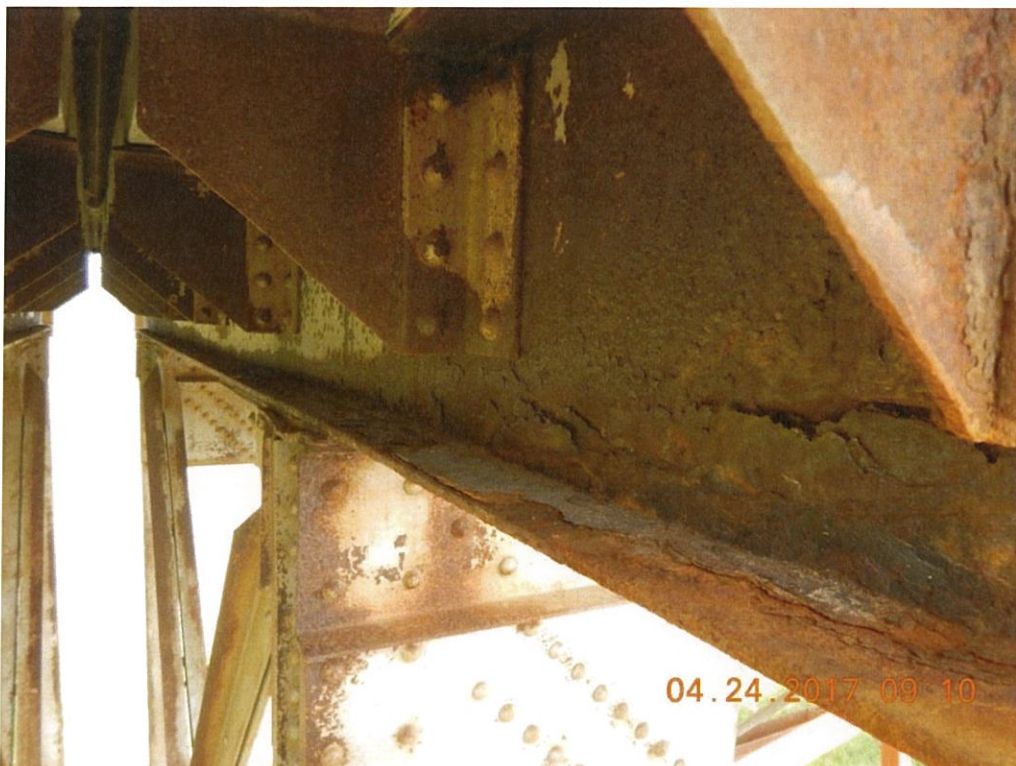
Photo 57: There are areas of delamination in the deck truss floorbeam faces below the deck joints. Span 8 Floorbeam 0 Rt. end shown.

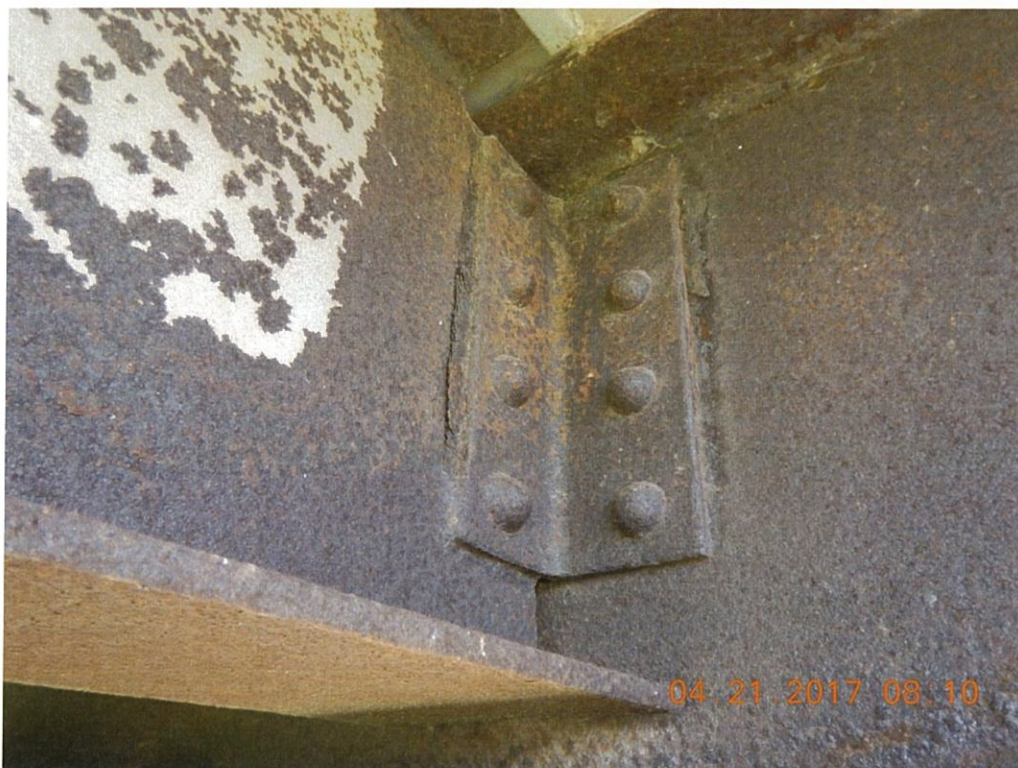
The stringers are in satisfactory condition with minor surface rust throughout. Heavier rust is present at some stringer ends and in the connection angles (Photo 58). The connection angles with packrust between the angle and floorbeam typically have minor packrust between the stringer web and connection angle as well (Photo 58). No significant dents or distortion was noted throughout the stringers; however, there are a few locations with minor bent flanges (Photo 62). Span 8 Stringer 4 has a gouge in the top cope at U3; the gouge is small and hasn't extended since the last time it was noted. The dents and gouge are likely from construction.

Photo 58: Minor packrust has developed between the deck truss floorbeam web and exterior stringer connection angle at some locations throughout. Span 2 Stringer 4 at Floorbeam 8 shown.

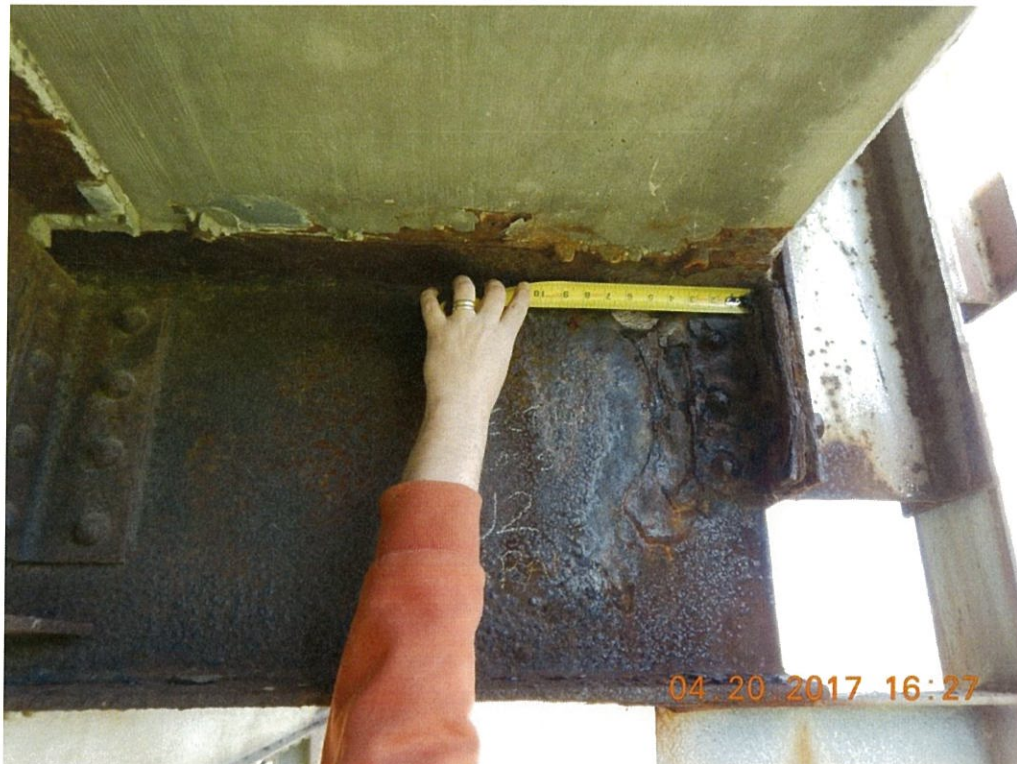
Several of the floorbeam ends have full penetration section loss varying in size (Photo 59). Most of these locations have been retrofitted with steel angles to strengthen the weakened web in these areas (Photo 60); the angles were typically welded on with the weld at Span 8 Floorbeam 4 Lt. cracked. The ends continue to deteriorate due to the exposure to rainfall but the deck replacement in 2004 was designed to cantilever outside of the exterior stringers making the floorbeams in the deteriorated area redundant.

Photo 59: Several of the deck truss floorbeam ends have full penetration section loss varying in size. Span 3 Floorbeam 2 Rt. shown.

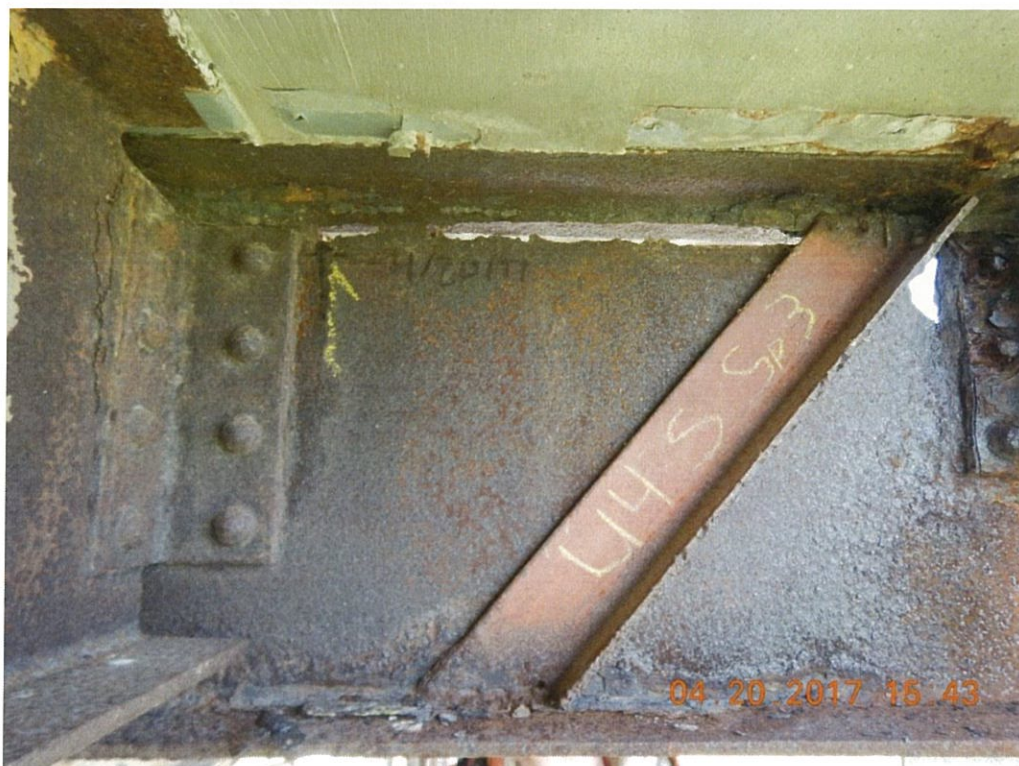
Photo 60: Most of the locations shown in Photo 59 have been retrofitted with steel angles to strengthen the weakened web. Span 3 Floorbeam 4 Rt. shown. This location has the worst section loss with extended growth towards the stringer clip angle since last being marked.

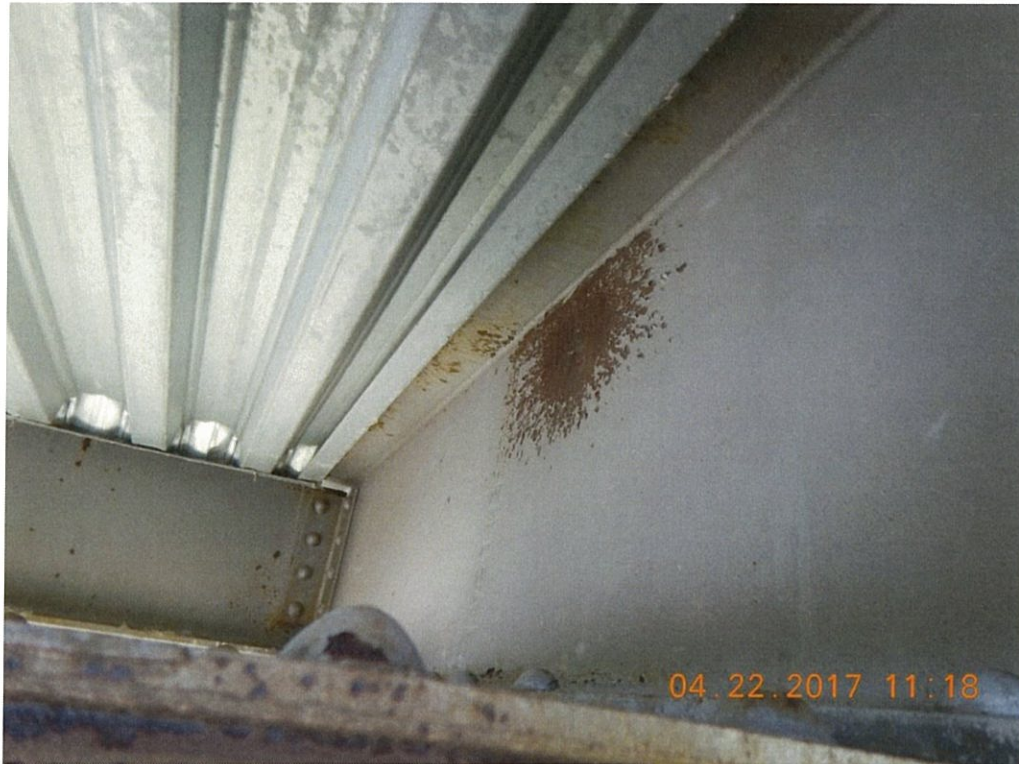
No significant dents or distortion was noted throughout the floorbeams; however, there are larger dimple dents in the floorbeam web near the exterior stringers in a few locations (Photo 61). These were most likely due to construction.

Photo 61: There are larger dimple dents in the deck truss floorbeam webs near the exterior stringers in a few locations. Span 4 Floorbeam 5 Lt. shown.

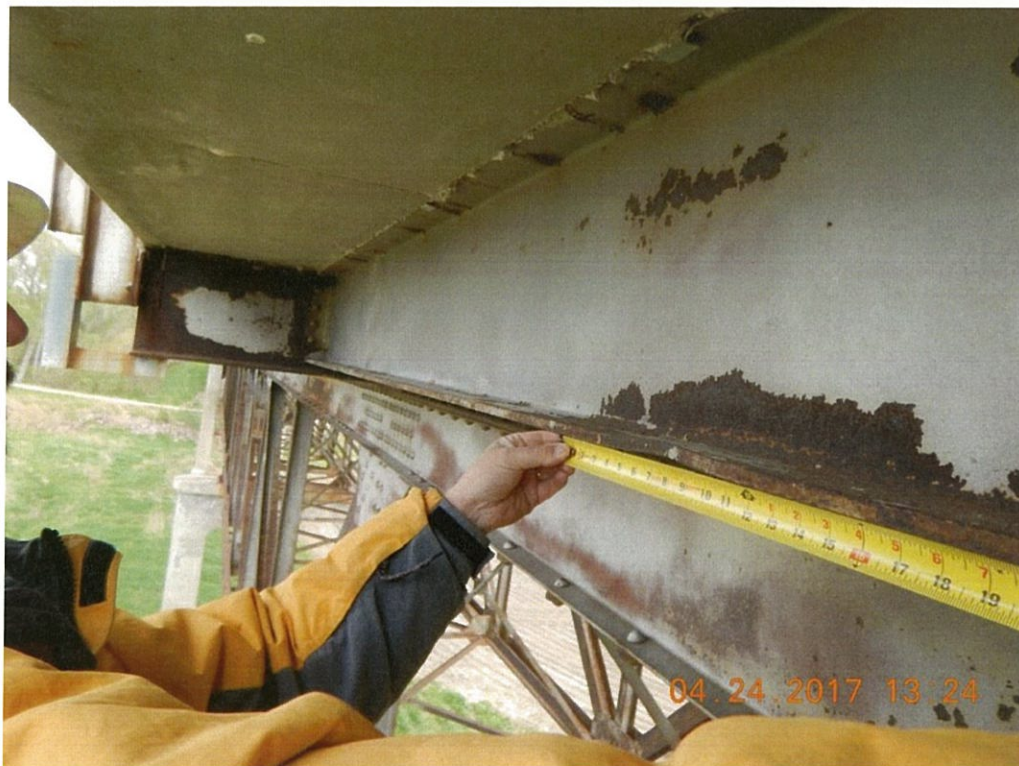
Photo 62: There are a few locations with minor bent flanges in the deck truss stringers. Span 7 Stringer 1 dent east of U3.

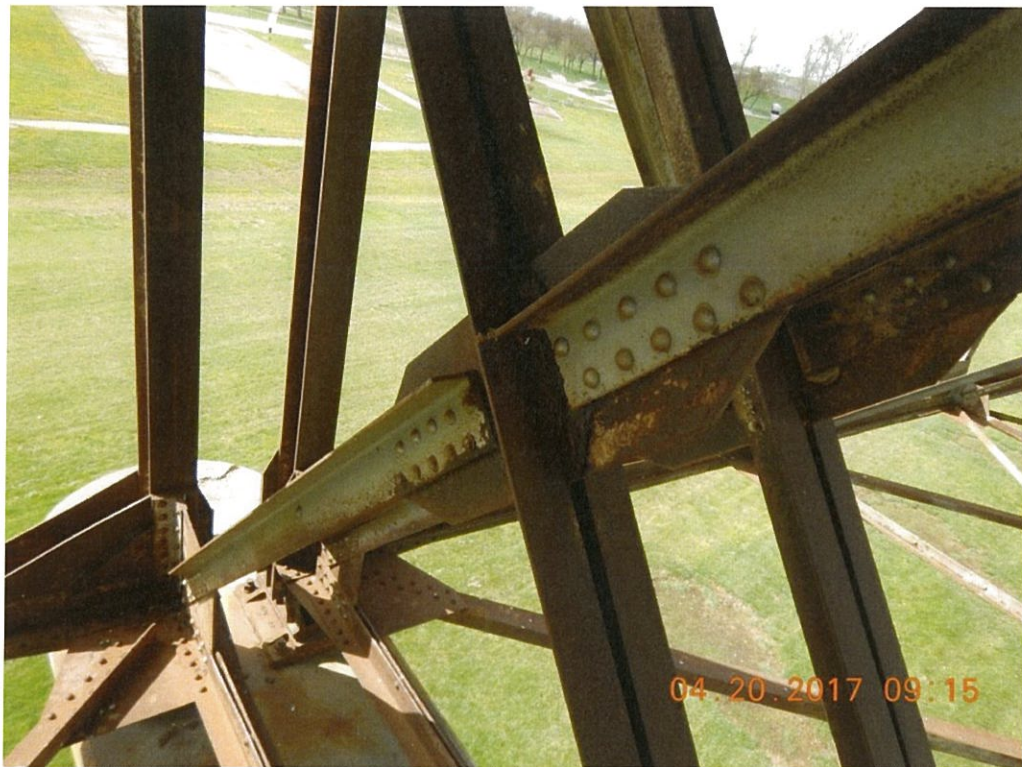
All lateral bracing – lower, upper, and in the vertical plane – are in satisfactory condition with minor surface rust throughout and packrust developing at the center of the bracing (Photo 63). Seven lower lateral bracing angles and one upper lateral bracing angle were bent and/or dented at the following locations:

Photo 63: Packrust is developing at the center of the deck truss bracing; the worst is typically in the vertical plane bracing at the ends of the spans. Span 3 L0 end shown.

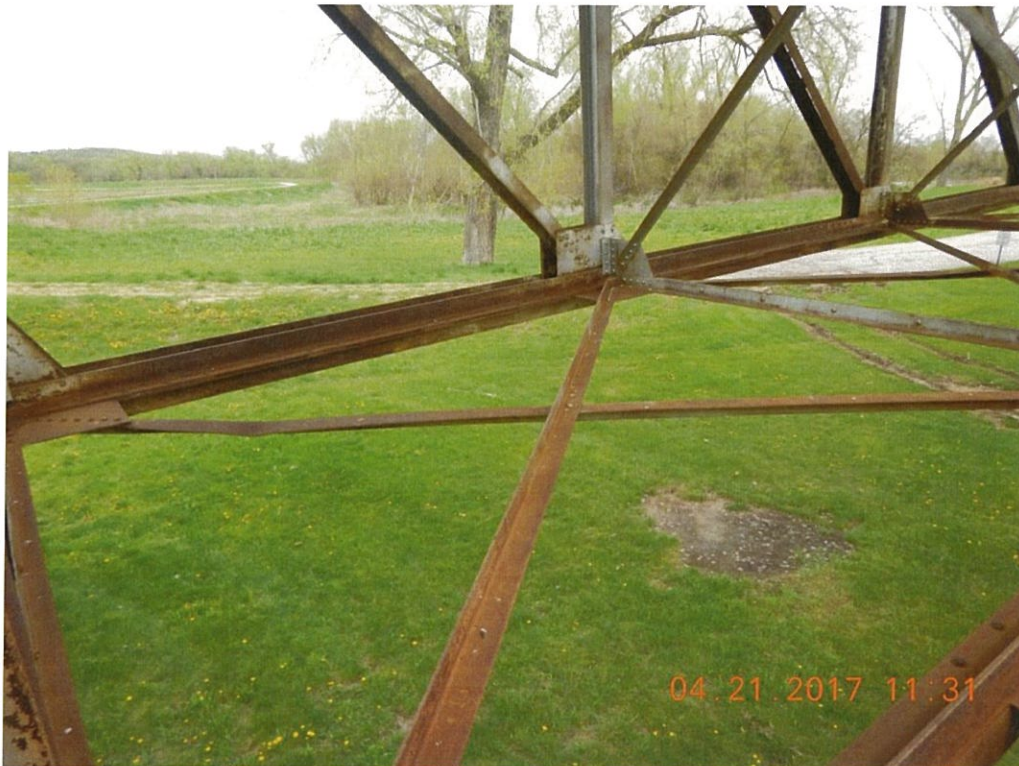
Span 1 Bay 3 lower (Photo 64)	Span 3 Bay 9 lower (Photo 67)
Span 1 Bay 4 lower (Photo 64)	Span 7 Bay 3 upper (Photo 68)
Span 2 Bay 5 lower (Photo 65)	Span 8 Bay 1 lower (Photo 69)
Span 3 Bay 4 lower (Photo 66)	Span 8 Bay 5 lower (Photo 70)

Photo 64: Deck truss lower lateral bracing is bent at Span 1 Bay 3 and 4; note Bay 3 is the closest bay shown in the photo.

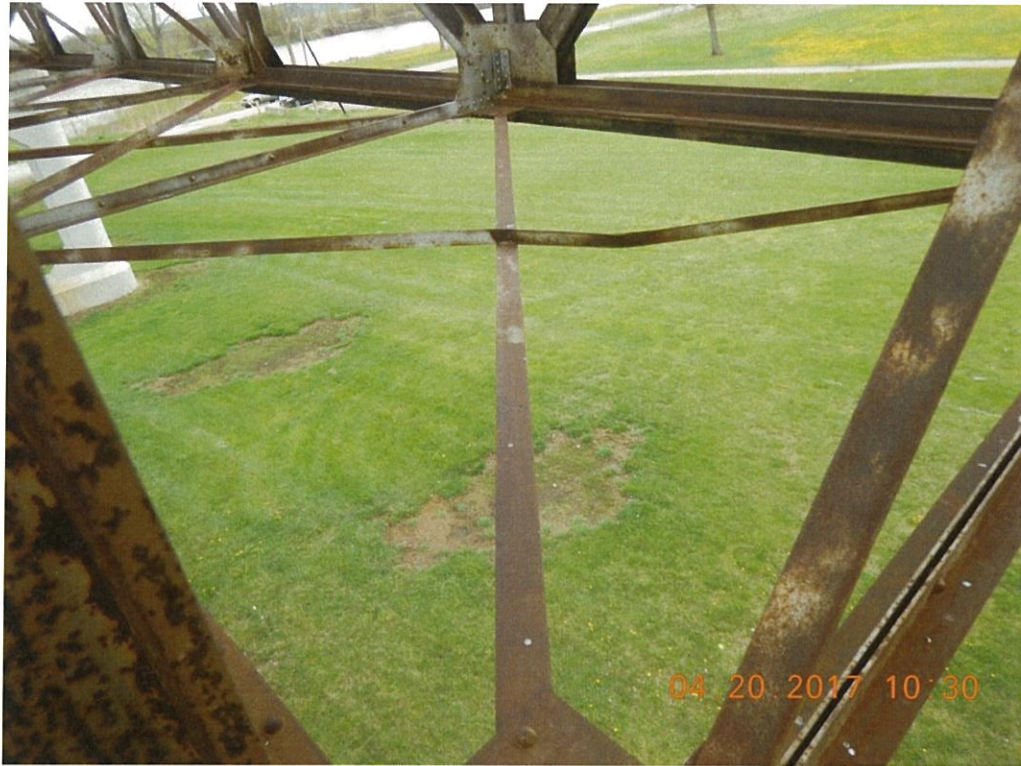
Photo 65: Deck truss lower lateral bracing is bent at Span 2 Bay 5.

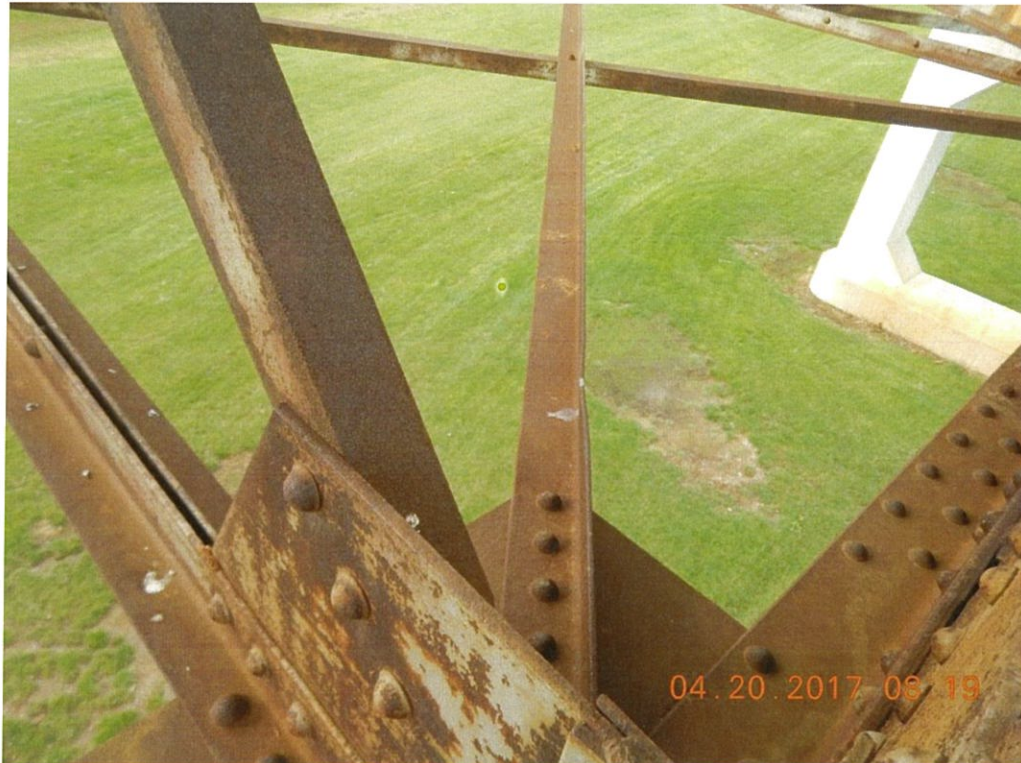
Photo 66: Deck truss lower lateral bracing is bent at Span 3 Bay 4.

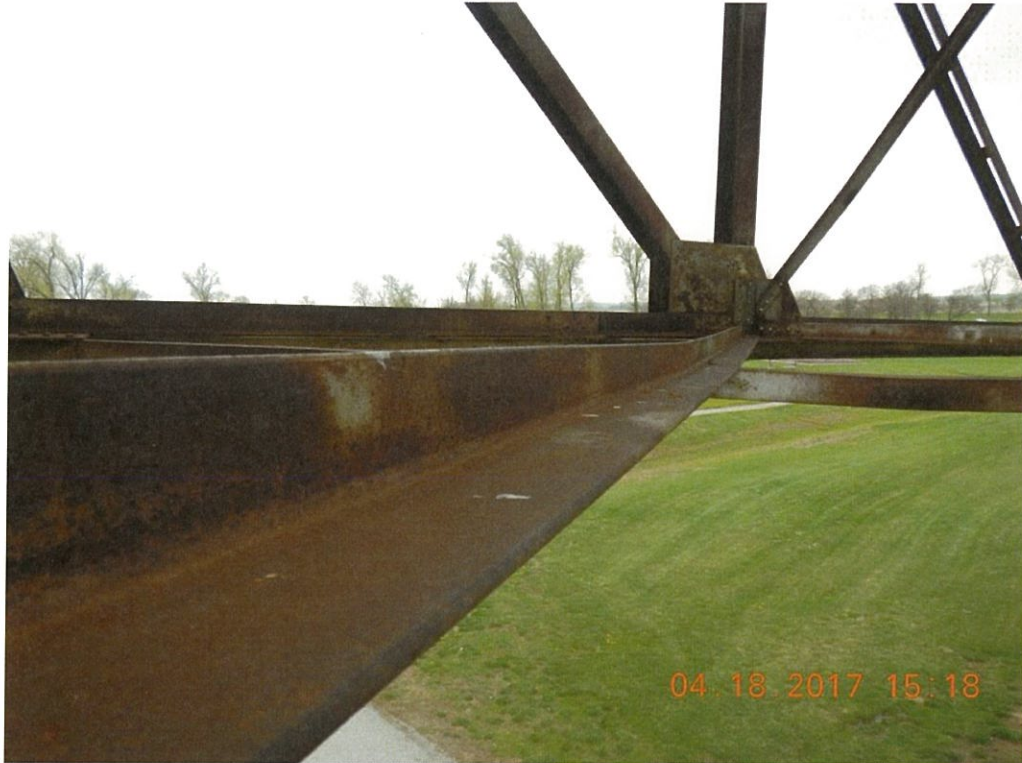
Photo 67: Deck truss lower lateral bracing is bent at Span 3 Bay 9.

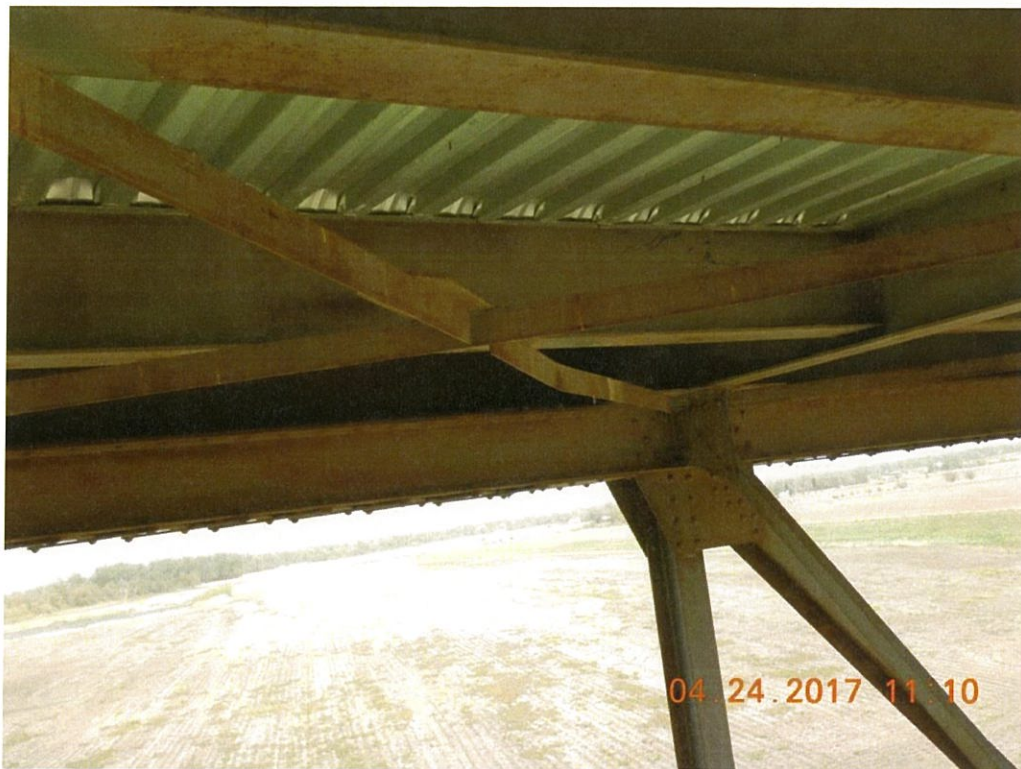
Photo 68: Deck truss upper lateral bracing is bent at Span 7 Bay 3.

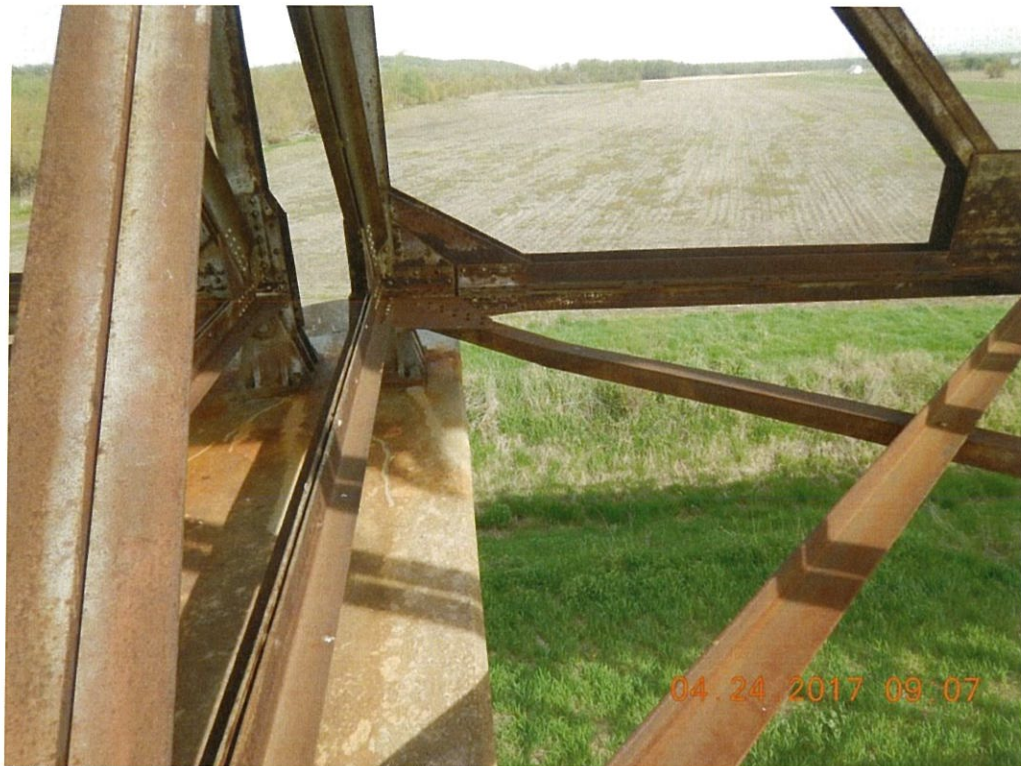
Photo 69: Deck truss lower lateral bracing is bent at Span 8 Bay 1.

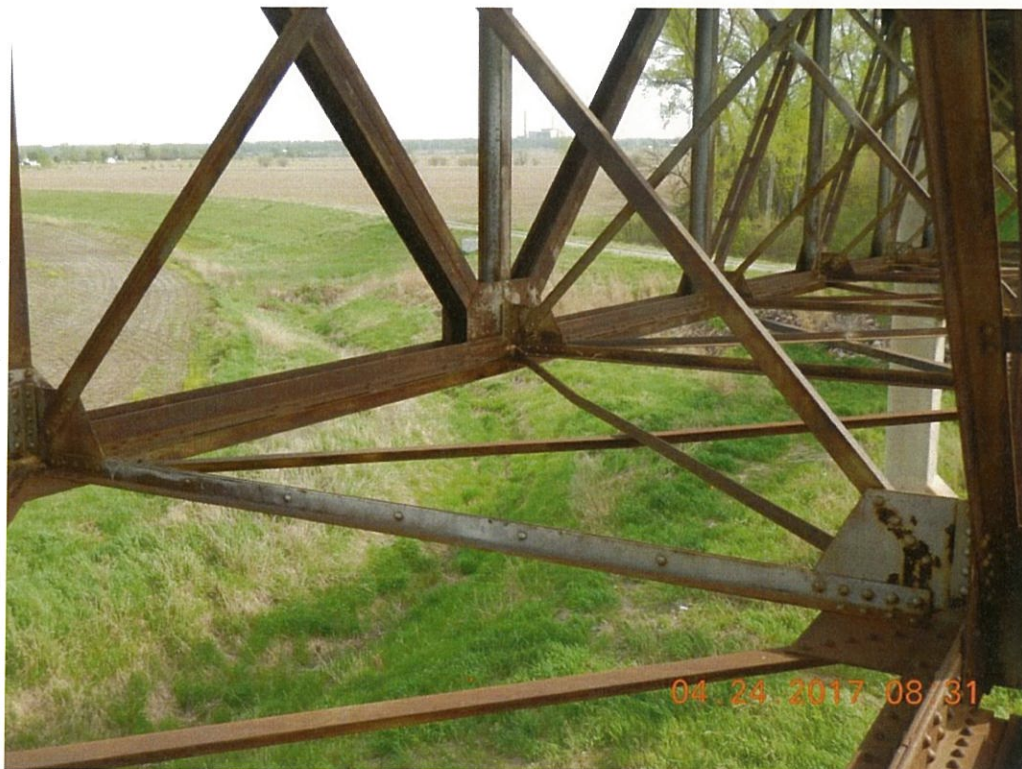
Photo 70: Deck truss lower lateral bracing is bent at Span 8 Bay 5.

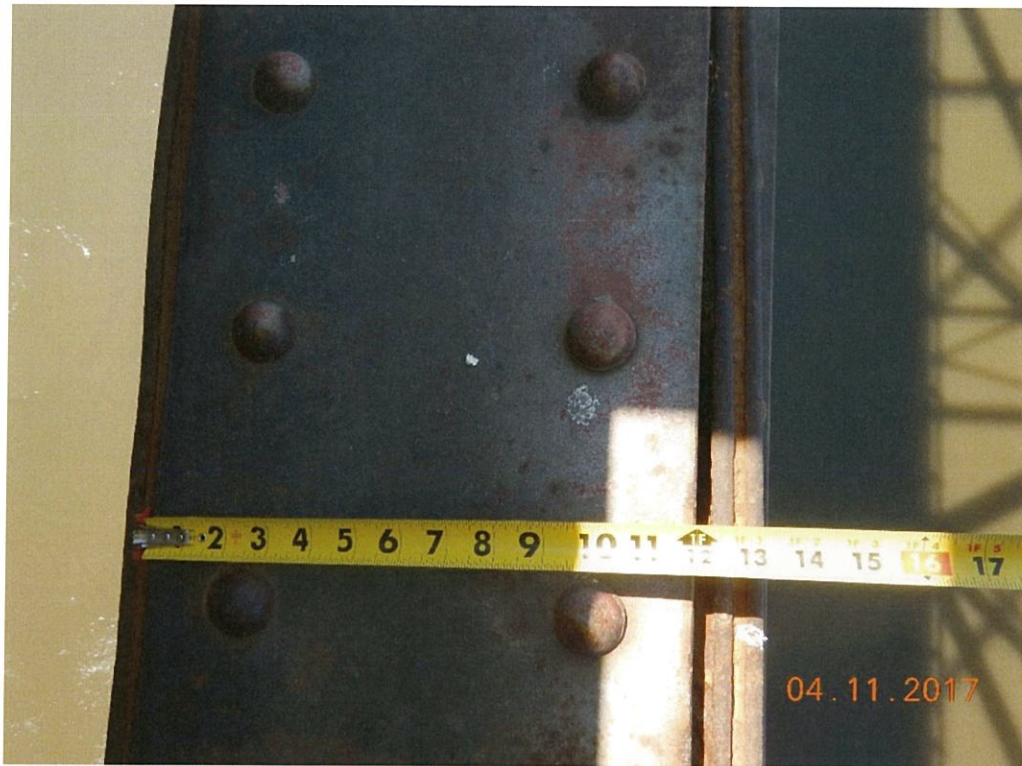
The lower chords are in fair condition. Packrust is present at most built-up members and gusset plate connections (Photos 74 and 75). The box type member shape used for the lower chord in the compression zones near Pier 5 has more packrust inside the members between the bottom plate and the web compared to the tension zones where an open type of member shape with smaller batten plates are used. The packrust has broken rivets in several locations identified below (Photo 76), quantities are approximate:

Photo 75: Packrust is present at most lower chords of the thru truss spans.

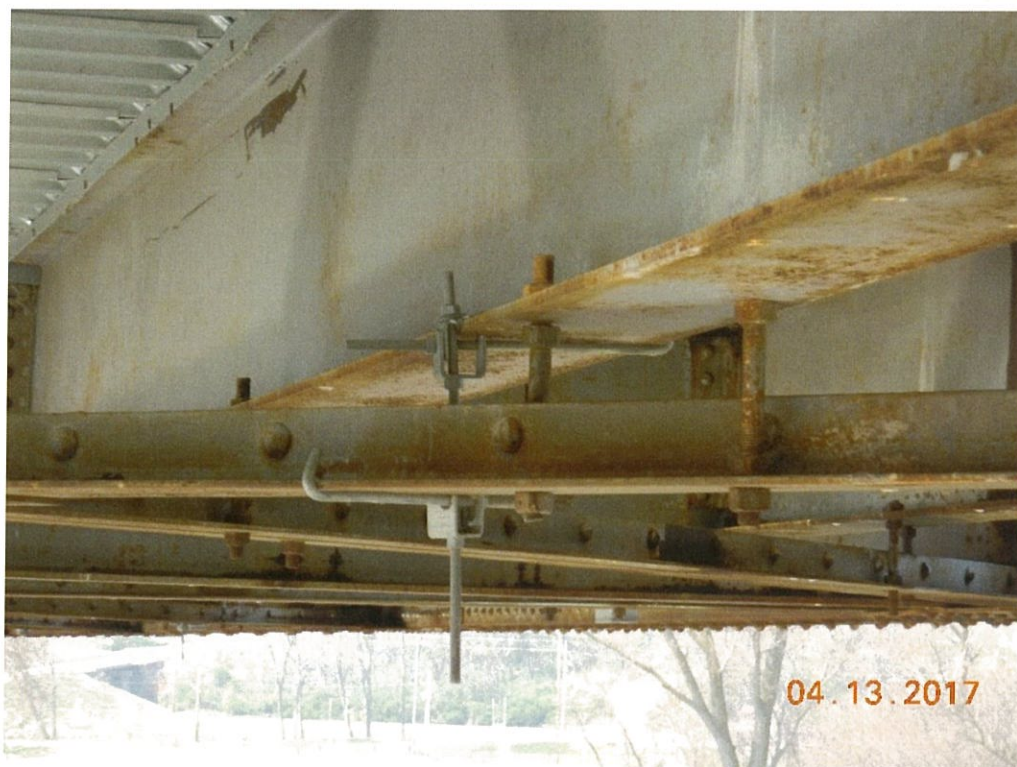
The lower lateral bracing are in fair condition. Some of the hanger bolts used to minimize vibrations of the bottom lateral bracing are bent, sheared off (Photo 82), or have missing nuts. New hanger rods have previously been installed at some of these locations near Pier 5 and appear to be functioning as intended (Photo 83).

Photo 83: New thru truss lower lateral bracing hanger rods have previously been installed at some locations near Pier 5 and appear to be functioning as intended.

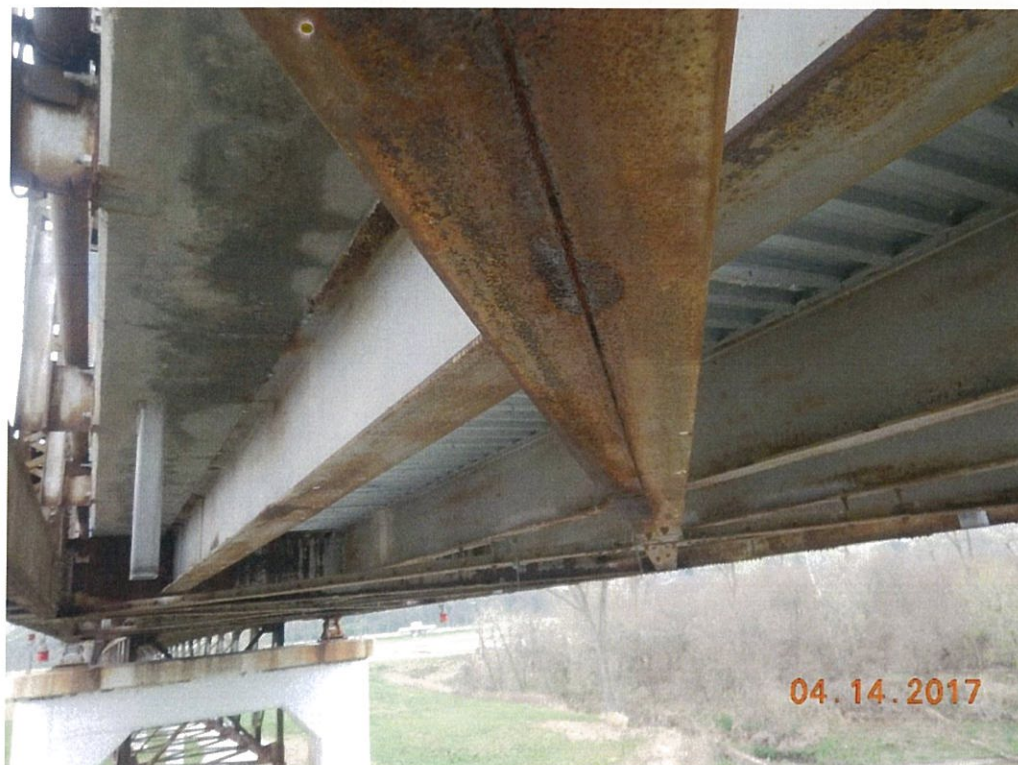
Lower lateral bracing from L2 Lt. to L3 Rt. is bent (Photo 84).

Photo 84: Span 5 lower lateral bracing from L2 Lt. to L3 Rt. is bent.

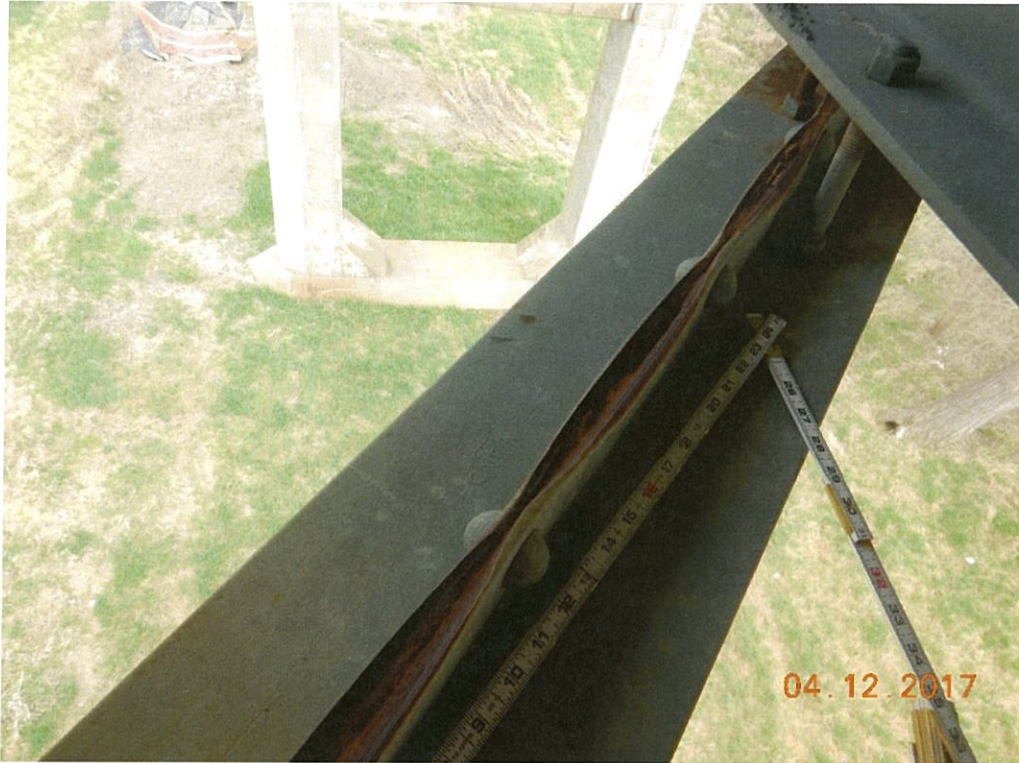
There is heavy packrust buildup between the angles of the lower lateral bracing (Photo 85). Areas of heavy corrosion and packrust are located at ends of the bracing angles near the gusset plate connections (Photo 86). The lower lateral bracing gusset plates themselves have corrosion and packrust forming; the plates at L1' and L2' have significant section loss with holes forming (Photo 87).

Photo 85: There is heavy packrust buildup between the angles of the thru truss lower lateral bracing.

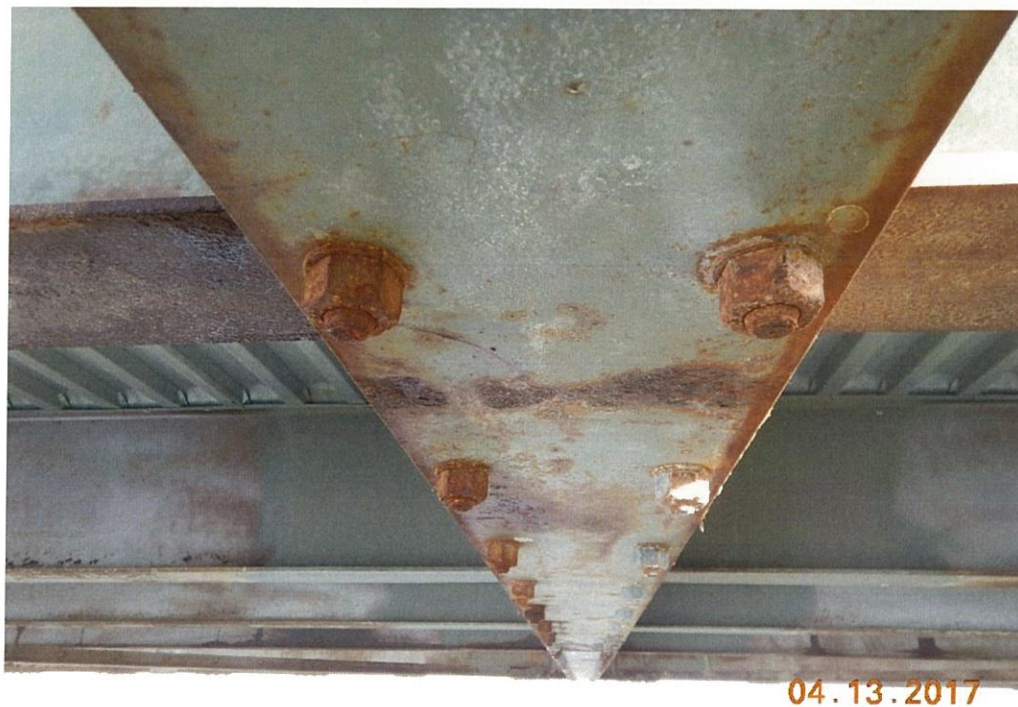
The floorbeams are in fair condition. Floorbeams L1' and L2' were strengthened in 2007, L8 and L3' in 2009, and L7' in 2012. The strengthening consisted of a 1/2" steel plate bolted to the bottom flanges (Photo 88) and, at L1', L2', and L7', a bolted and welded 1/2" steel plate on both sides of the web between the exterior stringer and lower truss chord connection (Photo 89). The strengthening was completed due to section loss from corrosion.

Photo 88: Typical thru truss floorbeam bottom flange repair.
