APPENDIX E. STRUCTURAL DOCUMENTS

**Bellevue Toll Bridge
East Mission Avenue over the Missouri River
Bellevue, Nebraska**

**Structure No. S370 01918
Fracture Critical and Routine NBIS Bridge Inspection
April 2017**

Prepared for:
Bellevue Bridge Commission

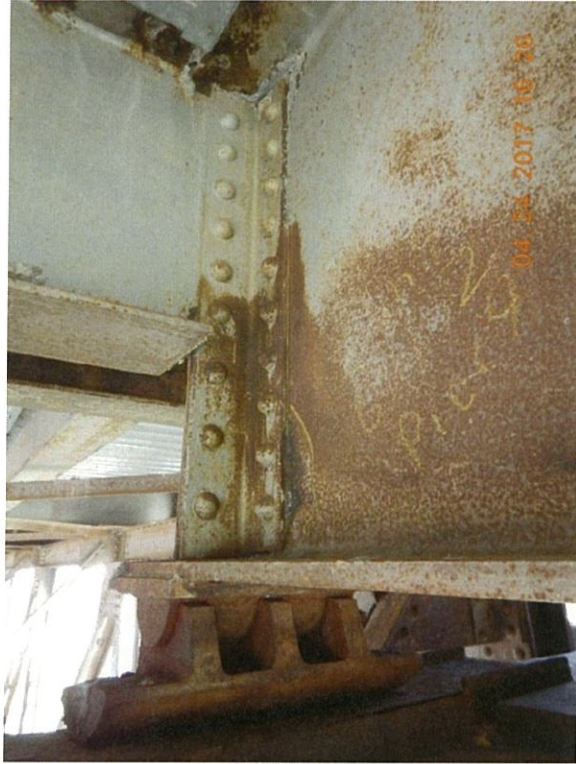
Photo 99: The leaking joints at above the ends of the girders have caused heavy rust with some section loss in the girder webs. Girder 2 interior face at Pier 8 shown.

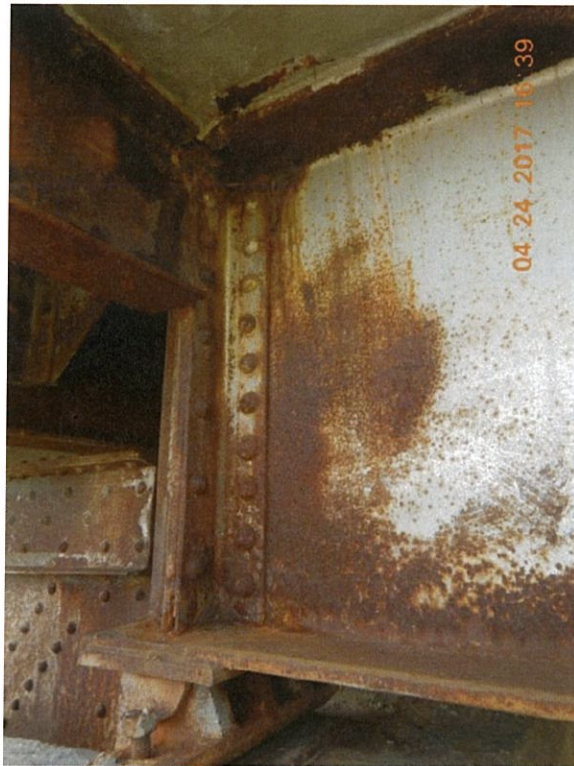
Photo 101: The leaking joints at above the ends of the girders have caused heavy rust with some section loss in the girder webs. Girder 4 exterior face at Pier 8 shown.

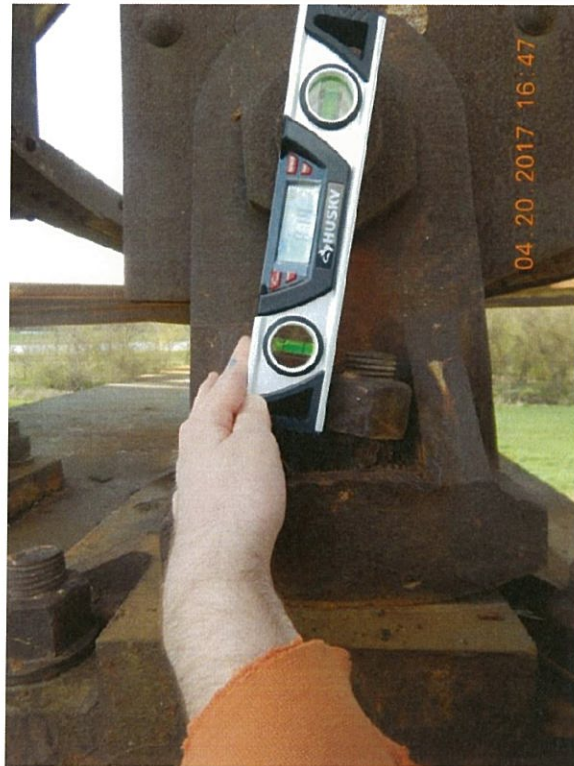
Photo 106: The deck truss anchor bolts at expansion bearings have delamination in the threads between the nut and the bearing plate; the slots are filled with debris causing some of the bolts to bend. Span 3 L0 Rt. exterior bolt shown.

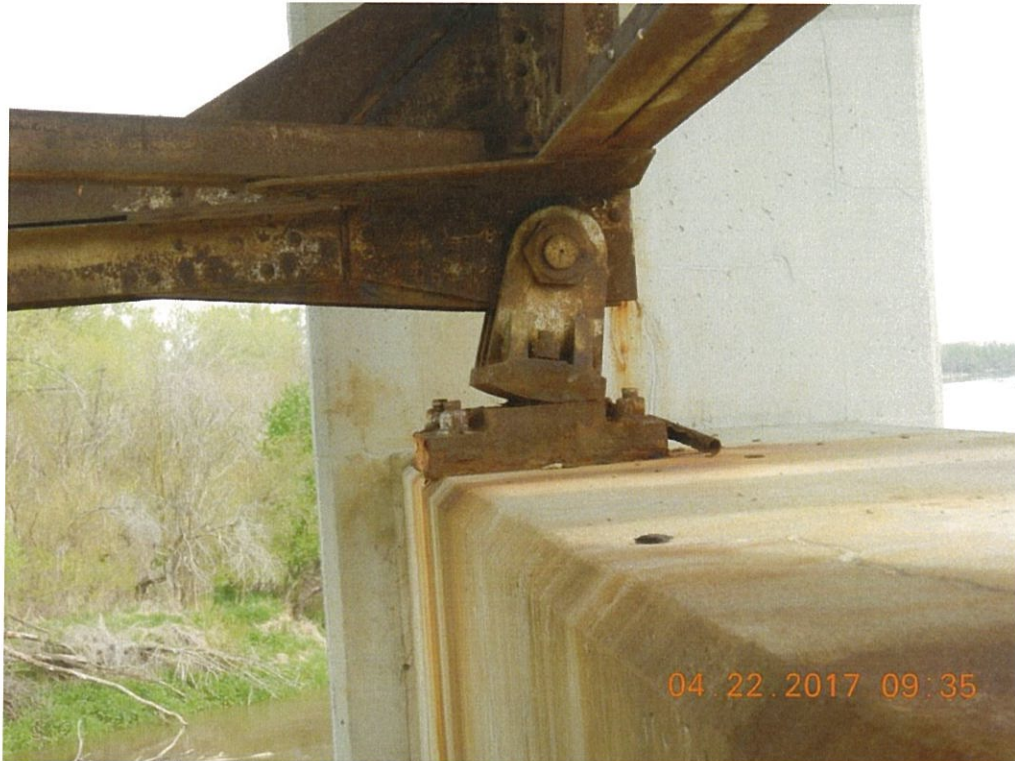
Photo 107: All of the deck truss expansion bearings appear to be over rotated. Span 4 L10 Lt. shown.

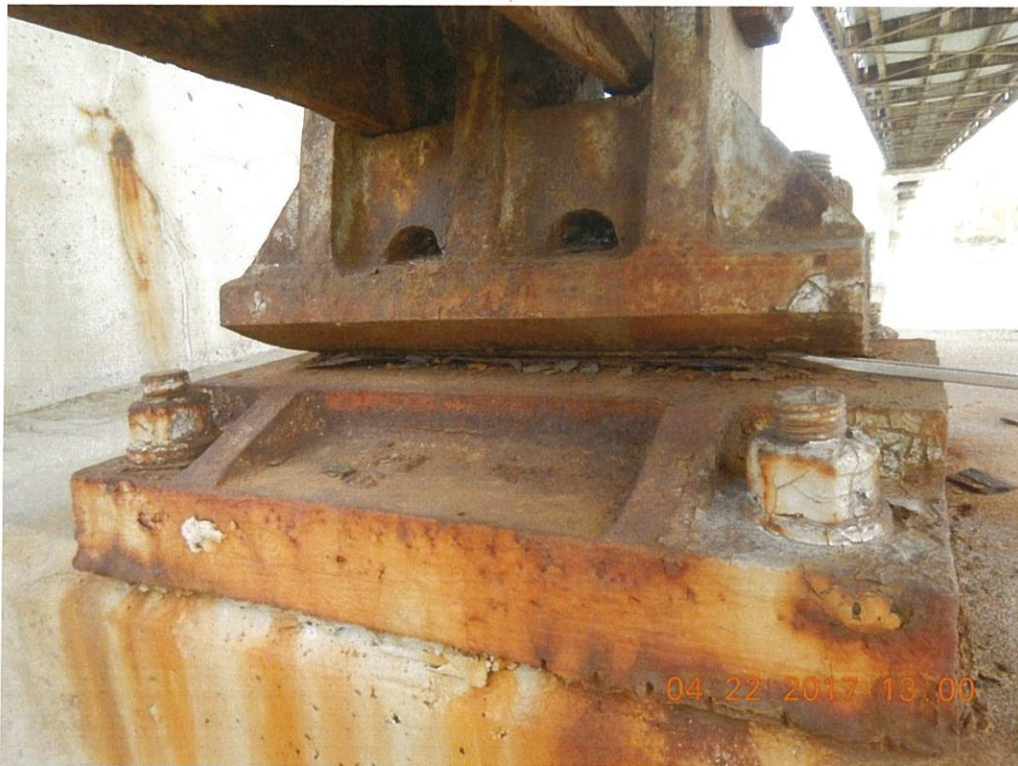
The Pier 6 bearings have heavy rust with delamination on parts of the plates and plate anchor nuts. The bearings do not appear to be overrated but appear to have shifted slightly towards the river. The anchor bolts have delamination in the threads between the nut and the bearing plate (Photo 109); the slots are filled with debris causing some of the bolts to bend. Packrust is developing below the rocker creating minor debris.

Photo 108: Packrust is developing below the deck truss expansion bearing rockers creating minor debris. Span 4 L10 Lt. shown.

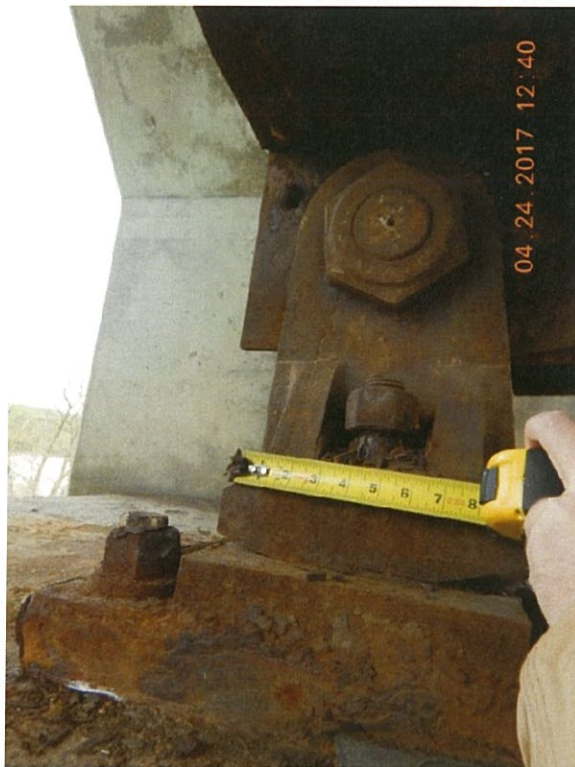
Photo 109: The deck truss expansion bearing anchor bolts have delamination in the threads between the nut and the bearing; the debris from this is filling up the slots. Span 7 L0 Lt. interior shown.

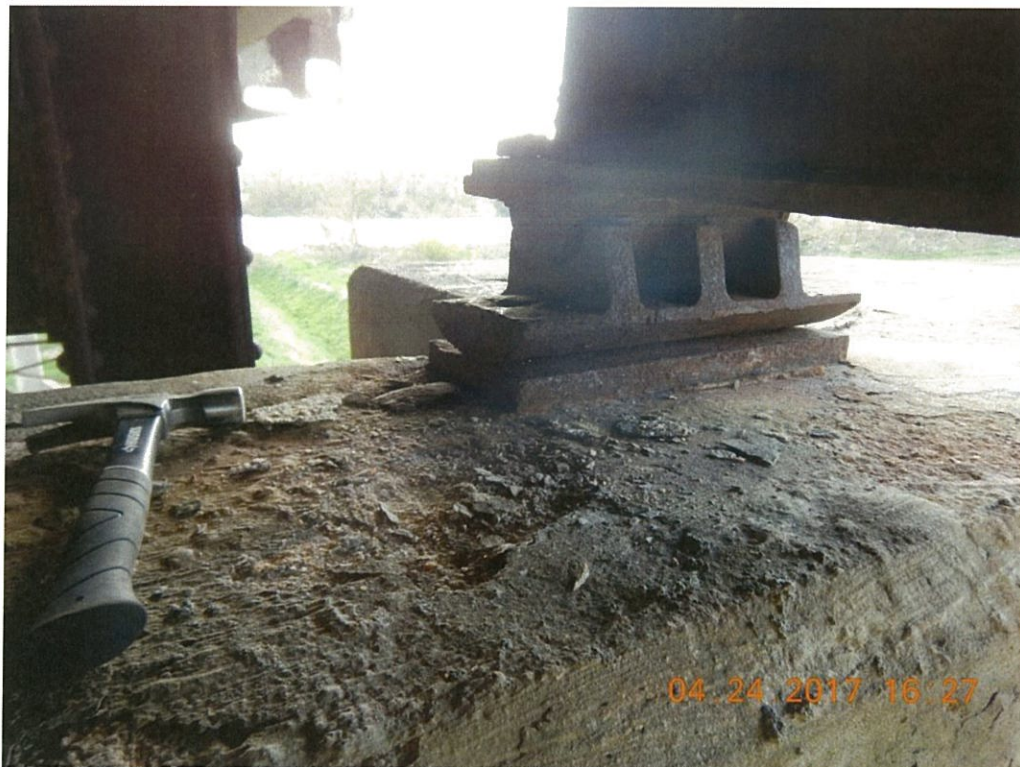
The Pier 8 bearings have heavy rust. Both anchor bolts at Girder 1 are sheared at the top of the slot (Photos 98 and 110). The south anchor bolt at Girder 2 is missing, the north has no nut (Photo 111). Both anchor bolts at Girder 3 are sheared at the top of the slot (Photo 112). The south anchor bolt nut of Girder 4 is approximately 1.5" above the plate. The slots of the sheared anchor bolts are typically filled with debris. The rotation of the bearings appears to not be the same at each girder and the bearings appear over rotated for the temperature observed at the time of inspection, 75 degrees. The concrete bearing seat repair at Girder 2 is in good condition.

Photo 110: Both anchor bolts of Span 9 Girder 1 are sheared at the top of the slot at the Pier 8 bearing.

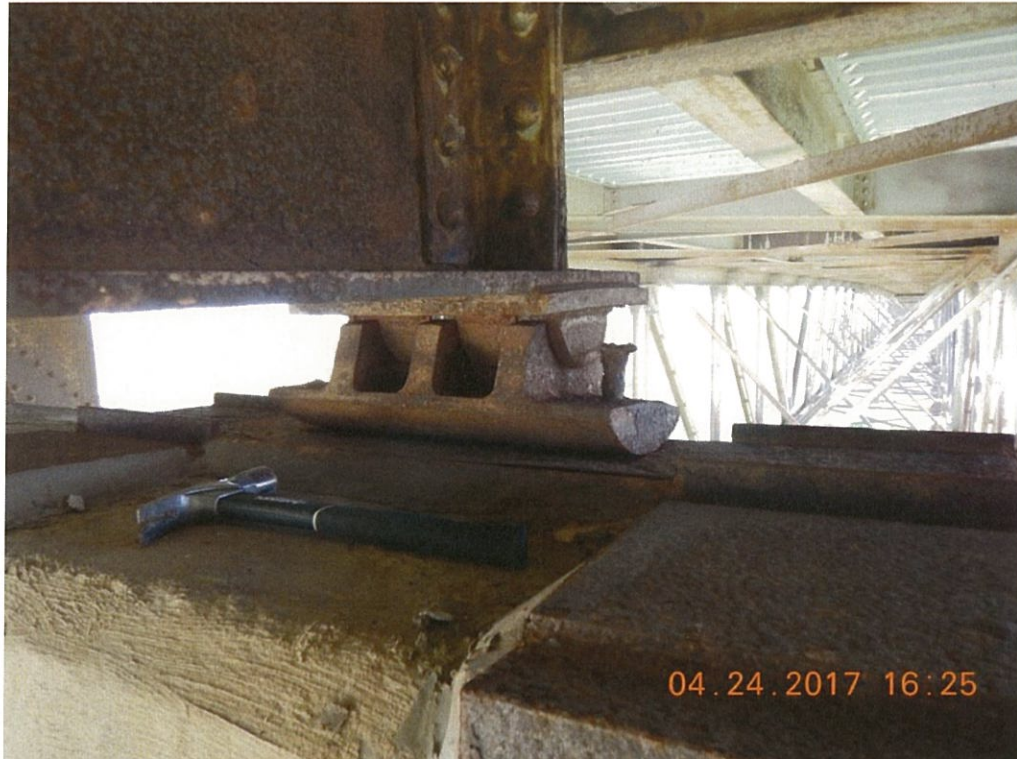
Photo 111: The south anchor bolt at Span 9 Girder 2 is missing at the Pier 8 bearing and the north has no nut.

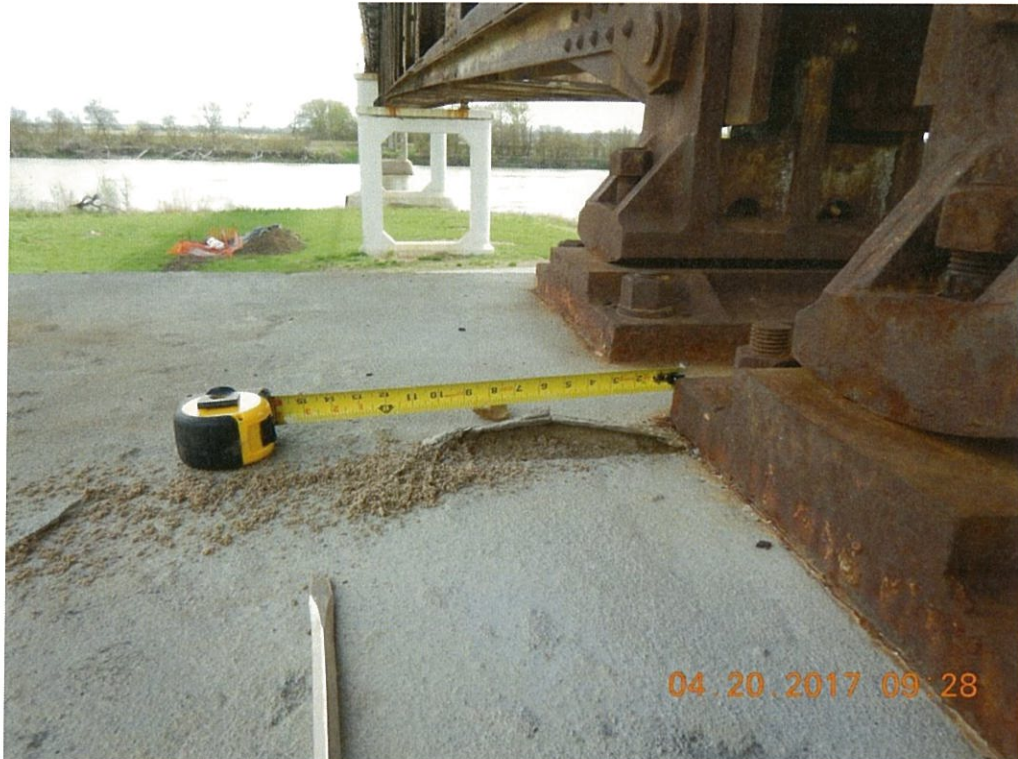
Pier 2 has map cracking throughout with typically wider cracks; most cracks remain sealed with the concrete paint/sealant. Minor spalling at the bottom of the wall at the southeast column. The top of the cap has sealant coat deterioration, approximately 1' by 1' with approximately 1" of sand and aggregate underneath it near both ends of the cap, two locations on the south (Photo 120) and one on the north (Photo 121) – one location at each end is next to a bearing.

Photo 121: The top of the Pier 2 cap has sealant coat deterioration with sand and aggregate underneath it at one location on the north.

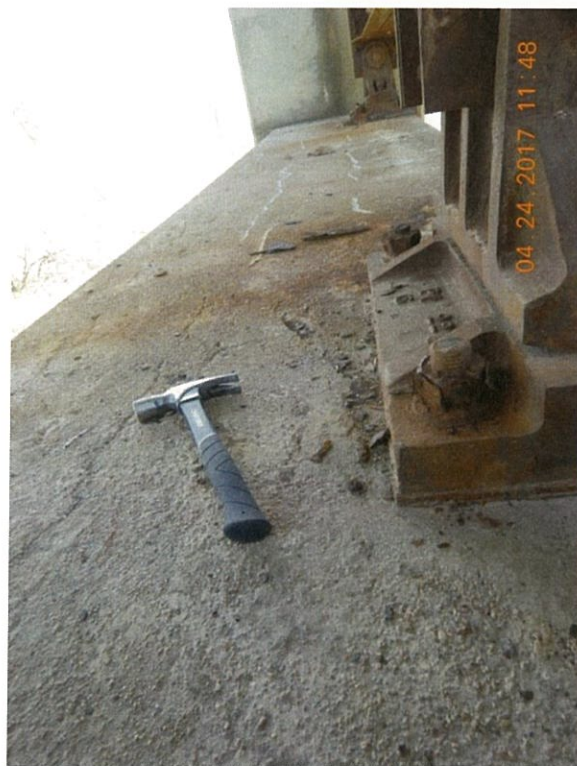
Pier 6 has map cracking throughout with typically wider cracks; most of the wider cracks remain sealed with crack sealant, no paint is present. The top of the west face of the bottom wall has a side crack with spalling in some locations. There is delamination of the cap behind the Span 7 south bearing (Photo 124). Minor spalling around the cracks around the Span 6 south bearing. Minor efflorescence on the Span 7 cap (Photo 125).

Photo 124: There is delamination of the Pier 6 cap behind the Span 7 south bearing.

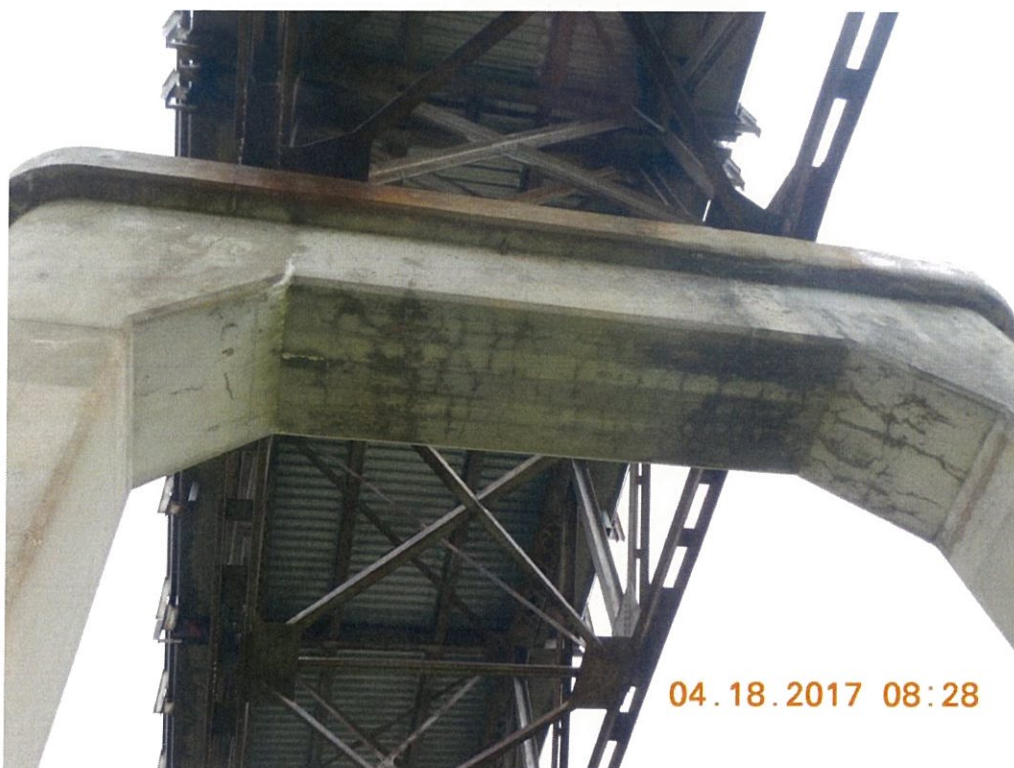
Pier 7 has map cracking throughout with typically wider cracks; most of the wider cracks remain sealed with crack sealant, no paint is present. There is more frequent map cracking on the bottom of the cap; there is also poor consolidation in some locations. Efflorescence is present at the bottom corners of the cap (Photo 126), the top ends of the cap, and the east face of the bottom wall. The patched concrete around the Span 8 south bearing is delaminating (Photo 127).

Photo 126: Efflorescence is present at the bottom corners of the Pier 7 cap. It is also present at the top ends of the cap and the east face of the bottom wall.

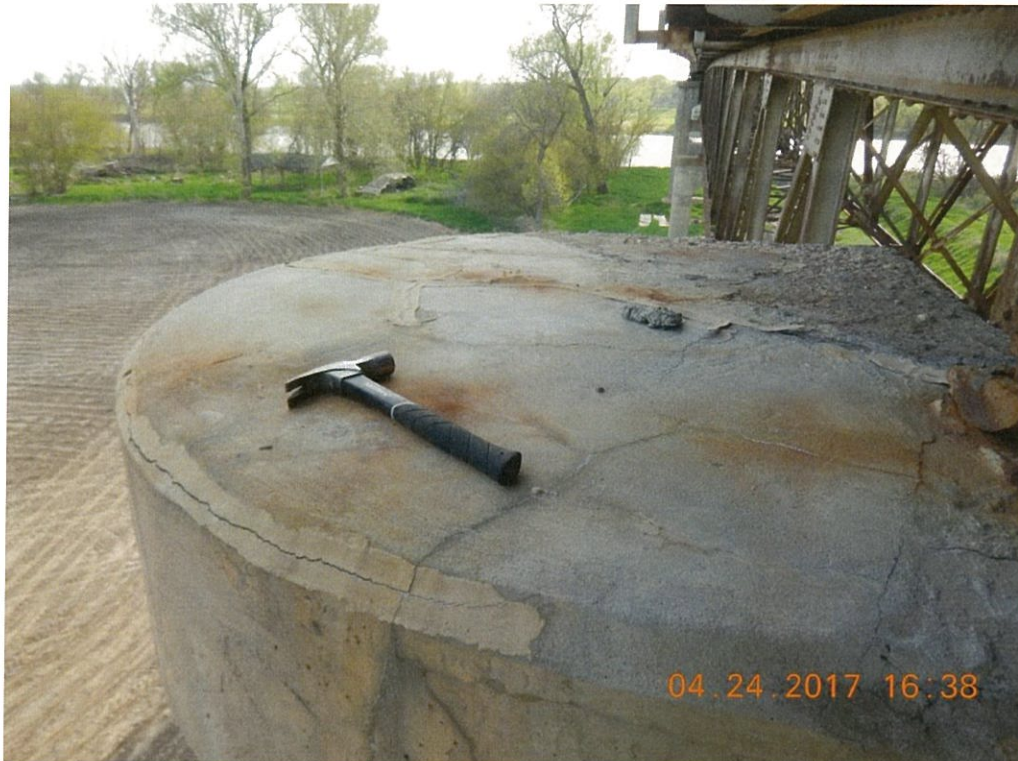
Pier 8 has map cracking throughout with typically wider cracks; most of the wider cracks remain sealed with crack sealant, no paint is present. The top of the bottom wall is scaling which is creating spalls around some of the cracks; larger spalls are present at the southwest corner and east faces of the wall (Photos 128 and 129). Efflorescence is present at the west face of the bottom wall (Photo 130). There are areas of poor consolidation on the bottom of the deck truss cap, the interior face of the south column near the top cap, and the west face of the south column near the top. Erosion around the ends of the pier has created spots for water to pool along the concrete. Heavier cracking with some efflorescence around the patching in the interior faces of both columns above the deck truss bearings. The top of the top cap is scaling at both ends. The concrete patch around the north girder bearing is breaking up (Photo 110). The concrete patch and south end of cap by the south girder bearing is delaminating (Photo 131).

Photo 131: The concrete patch and south end of the Pier 8 cap by the south girder bearing is delaminating.

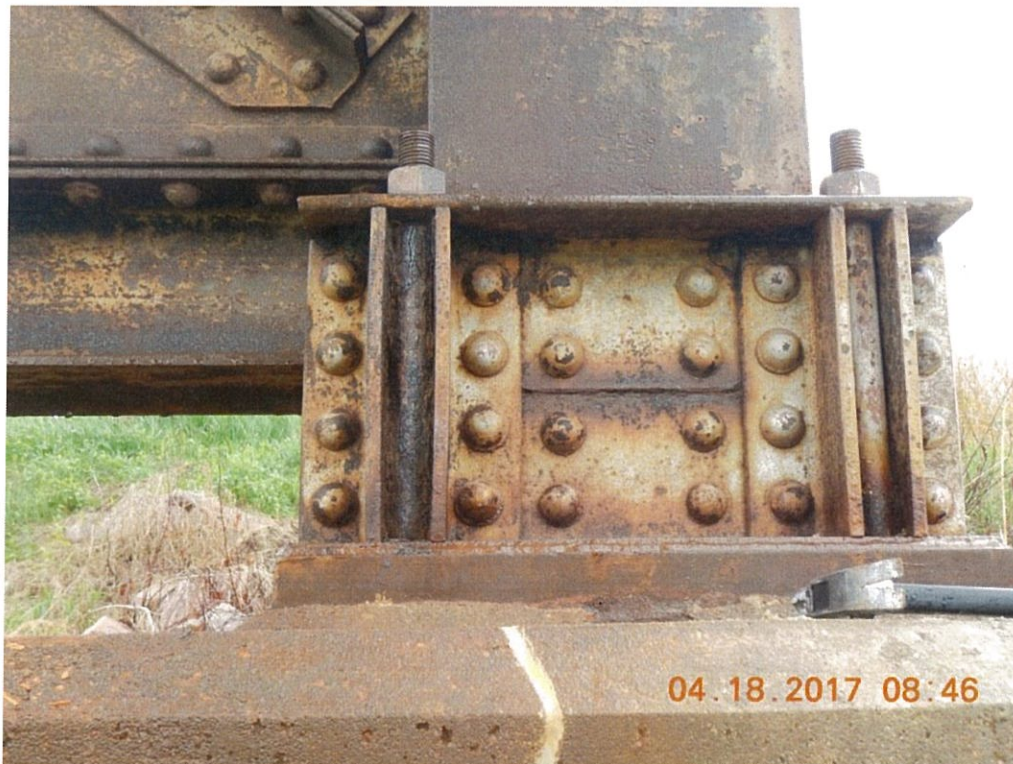
The Pier 9 concrete has heavier cracking throughout with typically wider cracks; most of the wider cracks remain sealed with crack sealant, no paint is present. The paint system is in poor condition throughout the steel, with large areas of complete paint failure, as noted at the June 2016 coatings inspection performed by KTA. There is surface rust throughout the steel. Heavy packrust has developed between the steel column anchor bolts and their stiffeners; there is section loss on some bolts (Photo 132). Water pools along the east face of the pier.

Photo 132: Heavy packrust has developed between the Pier 9 steel column anchor bolts and their stiffeners; there is section loss on some bolts. West bolts at the south column shown.

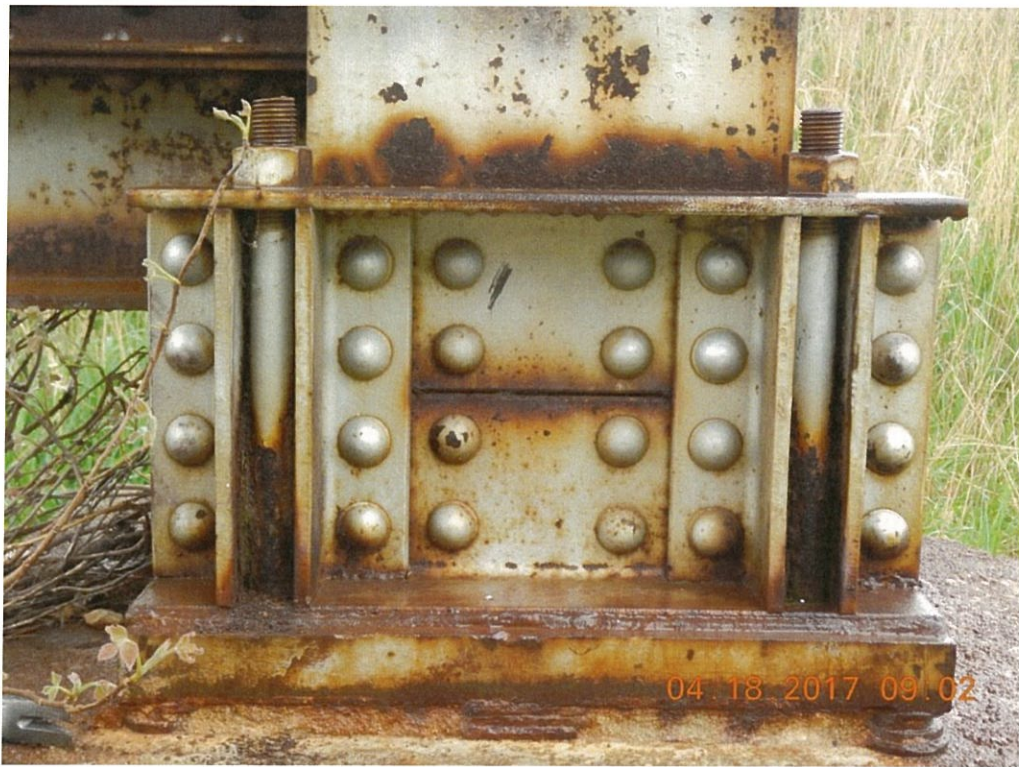
The Pier 10 concrete has heavier cracking throughout with typically wider cracks; most of the wider cracks remain sealed with crack sealant, no paint is present. The paint system is in poor condition throughout the steel, with large areas of complete paint failure, as noted at the June 2016 coatings inspection performed by KTA. There is surface rust throughout the steel. Heavy packrust has developed between the steel column anchor bolts and their stiffeners; there is section loss on some bolts (Photo 133). Small trees and vines are growing along the concrete and into the bottom steel strut.

Photo 133: Heavy packrust has developed between the steel column anchor bolts and their stiffeners; there is section loss on some bolts. East bolts at the north column shown.

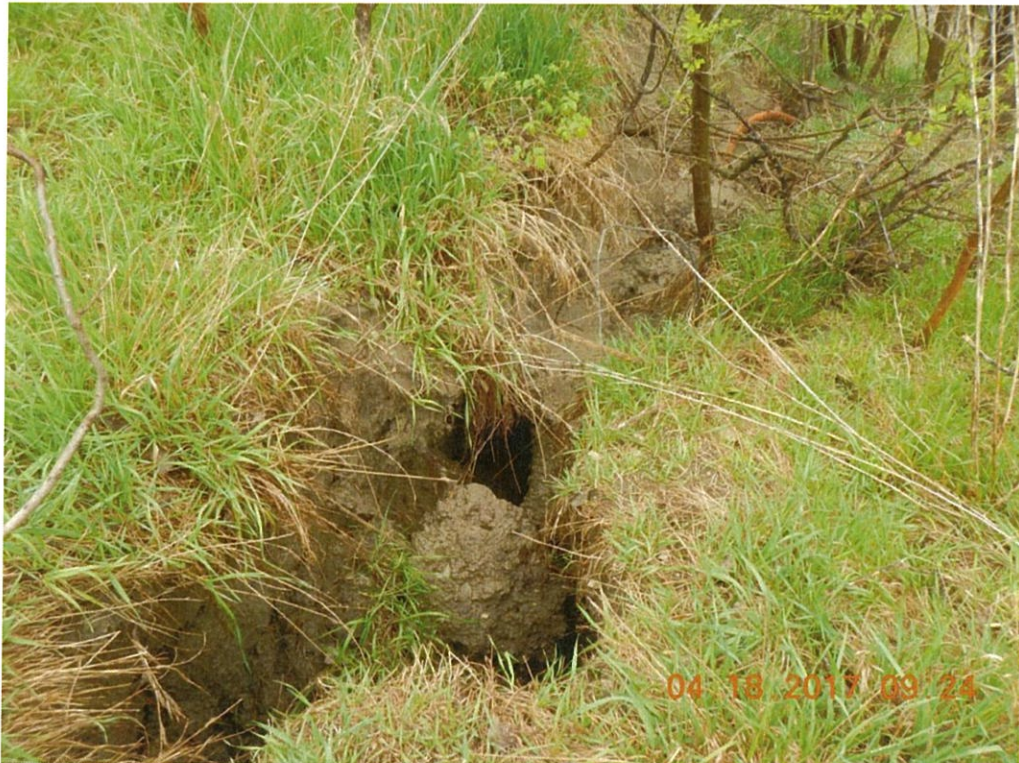
The undermining at the northeast corner of the east approach has previously created a 2' deep embankment erosion channel. The channel is now between 4' and 5' deep (Photo 134). The erosion at the northeast rail end previously noted appears to have been repaired or now blends in with the surrounding natural ground. There is erosion of the grass and soil below the deck drains of Spans 1 through 4 (Photo 135).

Photo 134: The undermining at the northeast corner of the east approach has previously created a 2' deep embankment erosion channel. The channel is now between 4' and 5' deep.

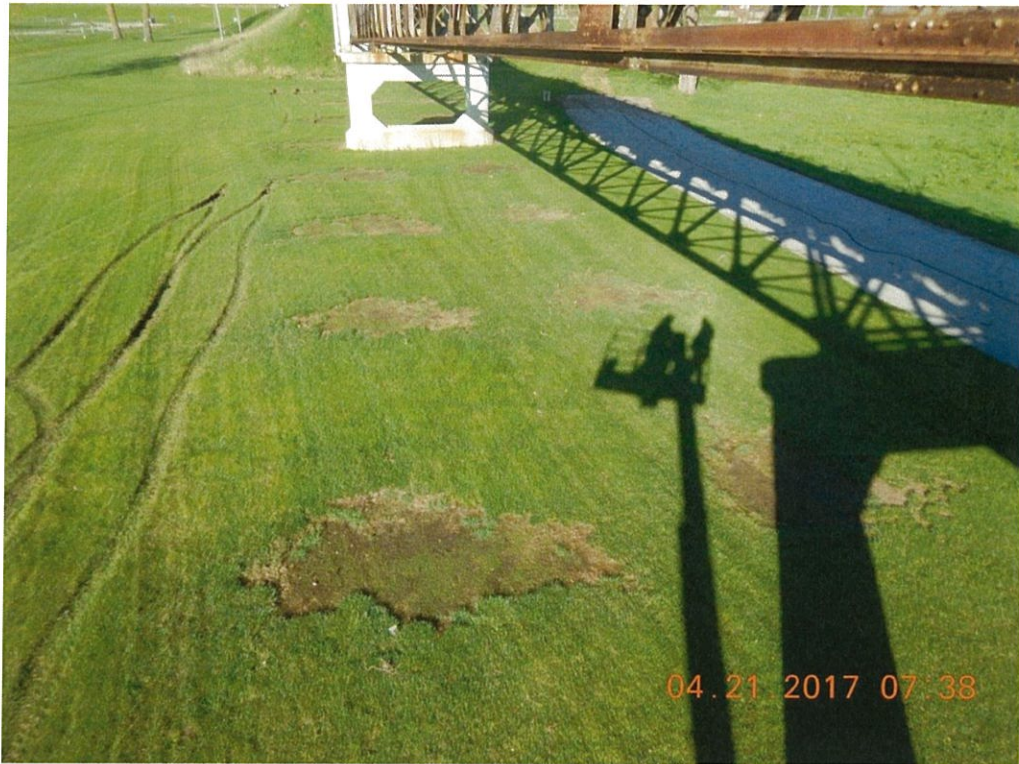
Photo 135: There is erosion of the grass and soil below the deck drains of Spans 1 through 4.

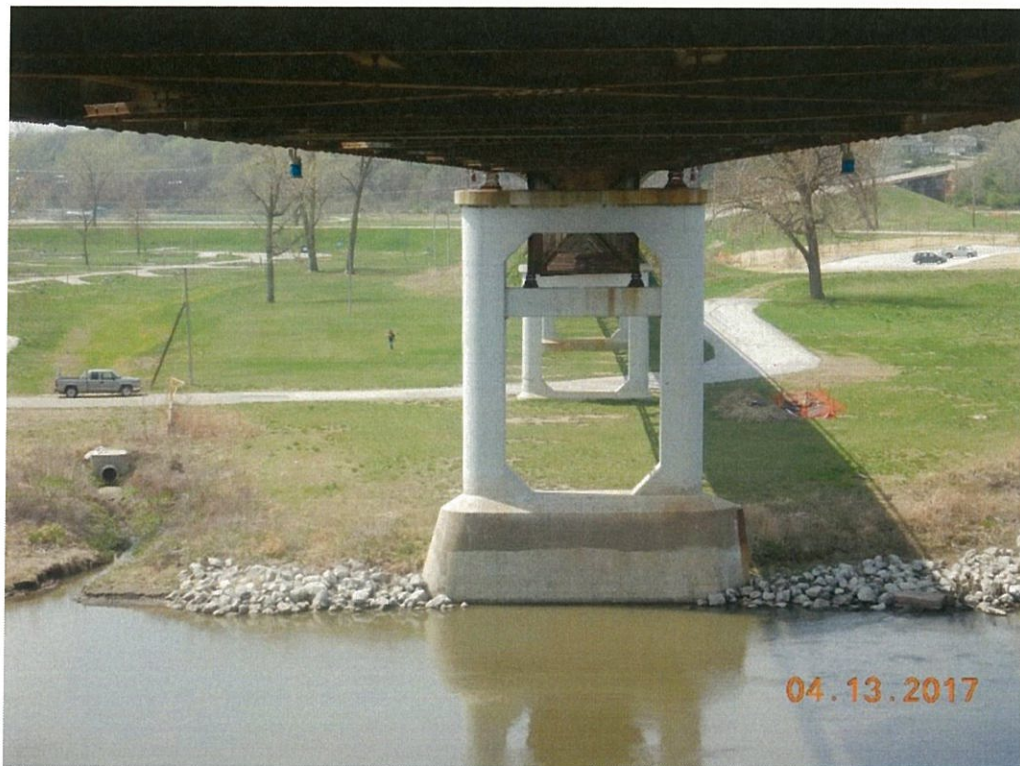
Riprap is sparse along the east face of Pier 4 (Photograph 136). At the time of inspection the waterline extended to the base of Pier 4, no scour or erosion was observed relating to the sparse riprap.

Photo 136: Riprap is sparse along the east face of Pier 4.

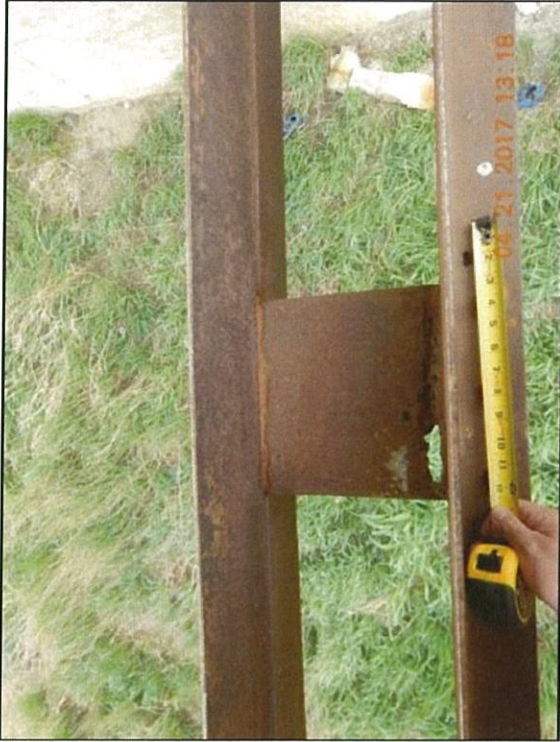
Span 1 L0L1 Lt exterior top angle hole at middle batten plate

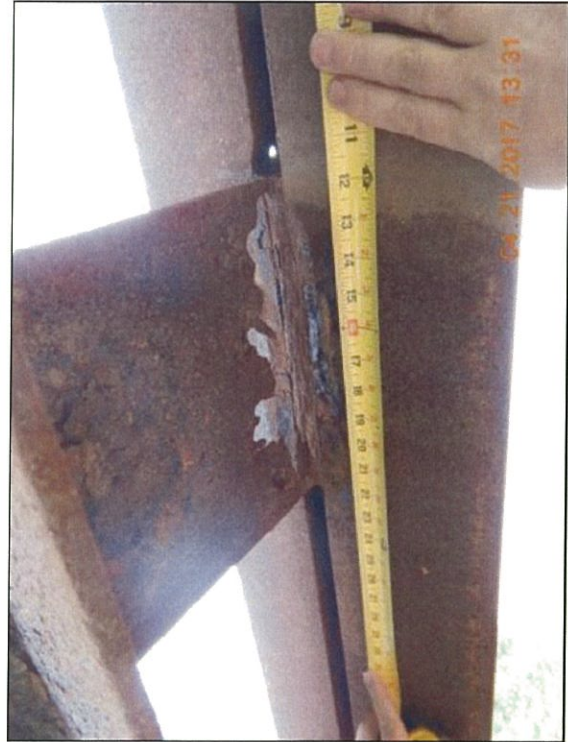
Span 1 L1L2 Lt bottom exterior angle hole below middle batten plate

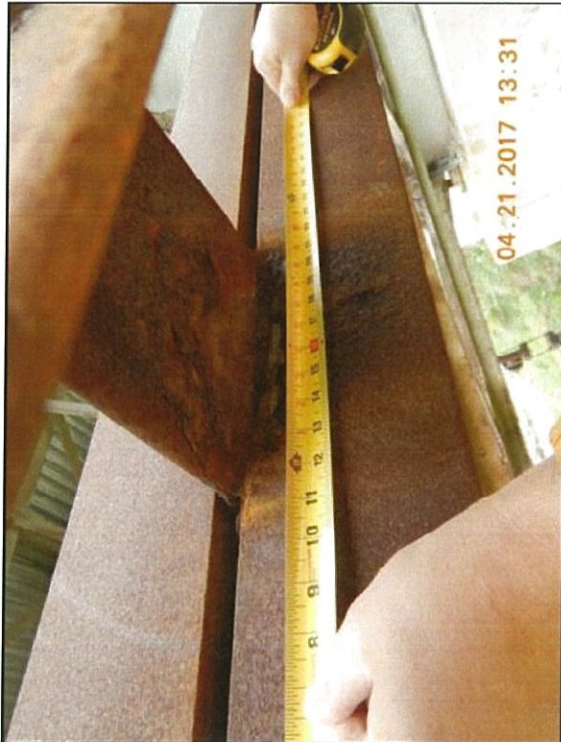
Span 1 L1L2 Lt bottom interior angle hole below middle batten plate

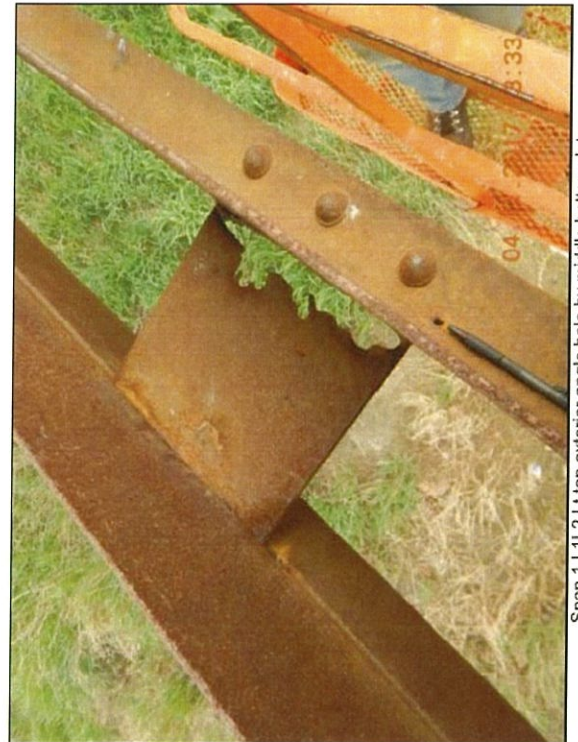
Span 1 L1L2 Lt top exterior angle hole by middle batten plate

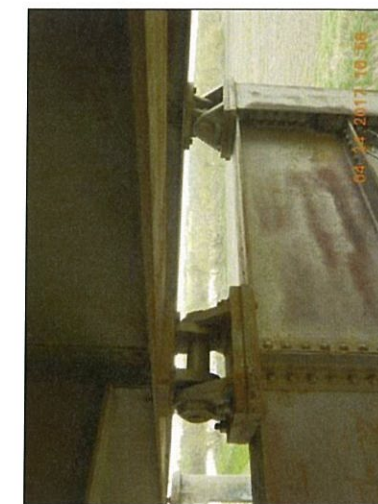
Bearings Pier 10 Girders 3 and 4

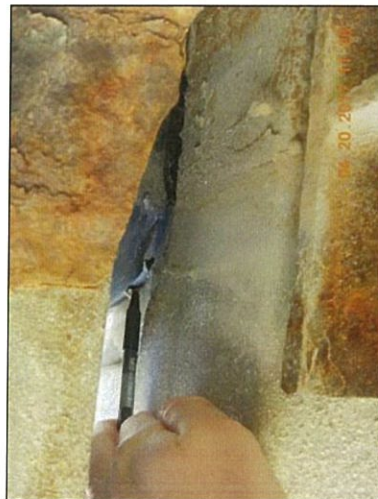
Pier 1 North deck joint torn

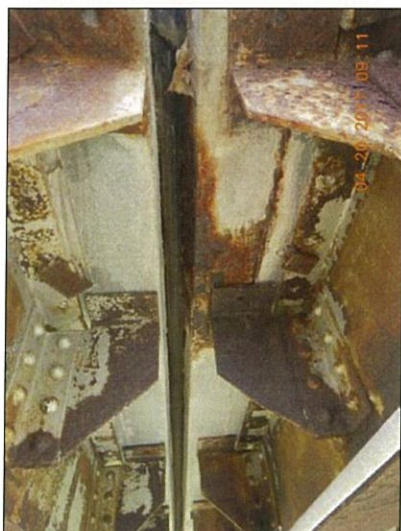
Pier 2 deck joint

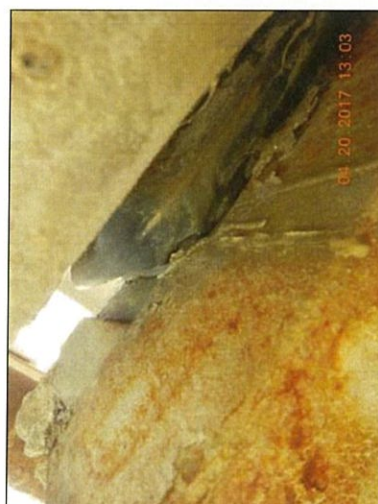
Pier 3 Deck joint cuts on South

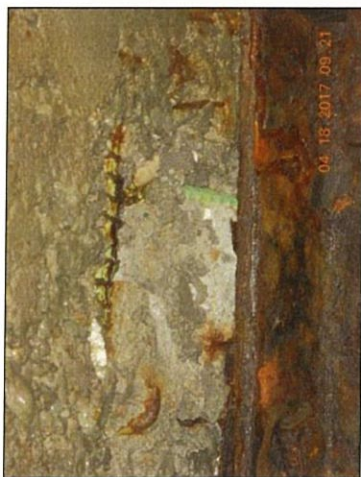
Span 11 Abutment 2 South deck corner poor consolidation with exposed rebar

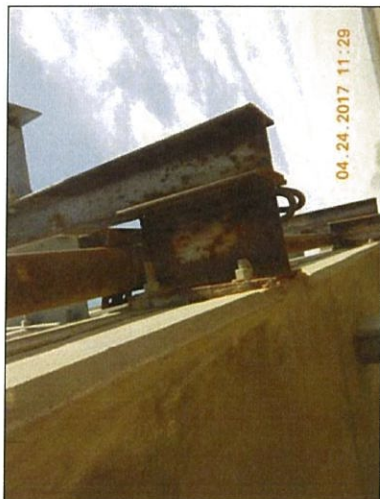
Span 7 Rail post near U0 bracket was loose - removed at ...

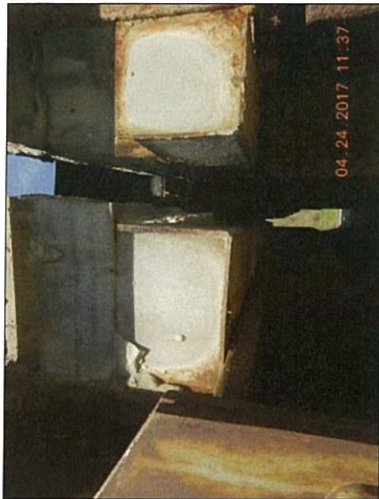
Pier 6 deck joint South end possible leak

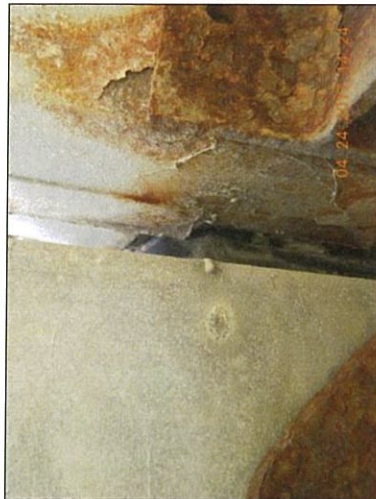
Pier 7 deck joint holes on north end

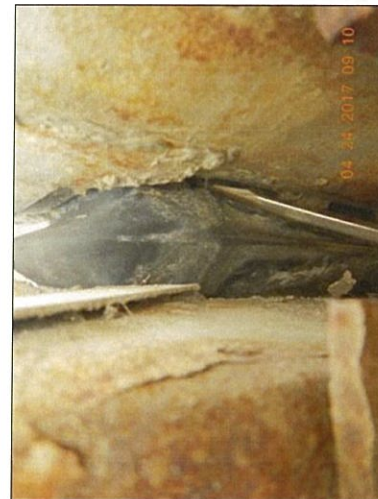
Pier 7 deck joint South end holes

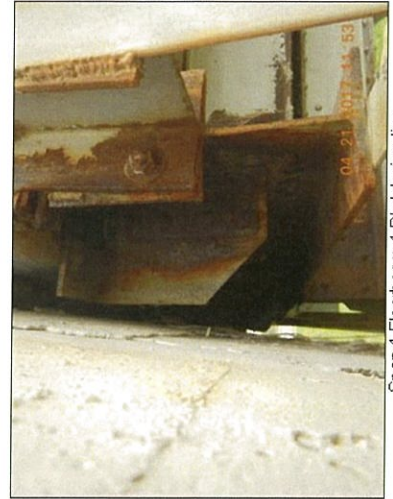
Span 1 Floorbeam 1 Rt deterioration

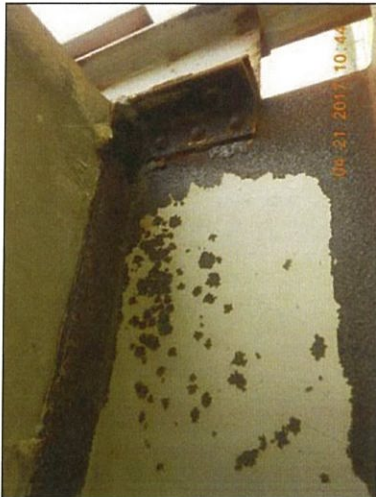
Span 1 Floorbeam 5 Rt heavy deterioration

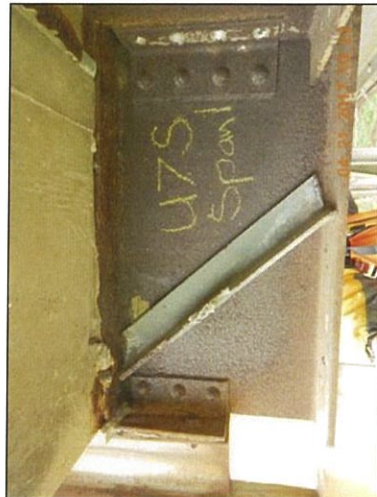
Span 1 Floorbeam 7 Rt stiffened and deterioration

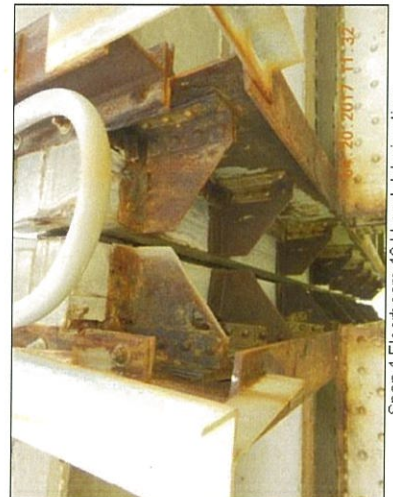
Span 1 Floorbeam 10 Lt end deterioration

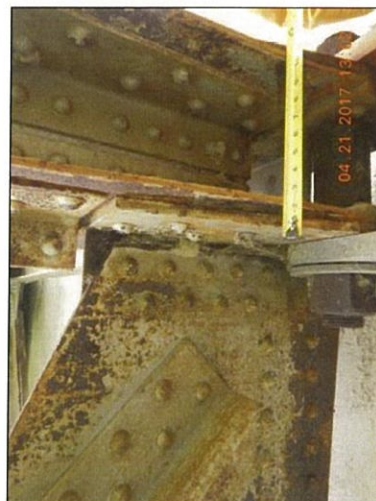
Span 1 L0 Lt bottom interior packrust

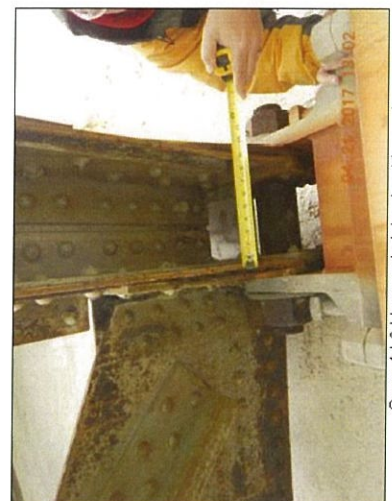
Span 1 L0 Lt gusset plates bent inward

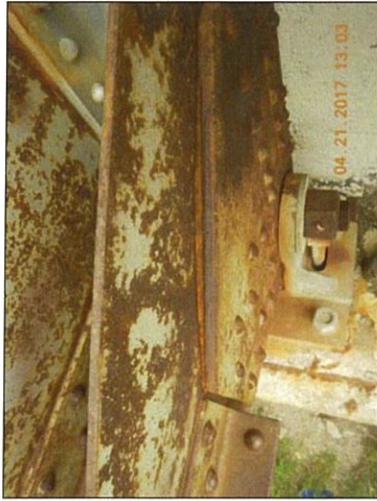
Span 1 L0 Lt top exterior packrust

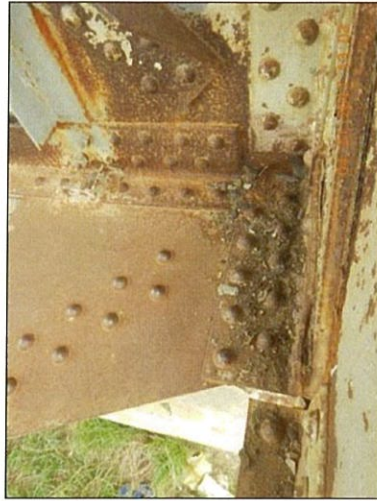
Span 1 L0 Lt top interior packrust

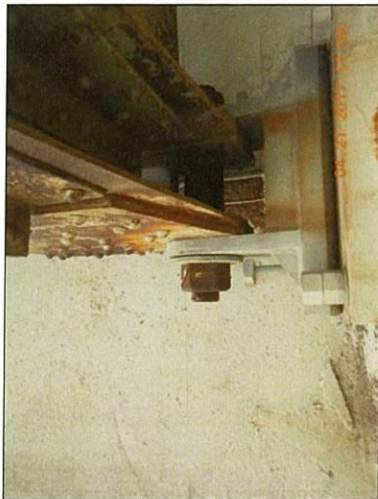
Span 1 L0 Rt bottom exterior packrust

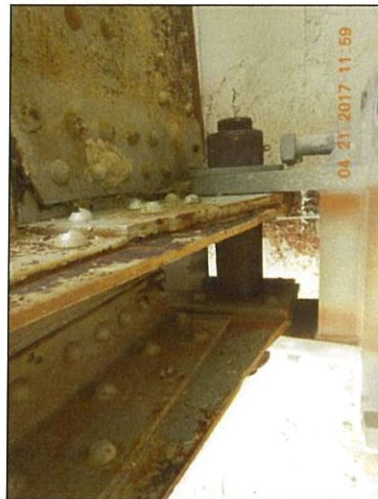
Span 1 L0 Rt bottom interior packrust

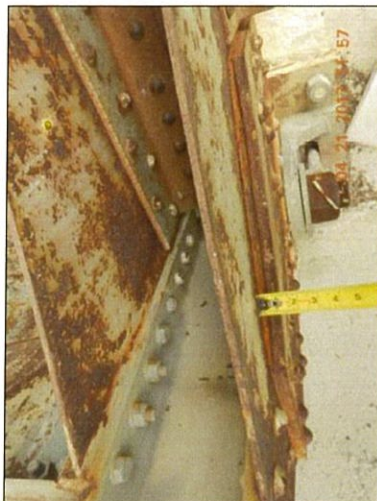
Span 1 L0 Rt top exterior packrust

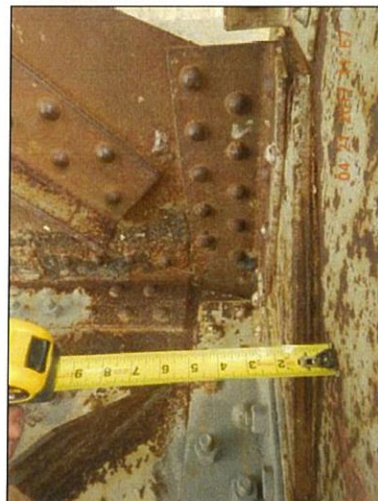
Span 1 L0 Rt top interior packrust

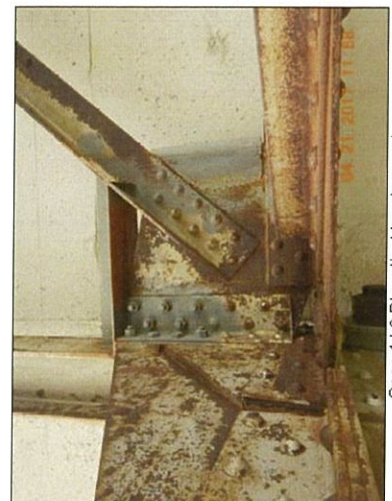
Span 1 L0 Rt vertical bracing angles

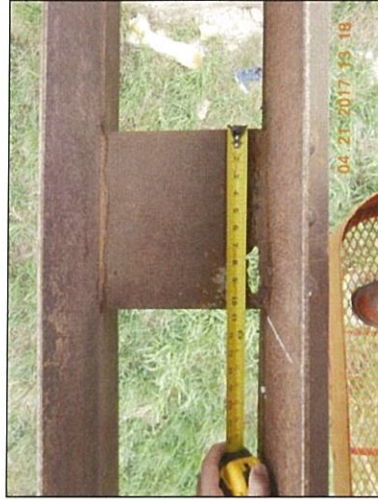
Span 1 L0L1 Lt middle batten plate hole

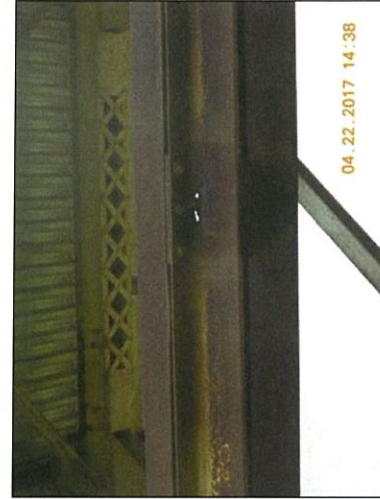
Span 1 L1L2 Lt exterior holes from ground

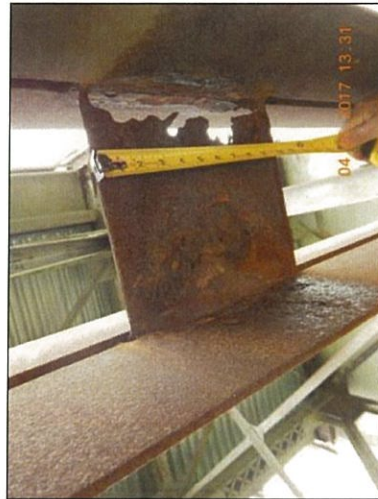
Span 1 L1L2 Lt middle batten plate hole

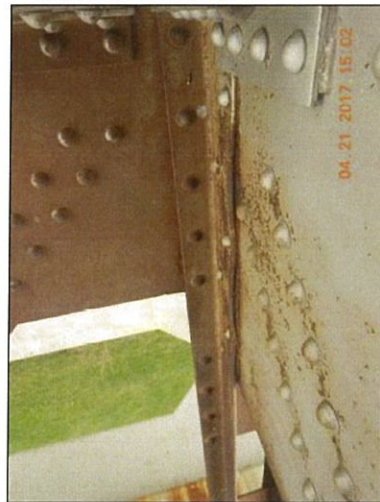
Span 1 L3 Rt exterior packrust

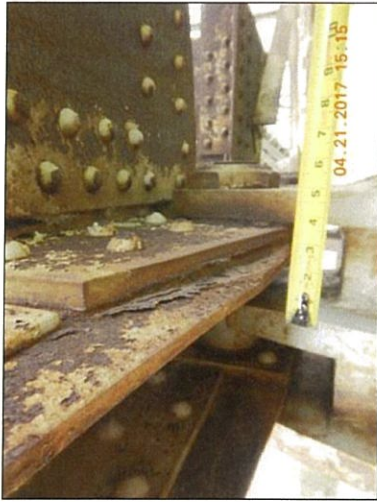
Span 1 L10 Lt bottom exterior packrust

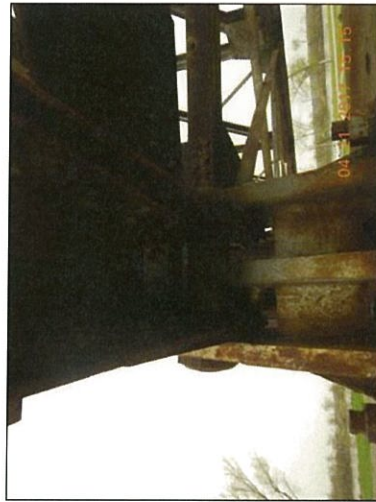
Span 1 L10 Lt bottom interior packrust

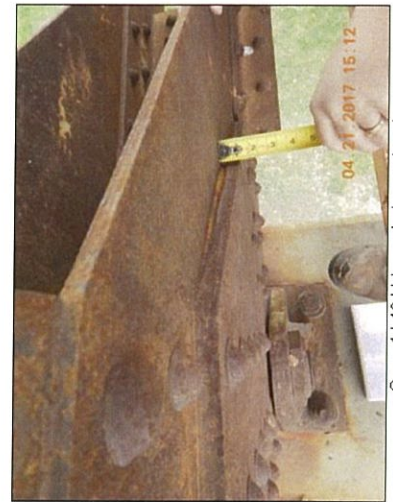
Span 1 L10 Lt gusset plates bent inward

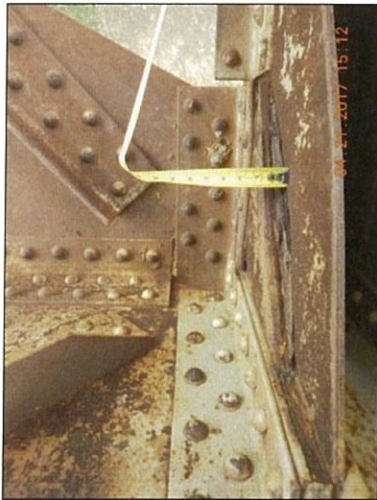
Span 1 L10 Lt top exterior packrust

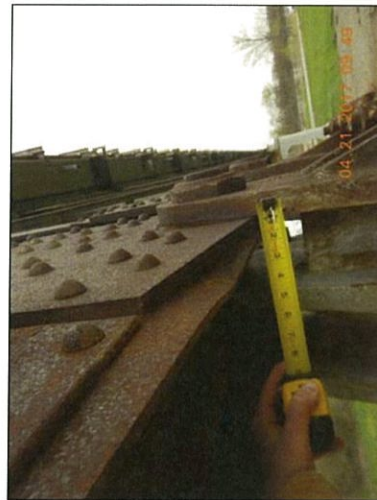
Span 1 L10 Lt top interior packrust

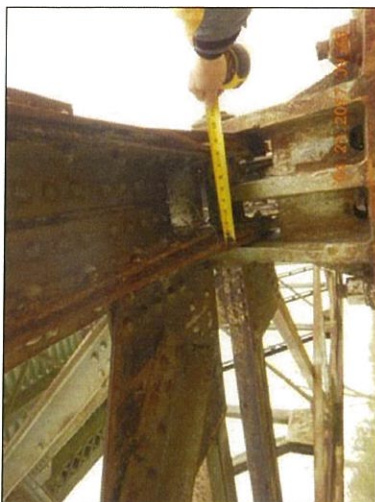
Span 1 L10 Rt bottom interior packrust

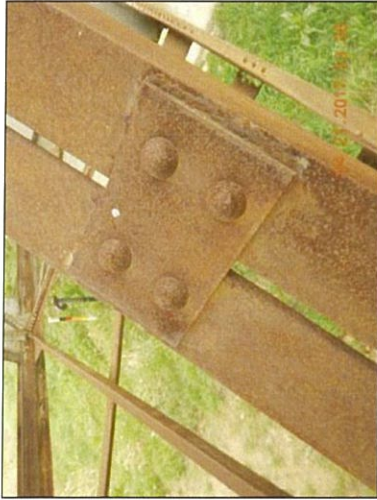
Span 1 L10 Rt top interior packrust

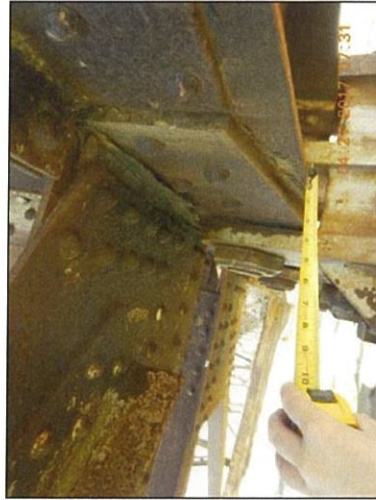
Span 1 U1L2 Lt batten plate deterioration

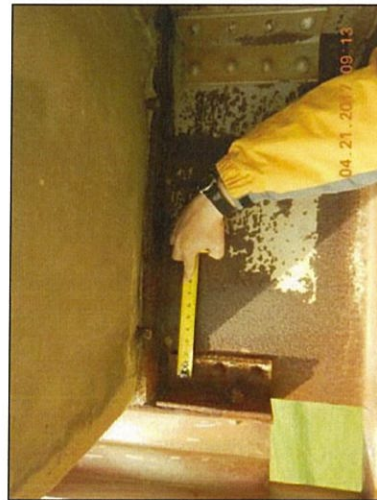
Span 2 Floorbeam 0 Lt end deterioration

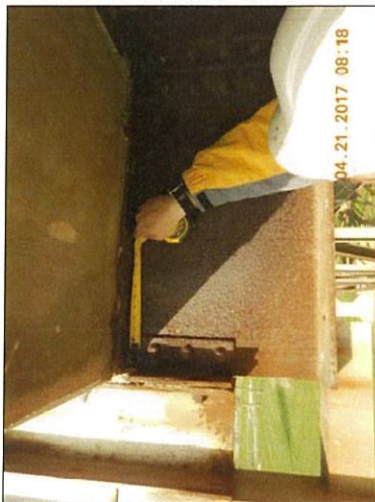
Span 2 Floorbeam 4 Lt deterioration and web hole

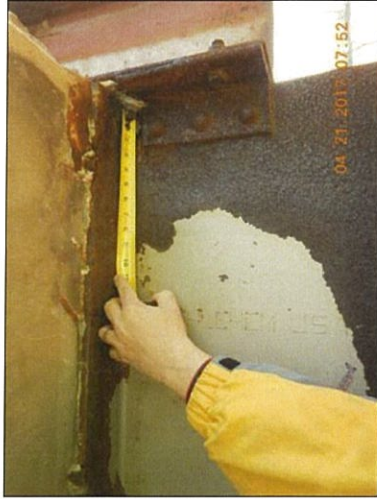
Span 2 Floorbeam 8 Rt stiffened and deterioration

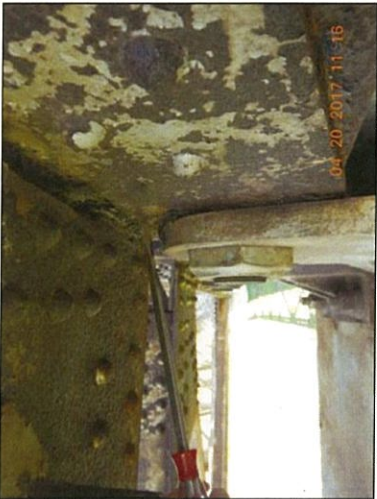
Span 2 L0 Lt bottom interior packrust
