APPENDIX E. STRUCTURAL DOCUMENTS

**Bellevue Toll Bridge
East Mission Avenue over the Missouri River
Bellevue, Nebraska**

**Structure No. S370 01918
Fracture Critical and Routine NBIS Bridge Inspection
April 2017**

Prepared for:
Bellevue Bridge Commission

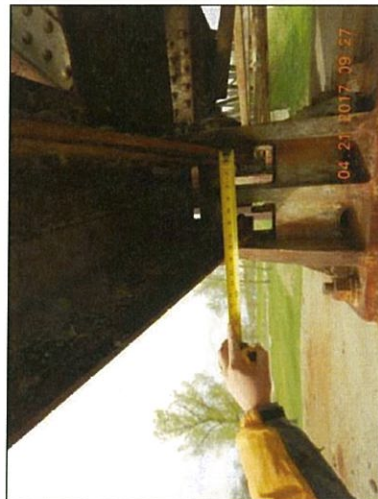
Span 2 L0 Rt bottom exterior packrust

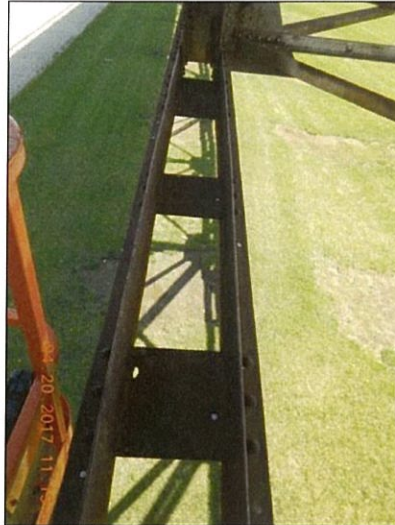
Span 2 L0 Rt top interior packrust

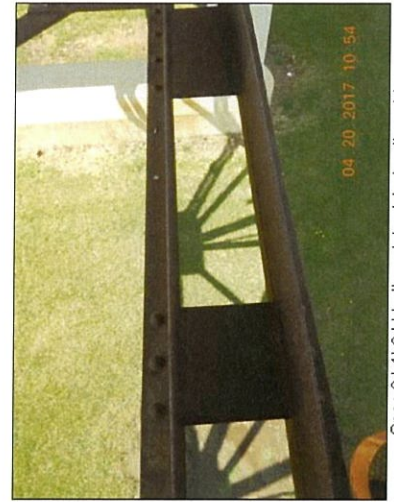
Span 2 L0L1 Lt batten plate deterioration from top

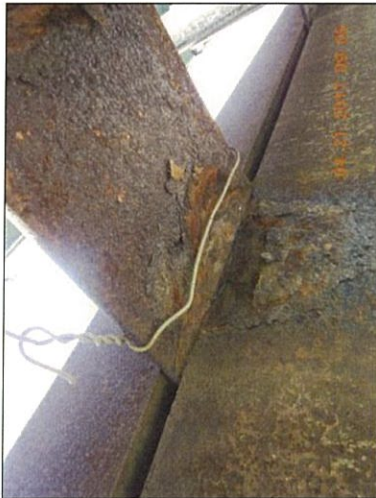
Span 2 L1L2 Lt batten plate deterioration at top

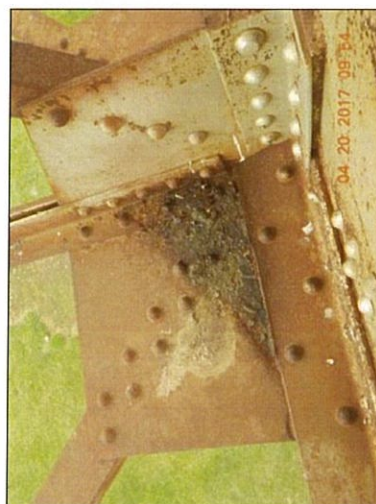
Span 2 L7L8 Lt bottom batten plate deterioration

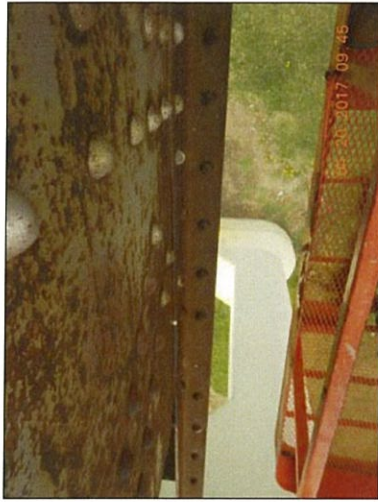
Span 2 L8L9 Lt bottom of splice packrust near L8

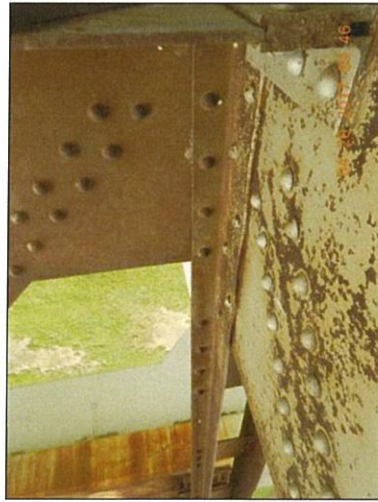
Span 2 L9 Lt exterior packrust at top of lower chords

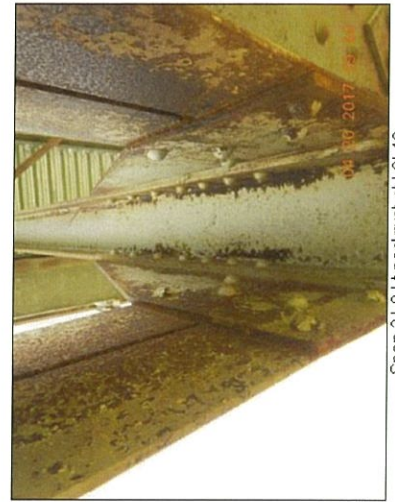
Span 2 L9 Lt interior packrust at top of lower chords

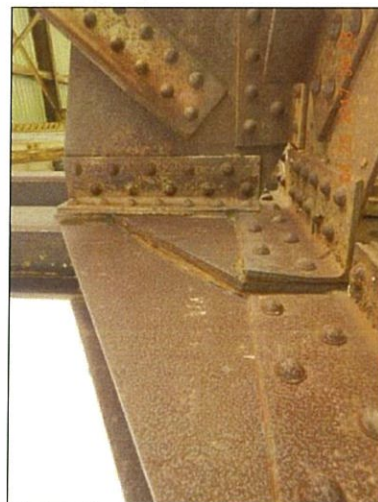
Span 2 L10 Lt top exterior plate packrust

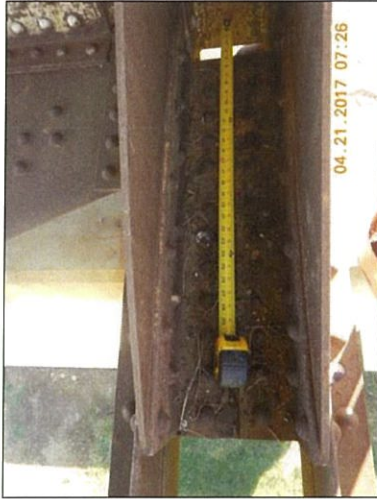
Span 2 L10 Rt bottom exterior packrust

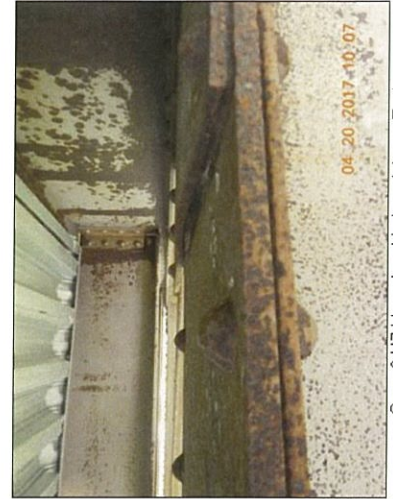
Span 2 U6L5 Lt packrust on top side

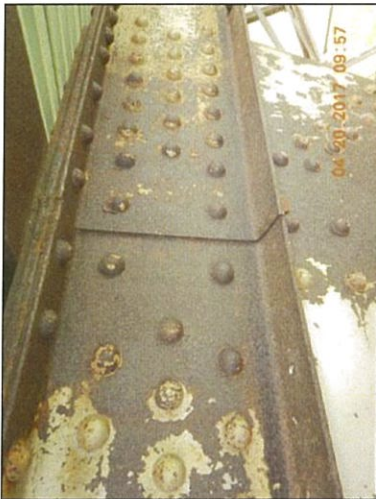
Span 2 U7 Lt packrust in top plate on East

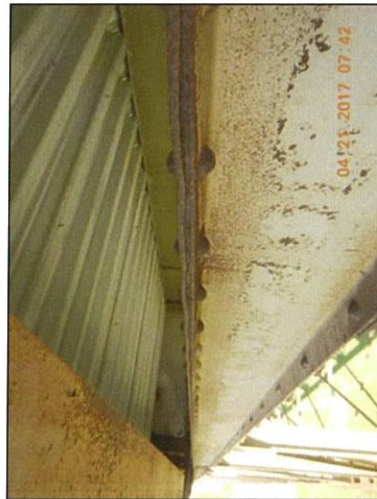
Span 2 U8 Lt exterior upper channels not lined up

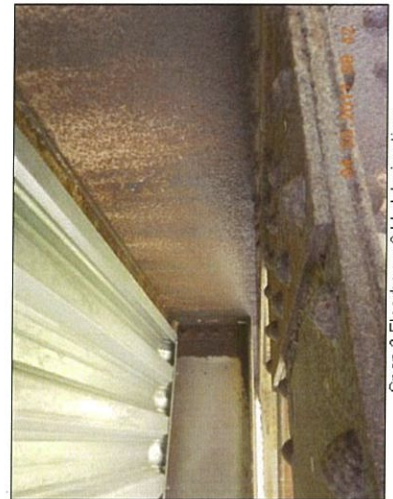
Span 2 U10 Rt typ packrust at upper chord cover plates

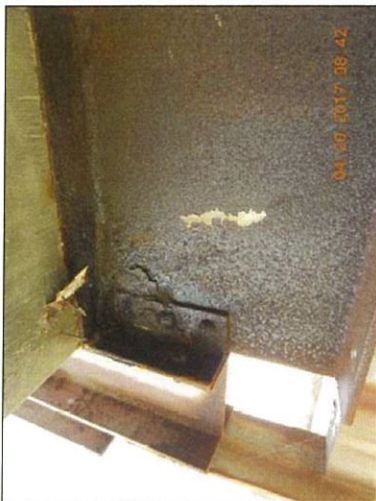
Span 3 Floorbeam 2 Lt deterioration

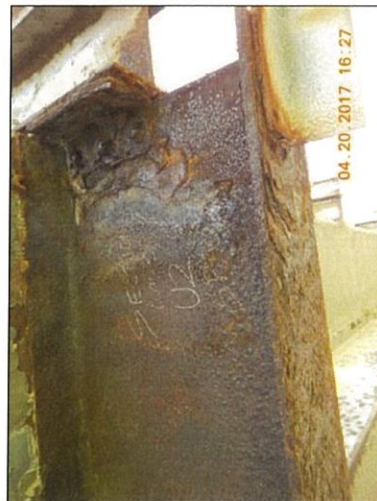
Span 3 Floorbeam 2 Lt web deterioration

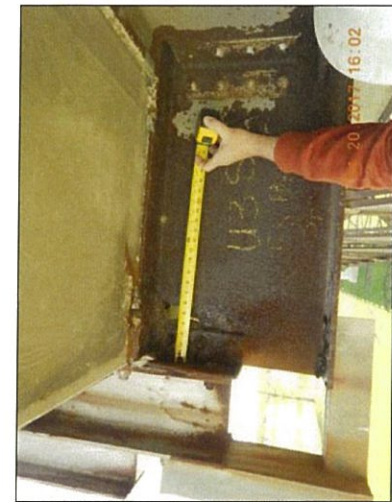
Span 3 Floorbeam 3 Lt hole

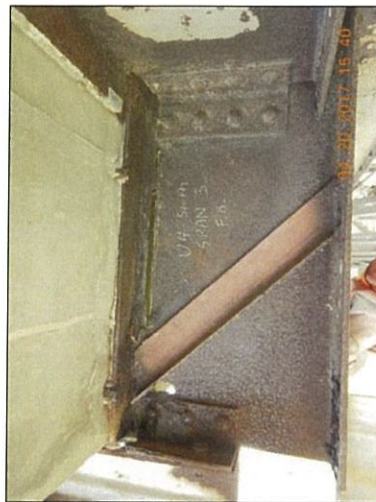
Span 3 Floorbeam 3 Rt deterioration

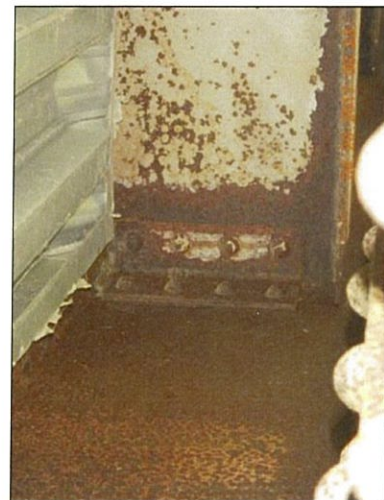
Span 3 Floorbeam 4 Rt west face deterioration

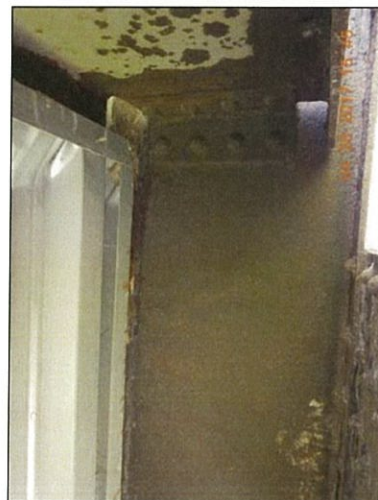
Span 3 Floorbeam 4 Stringer 2 exterior packrust

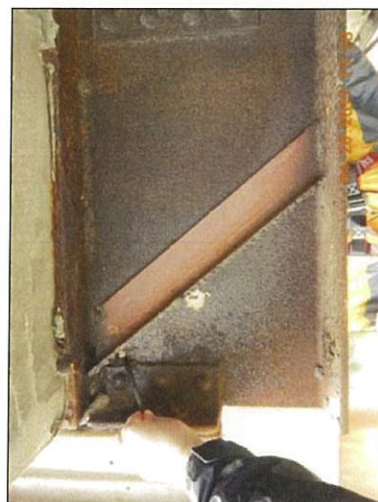
Span 3 Floorbeam 6 Rt stiffened and deterioration

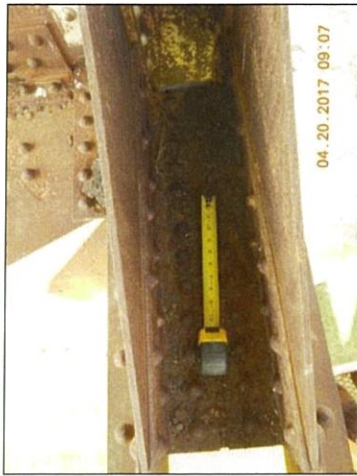
Span 3 L0 end vertical bracing packrust

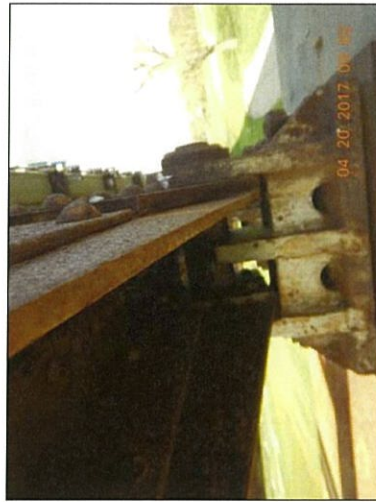
Span 3 L0 Lt end plate deterioration with rivets severely deteriorated on exterior side

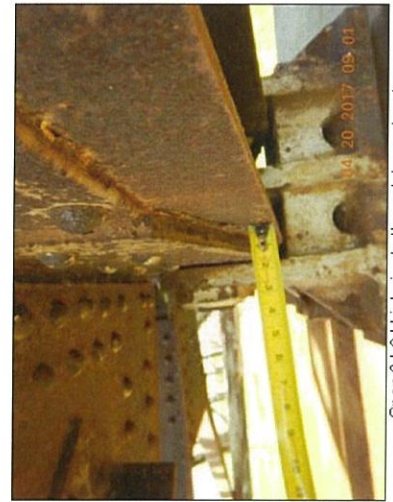
Span 3 L0 Lt exterior bottom plate packrust

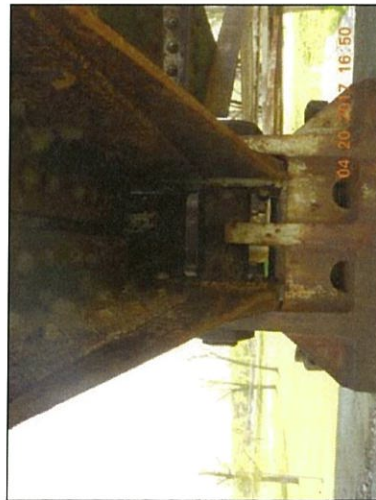
Span 3 L0 Lt interior top plate packrust

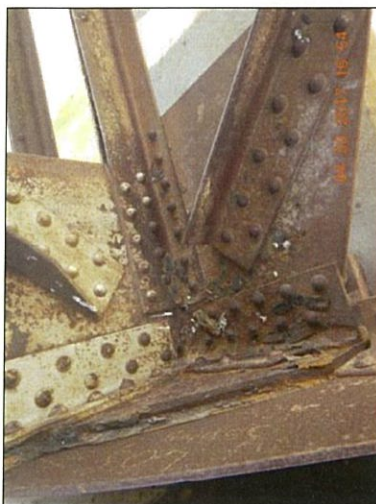
Span 3 L0 Rt exterior bottom plate packrust

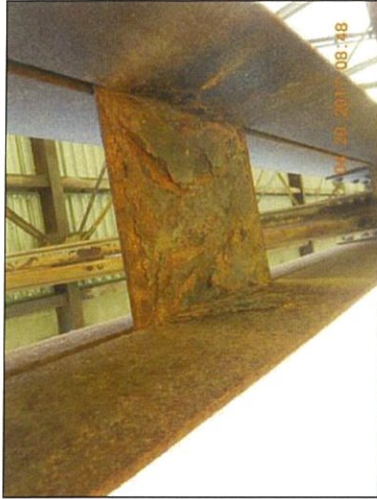
Span 3 L0L1 Lt bottom angles bent out

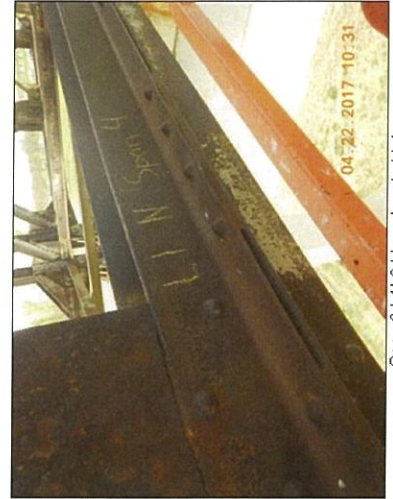
Span 3 L1L2 Lt first batten plate deterioration

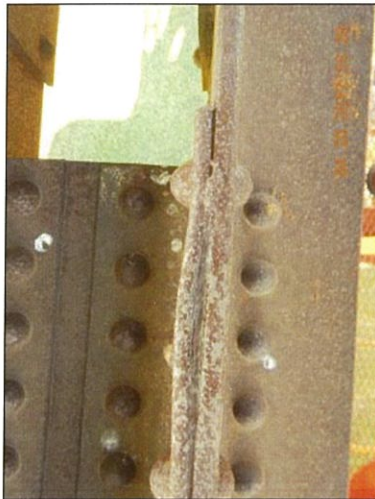
Span 3 L1L2 Lt packrust at L1

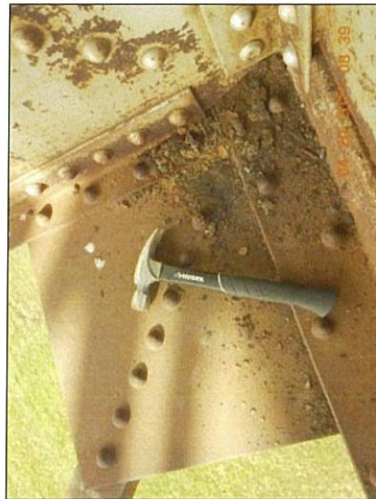
Span 3 L2 Lt horizontal gusset plate deterioration

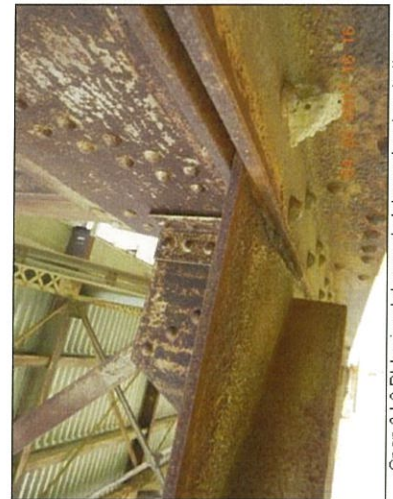
Span 3 L2 Rt horizontal gusset plate packrust on bottom

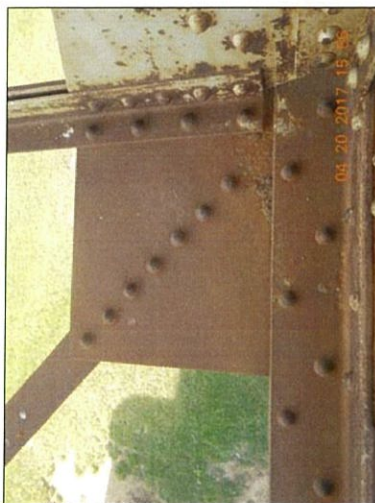
Span 3 L3 Rt horizontal gusset plate deterioration

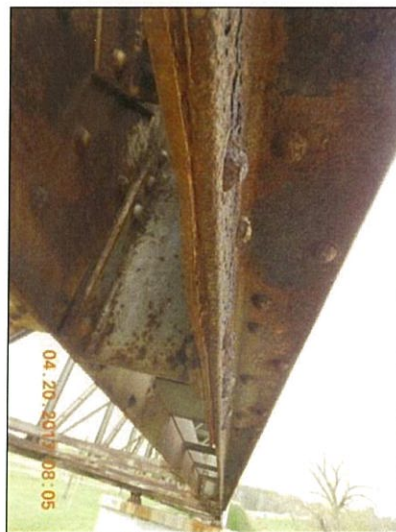
Span 3 L4 Lt bottom packrust

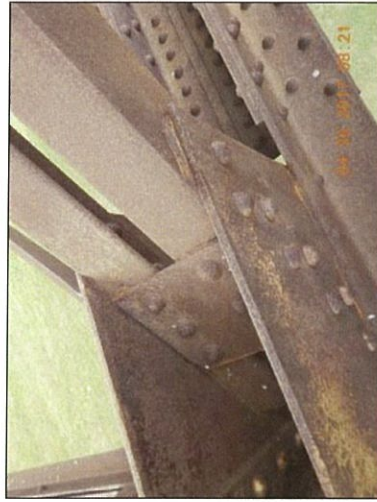
Span 3 L4 Lt packrust

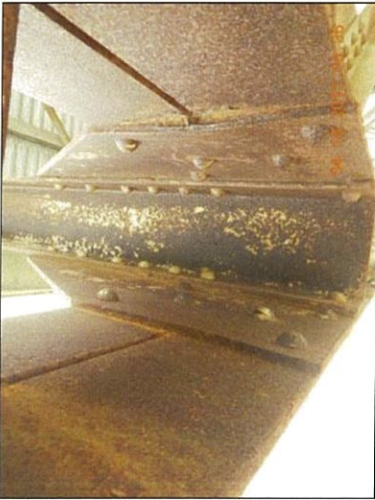
Span 3 L6L7 Lt at L7 packrust and loss

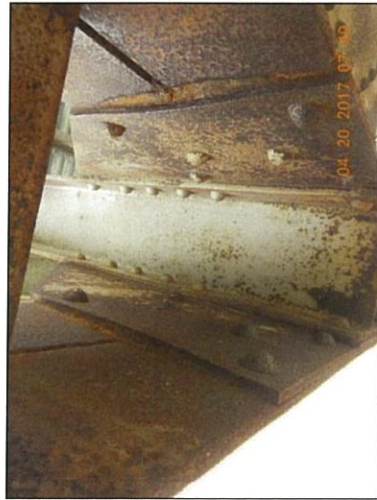
Span 3 L6L7 Lt plate deterioration at L7

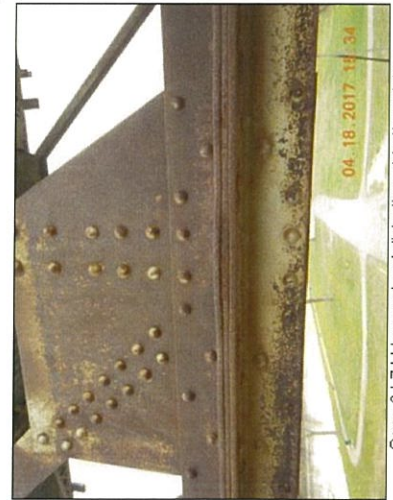
Span 3 L7 Lt lower chord distortion at batten plates

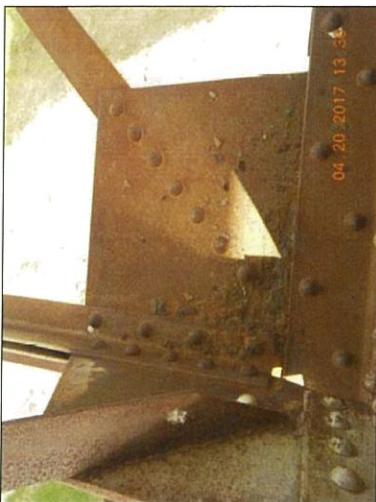
Span 3 L7 Rt horizontal gusset plate deterioration

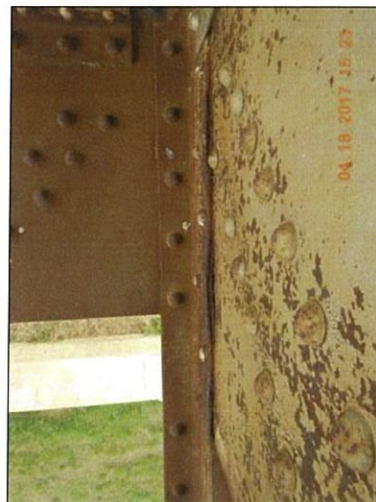
Span 3 L9 Lt interior packrust

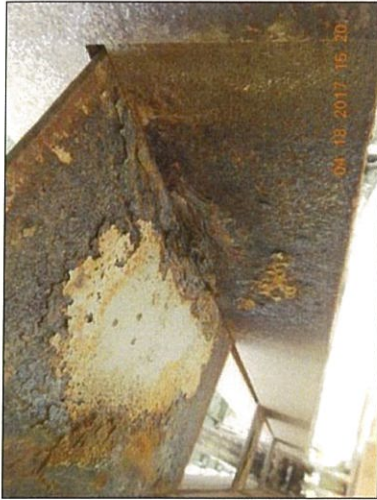
Span 3 L9L10 Lt batten and lower chord deterioration near L9

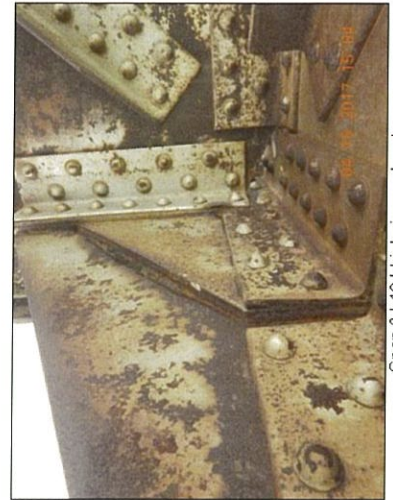
Span 3 L10 Lt interior packrust

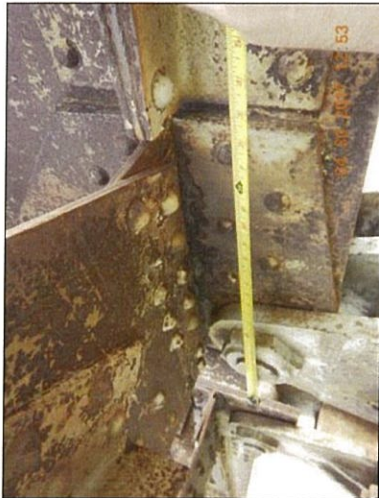
Span 3 L10 Rt bottom horizontal gusset plate packrust

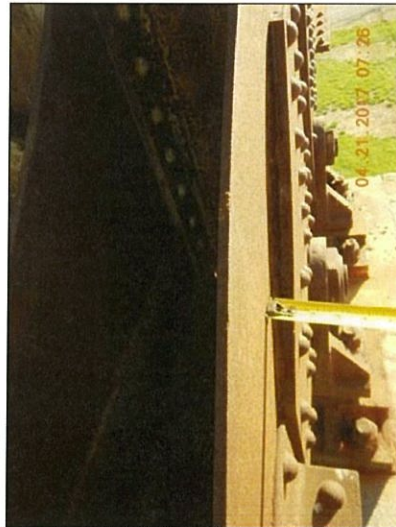
Span 3 L10 Rt top exterior packrust (2)

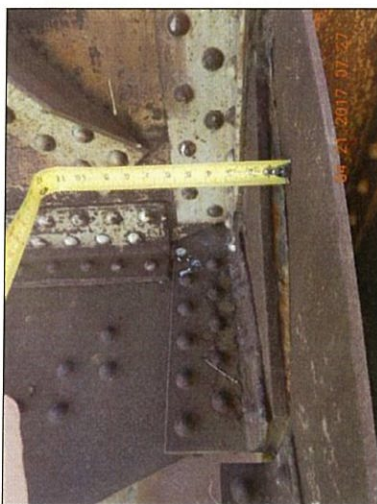
Span 3 L10 Rt top interior packrust (2)

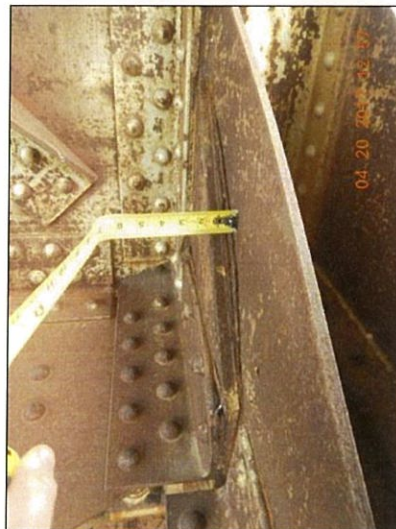
Span 3 L10 Rt top interior packrust

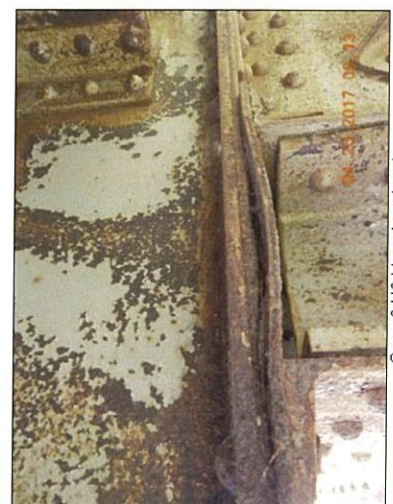
Span 3 U0 Lt end packrust

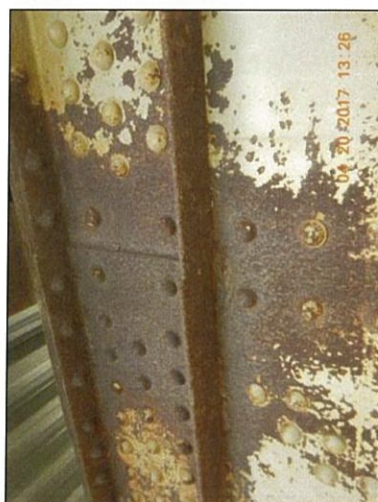
Span 3 U8 Rt exterior channels not lined up

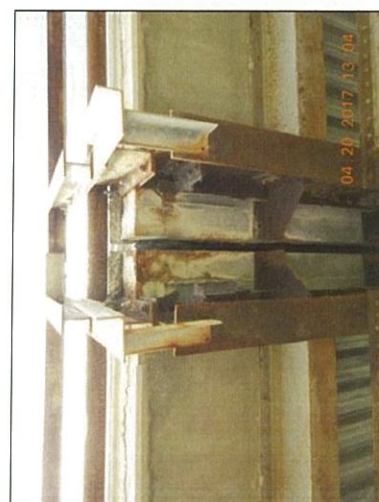
Span 3 U10 Rt deterioration below deck joint

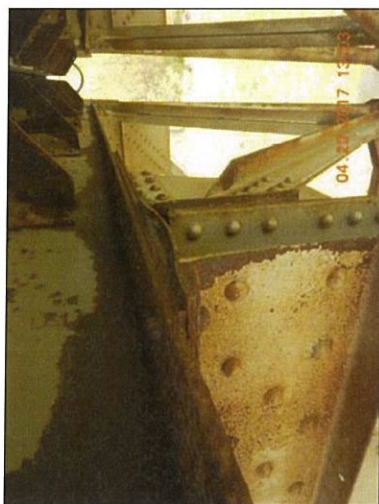
Span 3 U10 Rt end packrust

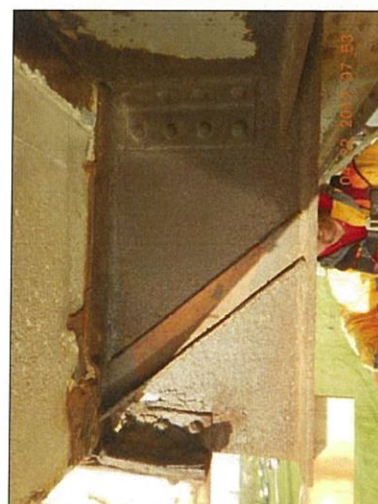
Span 4 Floorbeam 2 Rt stiffened and hole

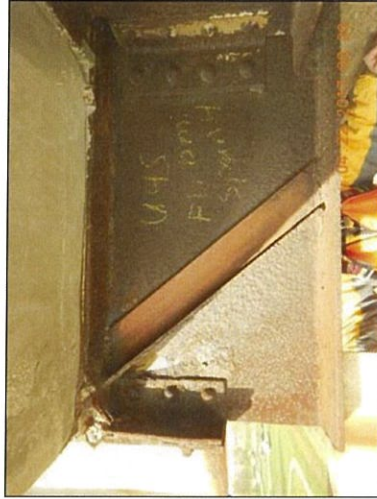
Span 4 Floorbeam 4 Rt stiffened and hole

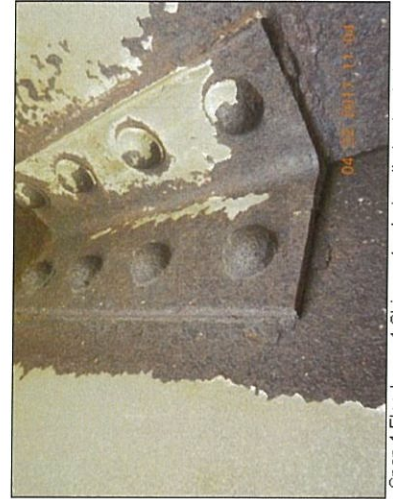
Span 4 Floorbeam 4 Stringer 1 exterior clip bent out at corner

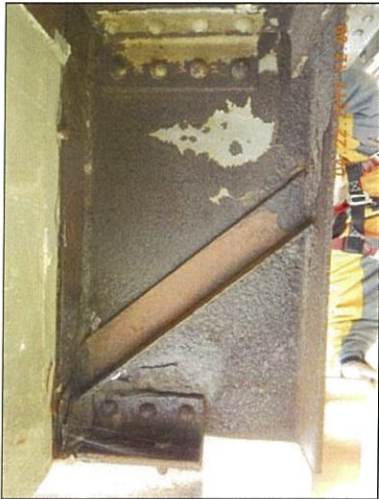
Span 4 Floorbeam 6 Lt stiffened and hole

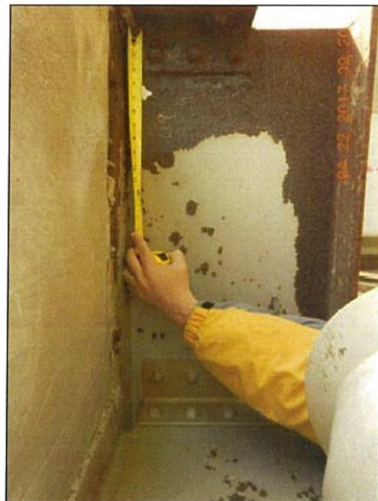
Span 4 Floorbeam 9 Rt hole

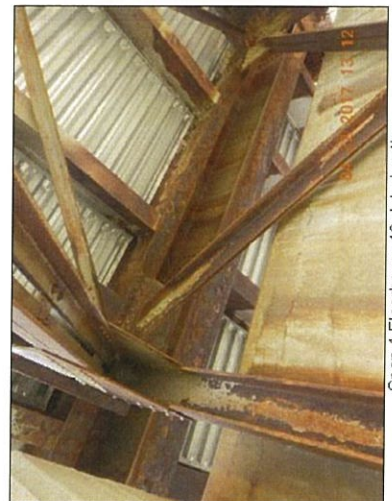
Span 4 Floorbeam 10 deterioration

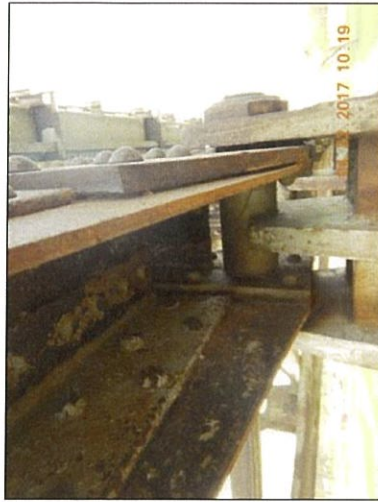
Span 4 L0 Lt bottom exterior packrust

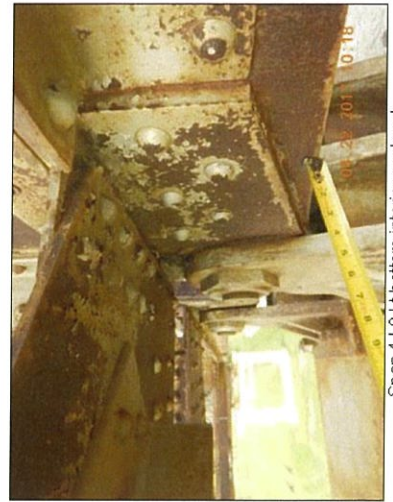
Span 4 L0 Lt bottom interior packrust

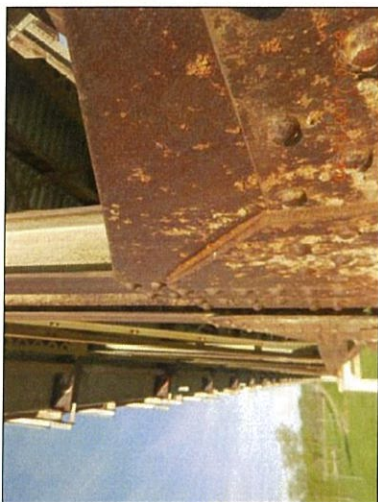
Span 4 L0 Rt top exterior packrust

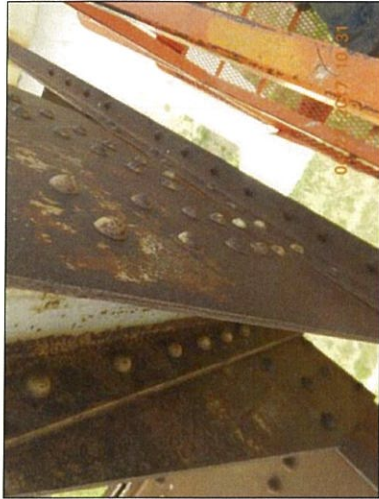
Span 4 L1 Lt exterior packrust

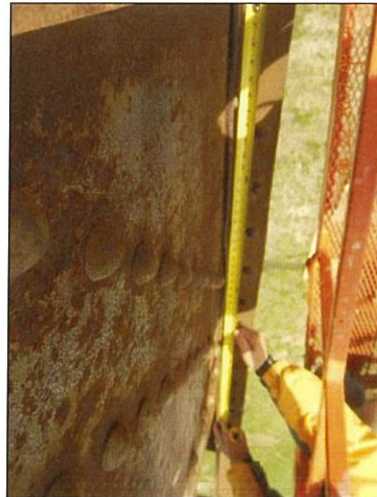
Span 4 L9 Rt exterior packrust

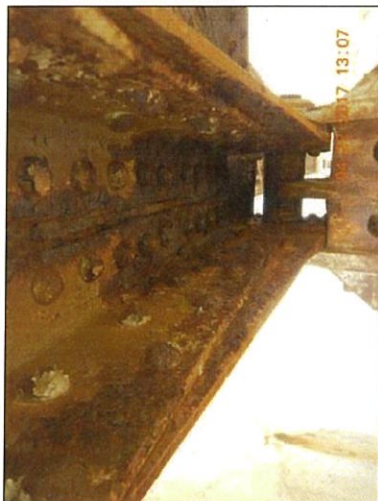
Span 4 L10 Lt bottom interior deterioration

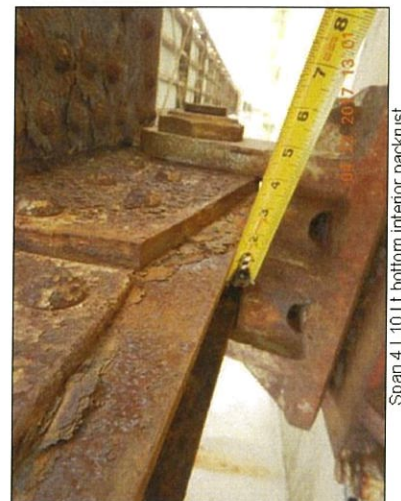
Span 4 L10 Lt bottom interior packrust

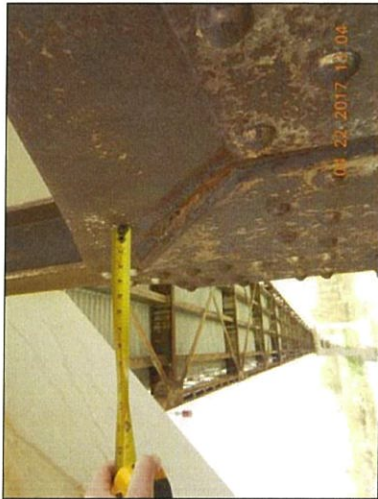
Span 4 L10 Lt top exterior packrust

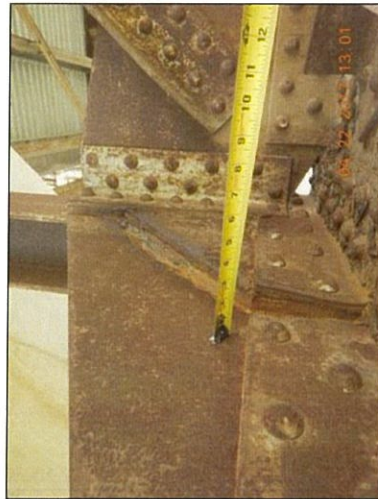
Span 4 L10 Lt top interior packrust (2)

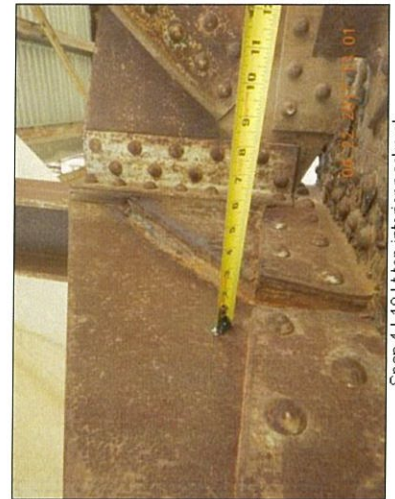
Span 4 L10 Lt top interior packrust

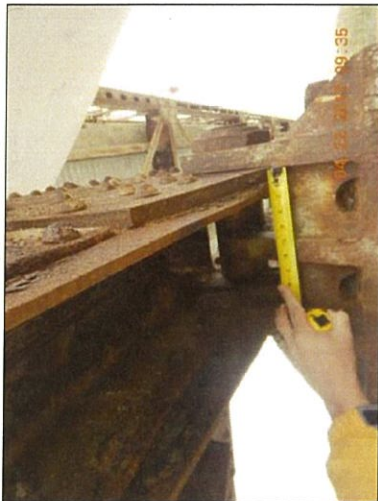
Span 4 L10 Rt bottom exterior packrust

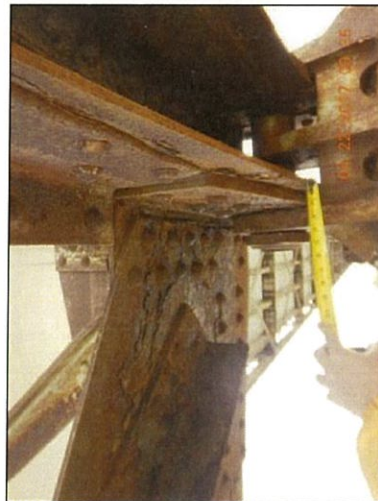
Span 4 L10 Rt bottom interior packrust

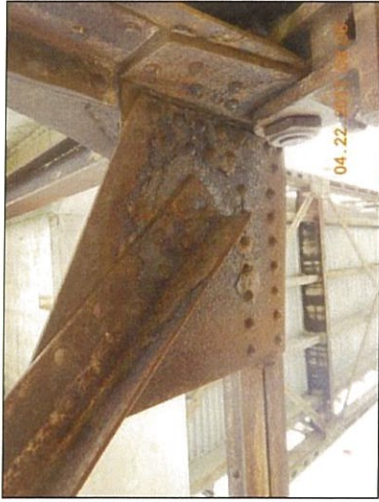
Span 4 L10 Rt horizontal gusset plate deterioration on bottom

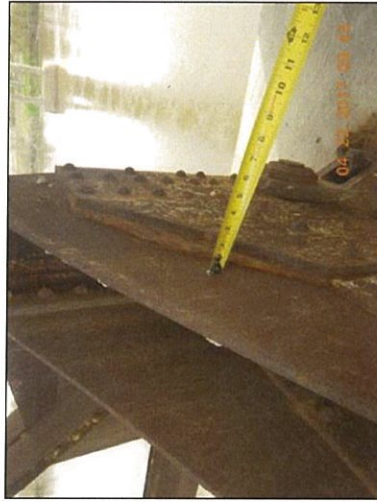
Span 4 L10 Rt top exterior packrust

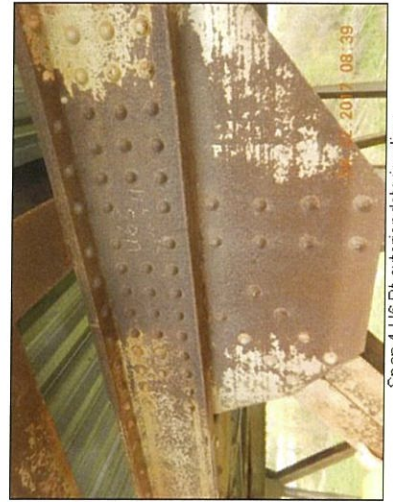
Span 4 U6 Rt exterior deterioration

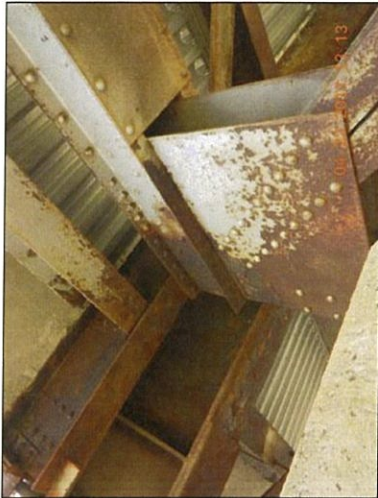
Span 4 U10 Lt exterior deterioration

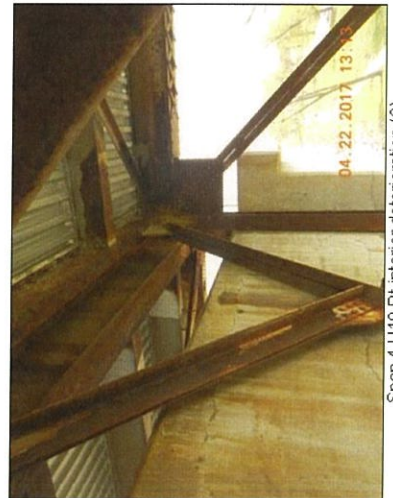
Span 4 U10 Rt interior deterioration (2)

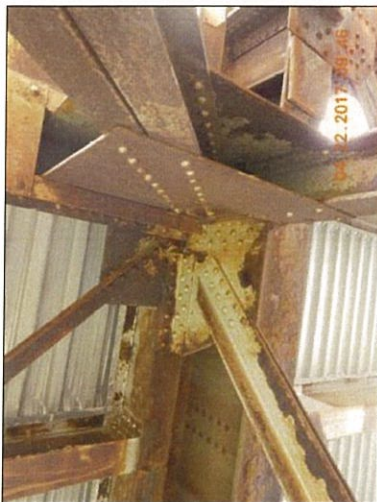
Span 4 U10 Rt interior deterioration

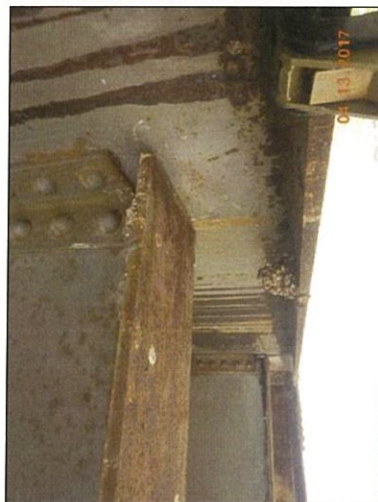
Span 5 Floorbeam 5 bottom flange bird debris

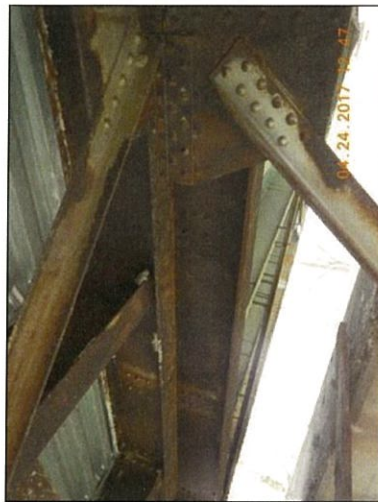
Span 7 Floorbeam 0 interior deterioration (2)

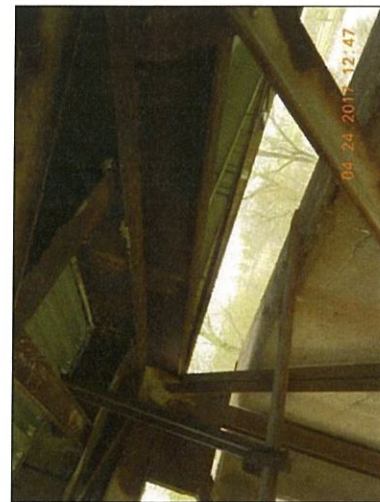
Span 7 Floorbeam 0 interior deterioration (3)

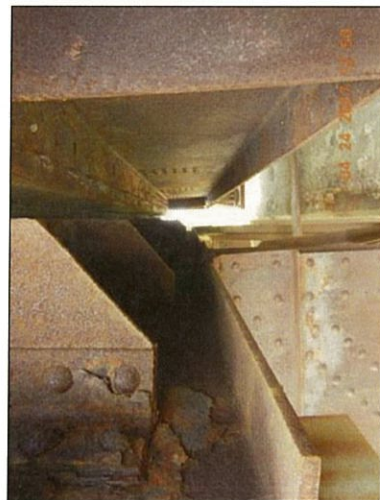
Span 7 Floorbeam 0 interior deterioration

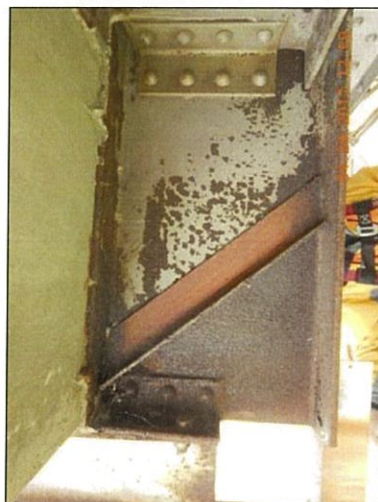
Span 7 Floorbeam 0 Rt interior deterioration

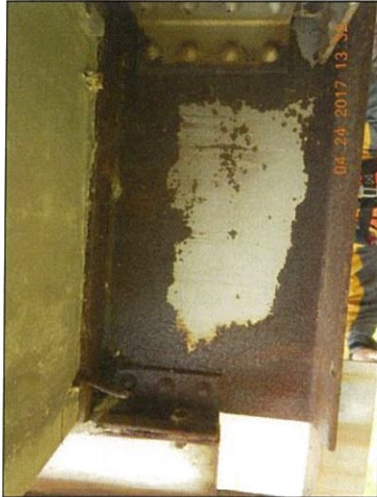
Span 7 Floorbeam 2 Rt stiffened and hole

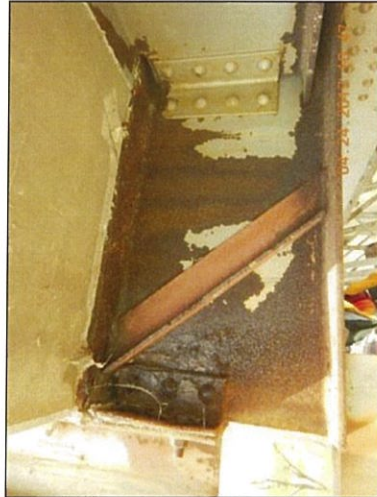
Span 7 Floorbeam 4 Lt hole

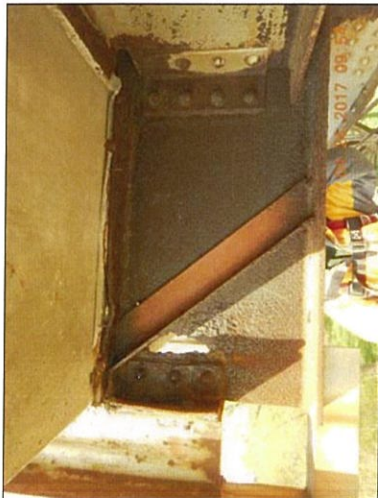
Span 7 Floorbeam 8 Rt east face deterioration

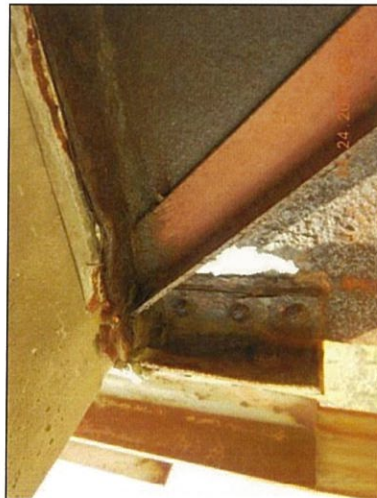
Span 7 Floorbeam 8 Rt stiffened and hole

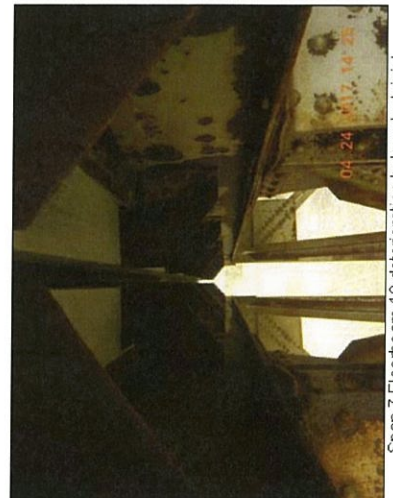
Span 7 Floorbeam 8 Rt top flange loss

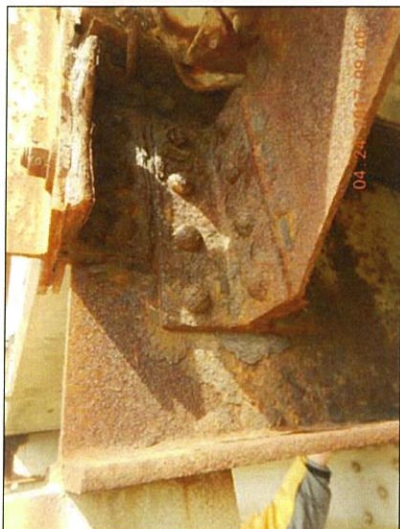
Span 7 Floorbeam 10 deterioration below deck joint

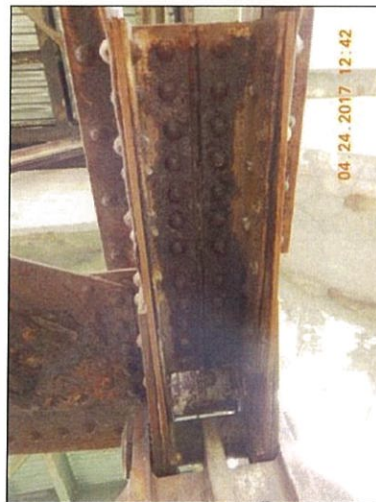
Span 7 Floorbeam 10 Rt deterioration below joint

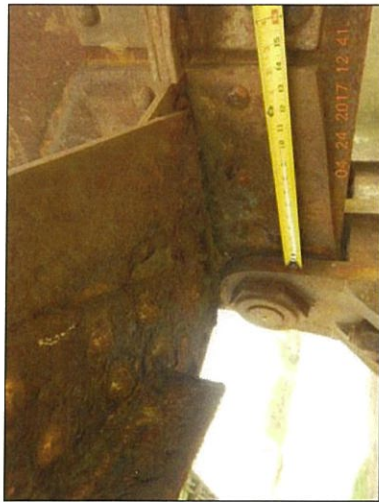
Span 7 L0 Lt bottom exterior packrust

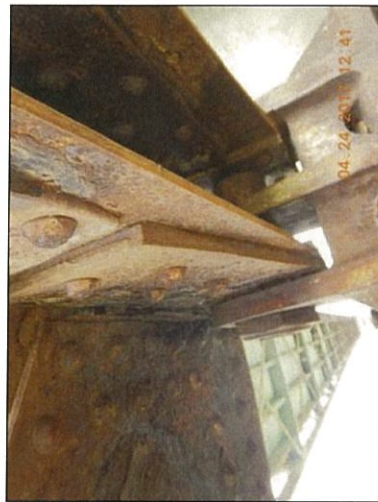
Span 7 L0 Lt bottom interior deterioration

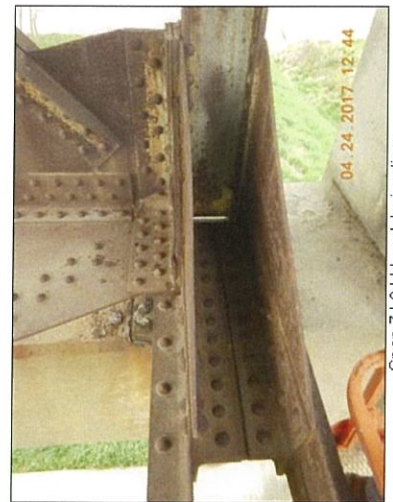
Span 7 L0 Lt bottom interior packrust

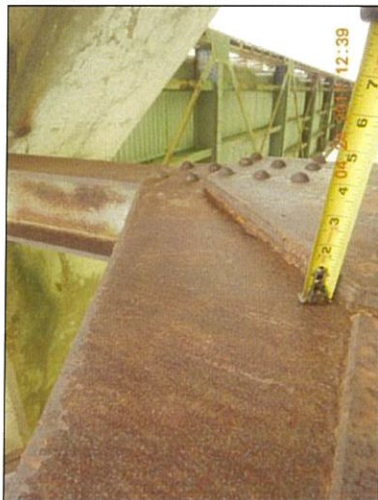
Span 7 L0 Lt top deterioration

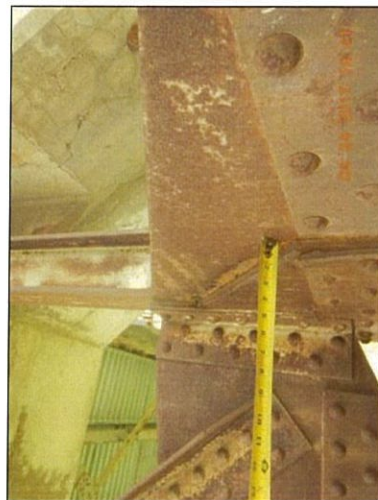
Span 7 L0 Lt top exterior packrust

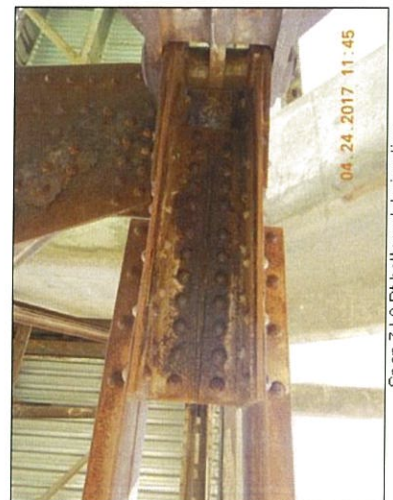
Span 7 L0 Lt top interior packrust

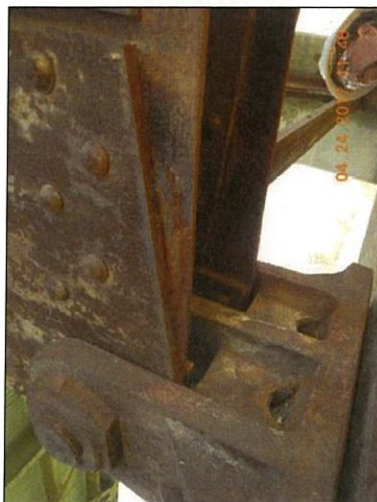
Span 7 L0 Rt bottom deterioration

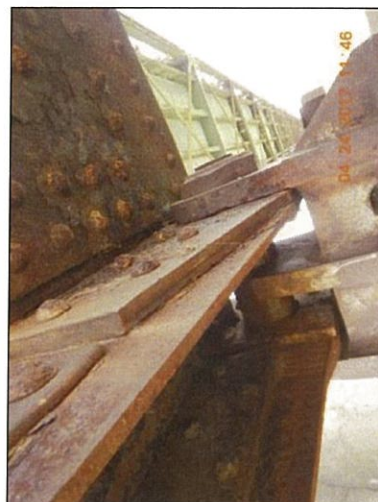
Span 7 L0 Rt bottom exterior packrust

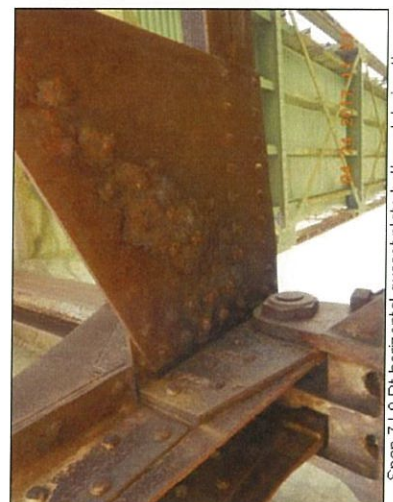
Span 7 L0 Rt bottom interior packrust

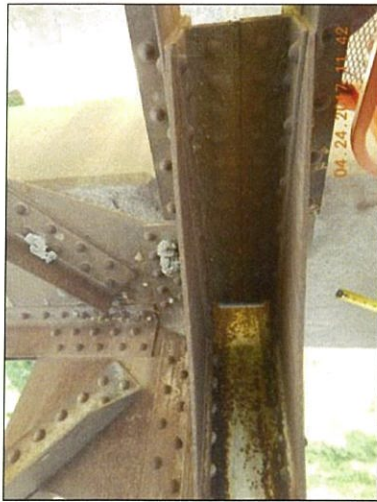
Span 7 L0 Rt horizontal gusset plate bottom deterioration

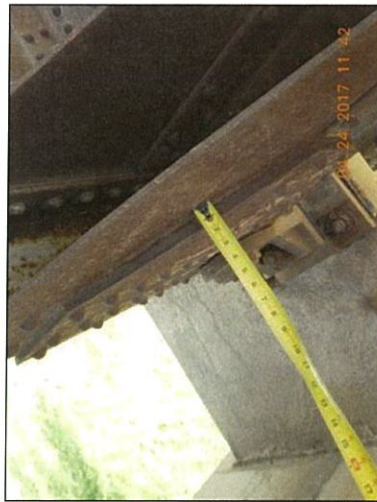
Span 7 L0 Rt top deterioration

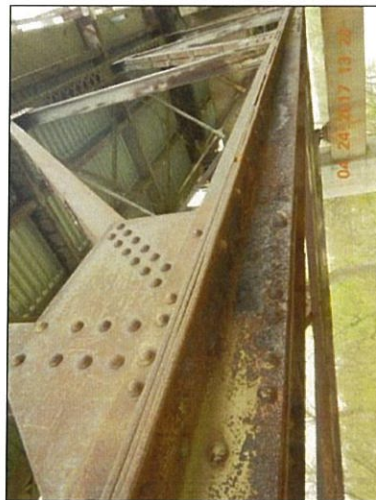
Span 7 L0L1 Lt bottom interior leg distortion

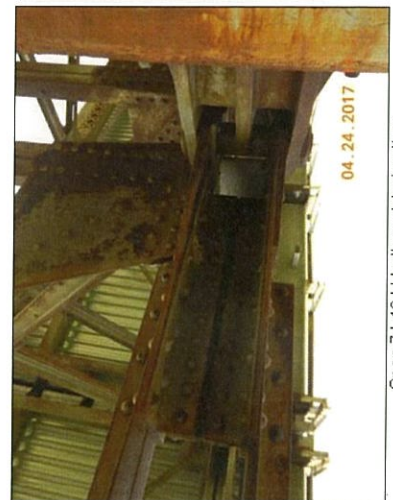
Span 7 L3 Lt exterior deterioration

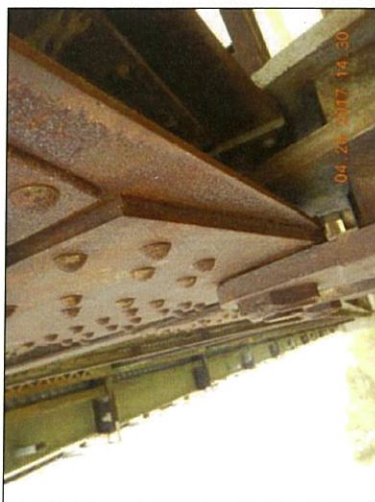
Span 7 L10 Lt bottom deterioration

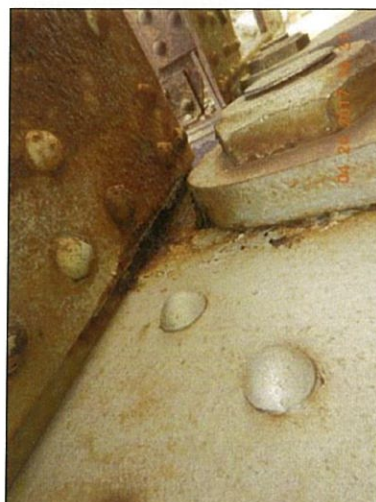
Span 7 L10 Lt bottom exterior packrust

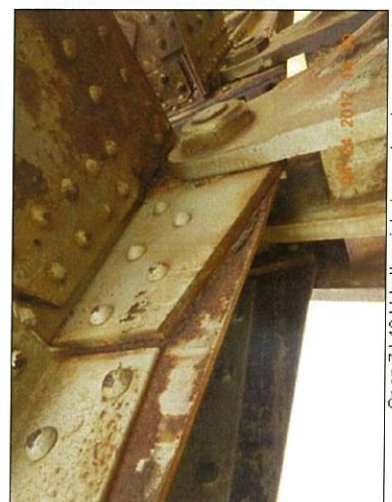
Span 7 L10 Lt bottom interior deterioration

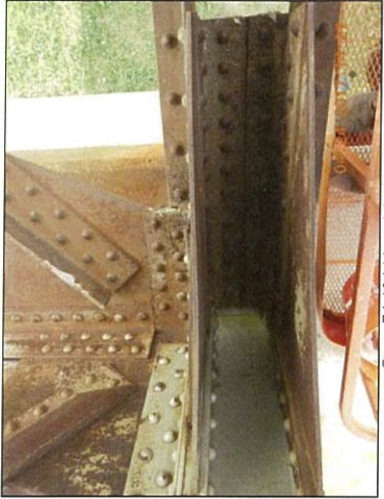
Span 7 L10 Lt bottom interior packrust

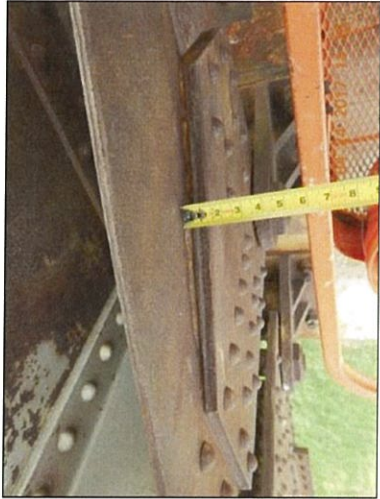
Span 7 L10 Lt top deterioration

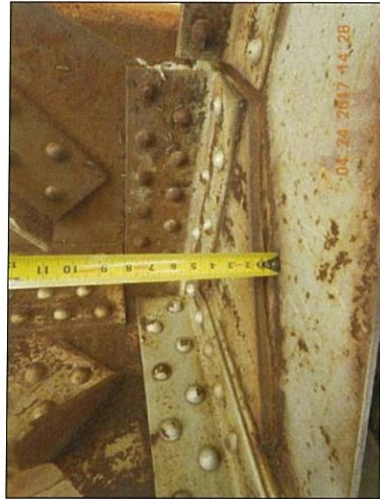
Span 7 L10 Lt top exterior packrust

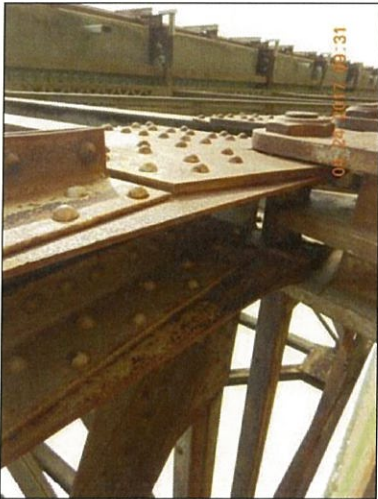
Span 7 L10 Lt top interior packrust

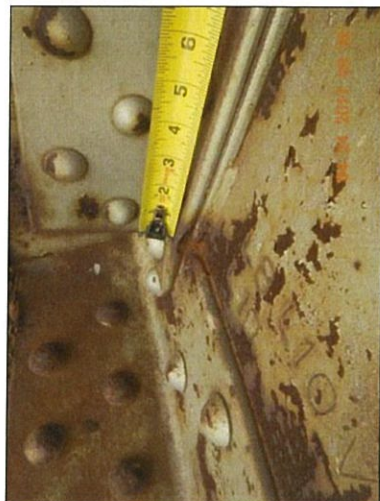
Span 7 L10 Rt top interior deterioration

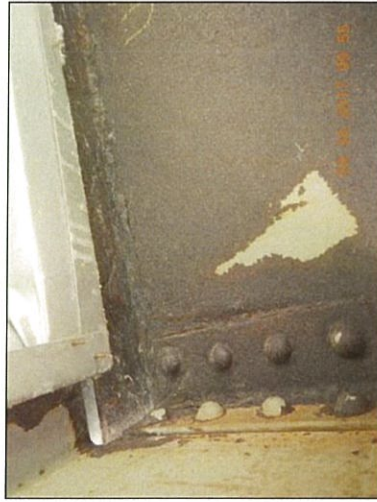
Span 7 Stringer 4 at U8 connection loss on East

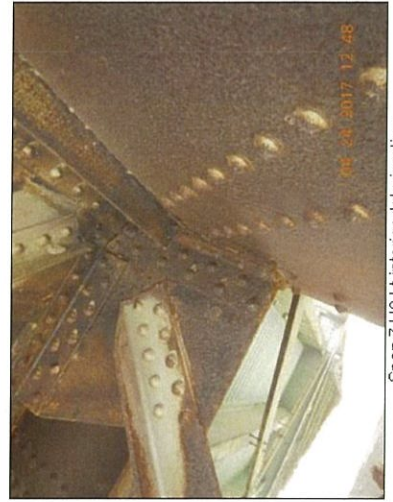
Span 7 U0 Lt interior deterioration

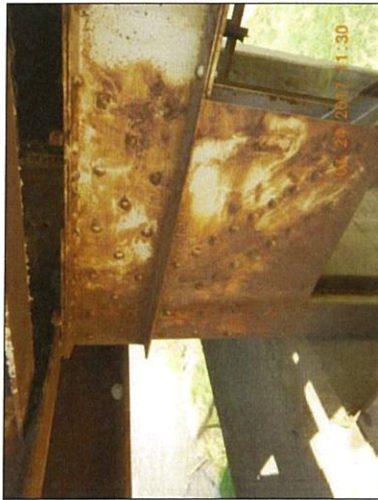
Span 7 U0 Rt exterior deterioration

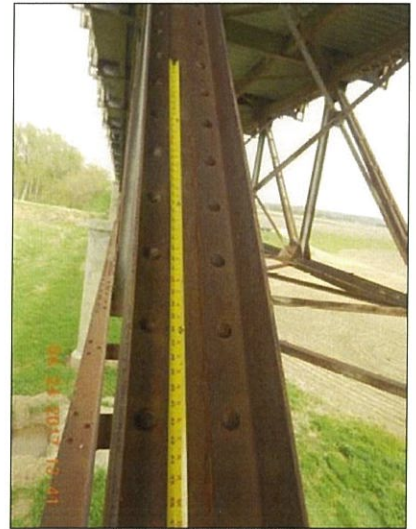
Span 7 U6L5 Lt packrust

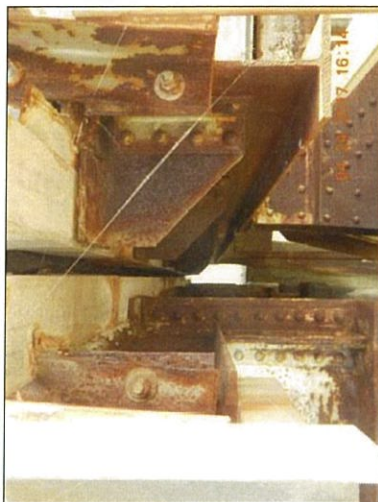
Span 8 Floorbeam 0 Lt deterioration below deck joint

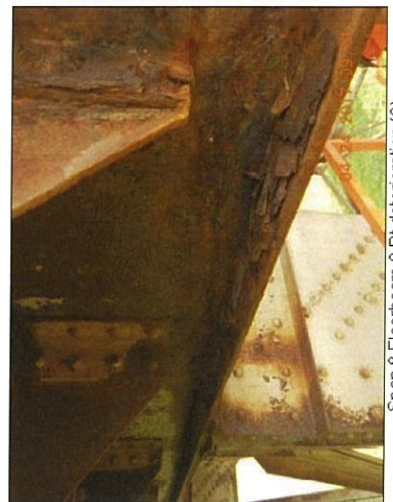
Span 8 Floorbeam 0 Rt deterioration (2)

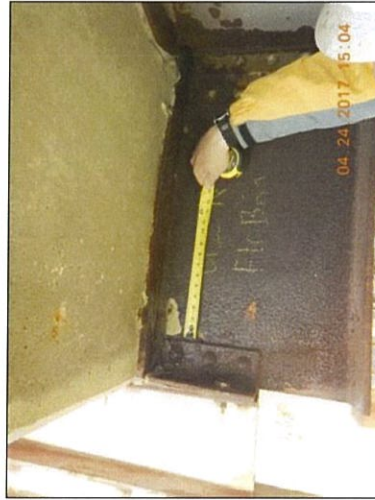
Span 8 Floorbeam 2 Lt hole

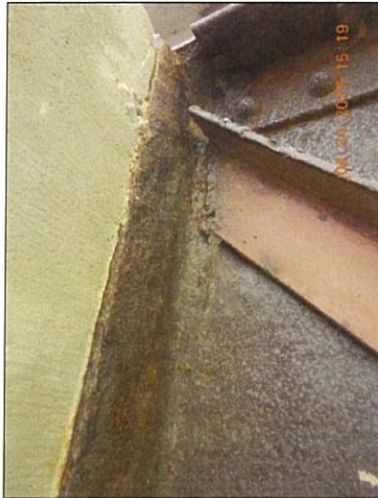
Span 8 Floorbeam 4 Lt top stiffened weld crack on East
