APPENDIX E. STRUCTURAL DOCUMENTS

**Bellevue Toll Bridge
East Mission Avenue over the Missouri River
Bellevue, Nebraska**

**Structure No. S370 01918
Fracture Critical and Routine NBIS Bridge Inspection
April 2017**

Prepared for:
Bellevue Bridge Commission

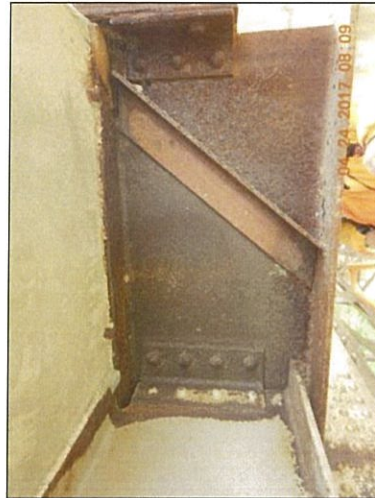
Span 8 Floorbeam 6 Rt stiffened and hole

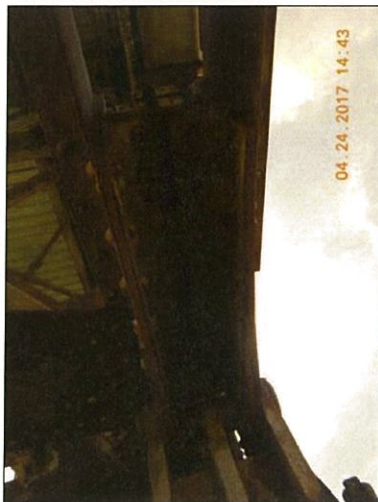
Span 8 L0 Lt bottom deterioration

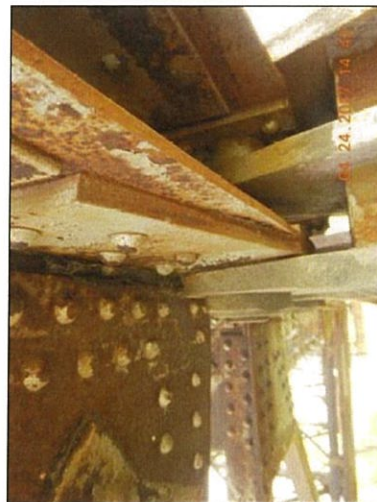
Span 8 L0 Lt bottom interior packrust

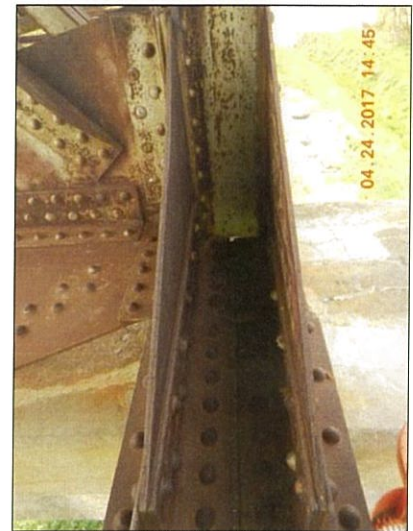
Span 8 L0 Lt top deterioration

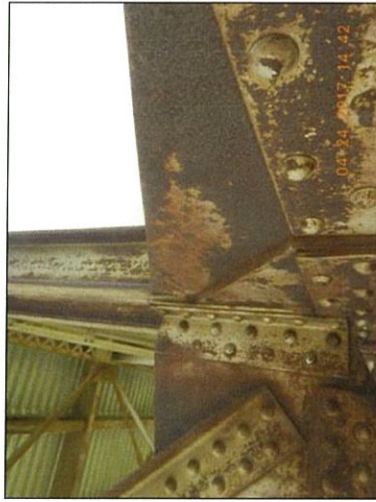
Span 8 L0 Lt top interior packrust

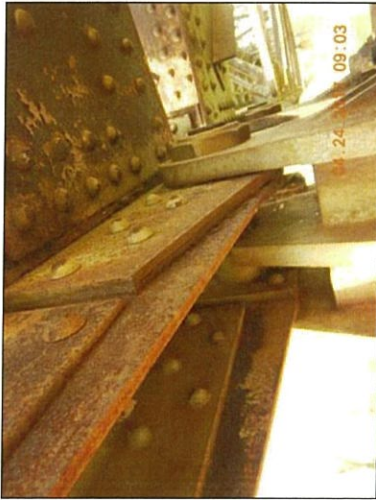
Span 8 L0 Rt bottom interior packrust

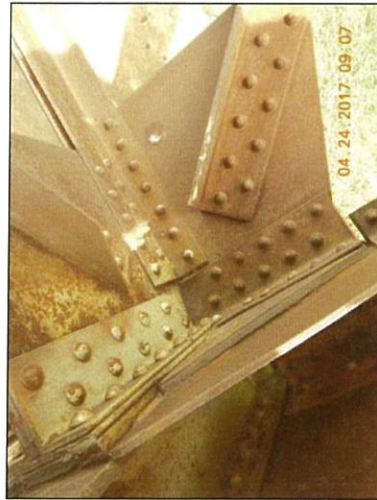
Span 8 L0 Rt horizontal gusset plate deterioration

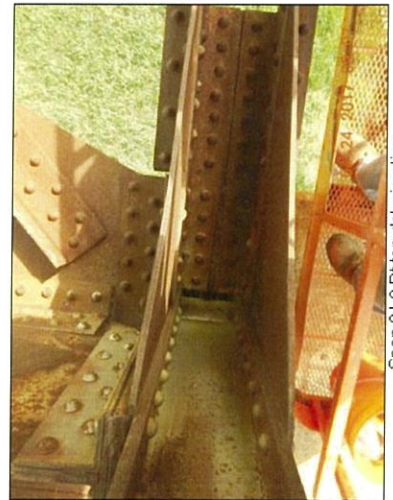
Span 8 L0 Rt top deterioration

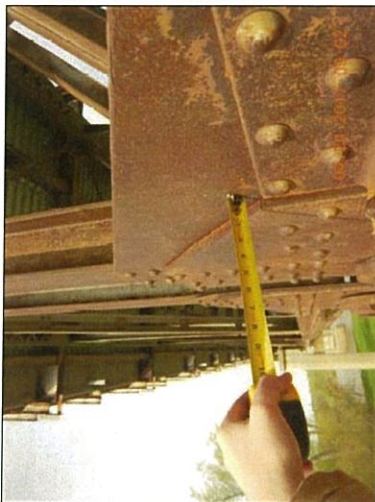
Span 8 L0 Rt top exterior packrust

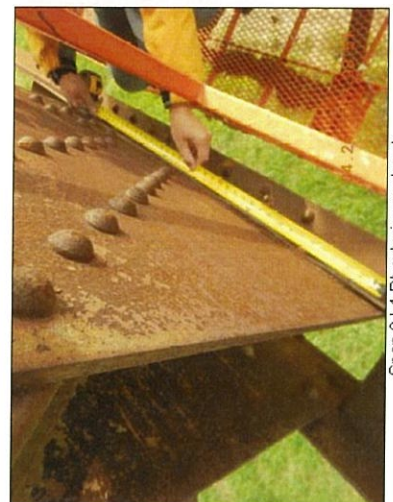
Span 8 L1 Rt exterior packrust

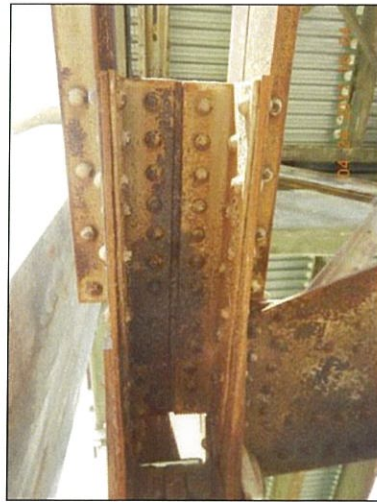
Span 8 L10 Lt bottom deterioration

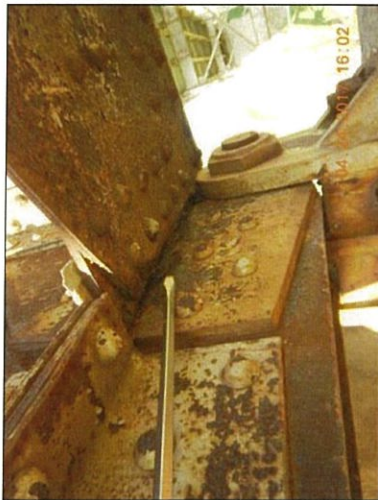
Span 8 L10 Lt bottom interior deterioration

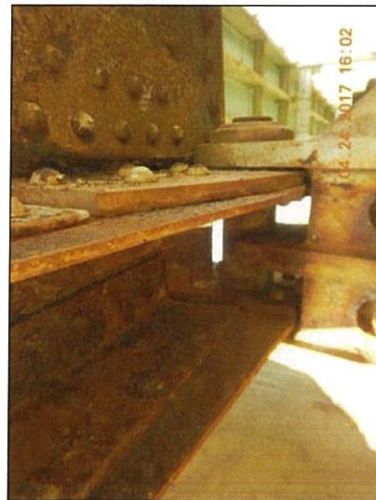
Span 8 L10 Lt bottom interior packrust

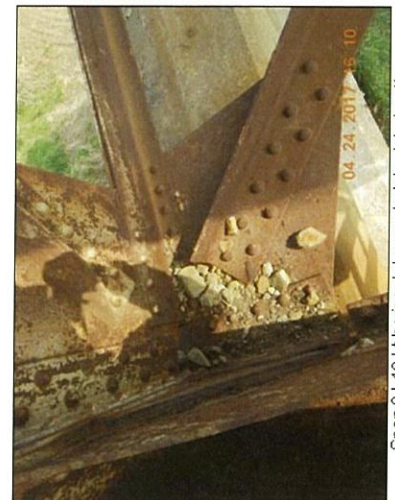
Span 8 L10 Lt horizontal gusset plate deterioration

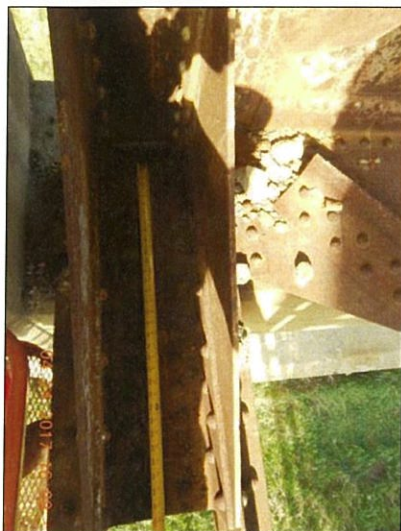
Span 8 L10 Lt top deterioration

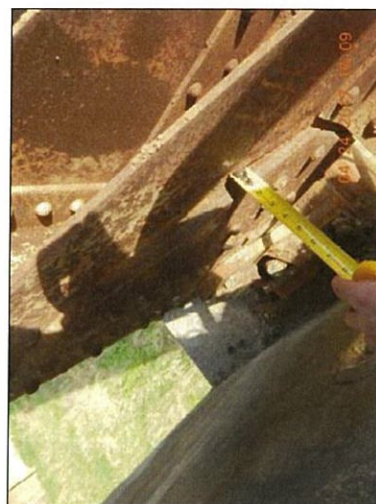
Span 8 L10 Lt top exterior packrust

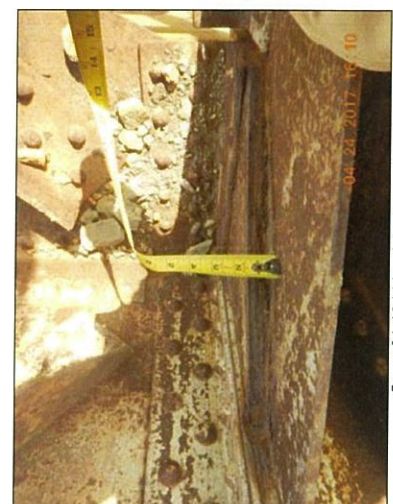
Span 8 L10 Lt top interior packrust

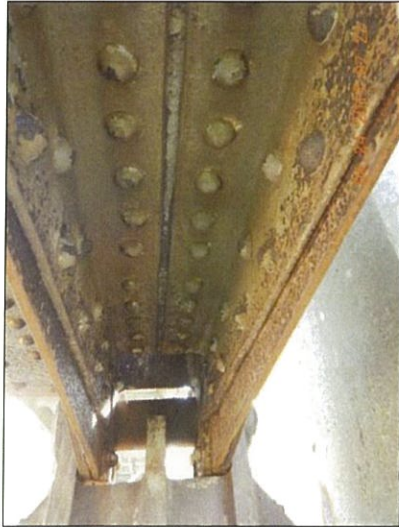
Span 8 L10 Rt bottom deterioration

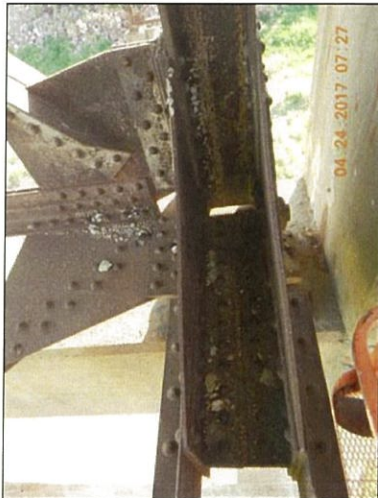
Span 8 L10 Rt top deterioration

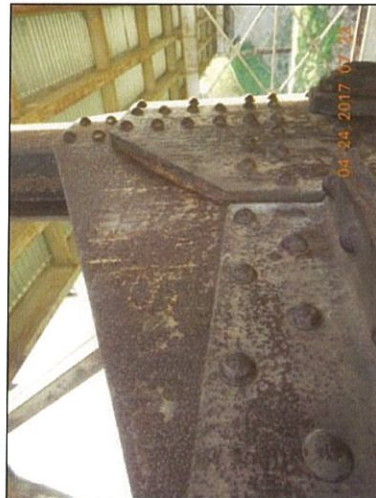
Span 8 L10 Rt top exterior packrust

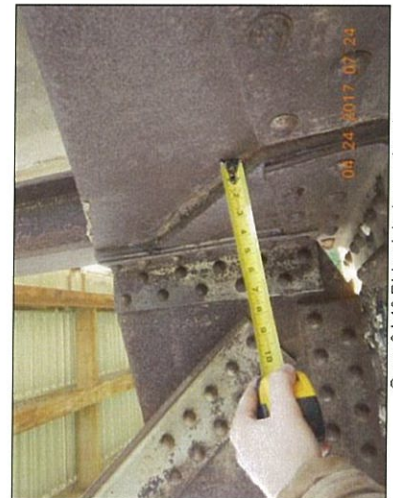
Span 8 L10 Rt top interior packrust

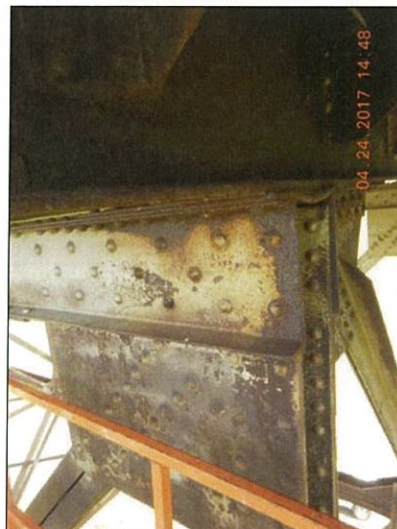
Span 8 U0 Lt exterior deterioration

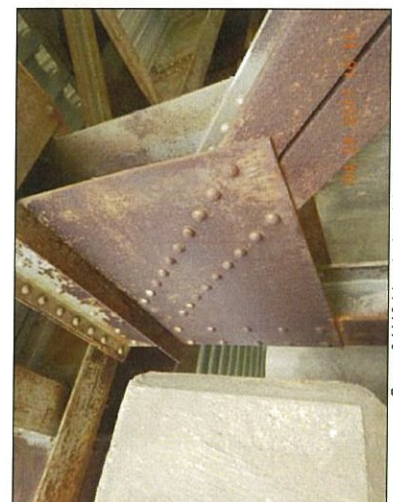
Span 8 U10 Lt exterior deterioration

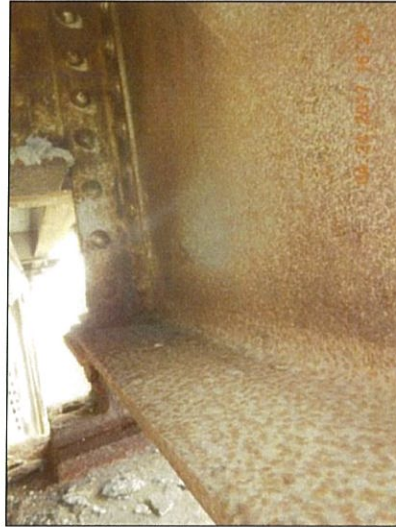
Span 9 Girder 1 interior deterioration at Pier 8

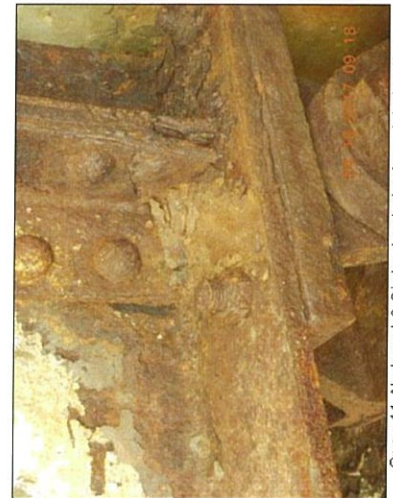
Span 11 Abutment 2 Girder 4 exterior face deterioration

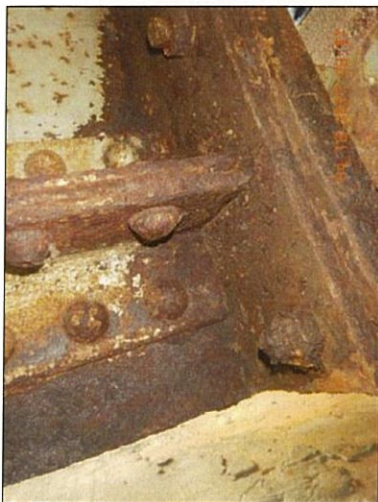
Span 11 Abutment 2 Girder 4 interior face deterioration

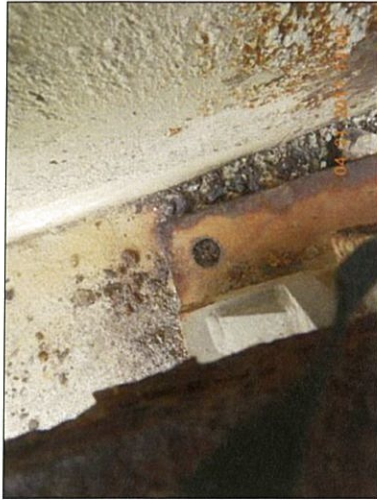
Span 1 L0 Lt interior-back bolt not installed - typ Rt

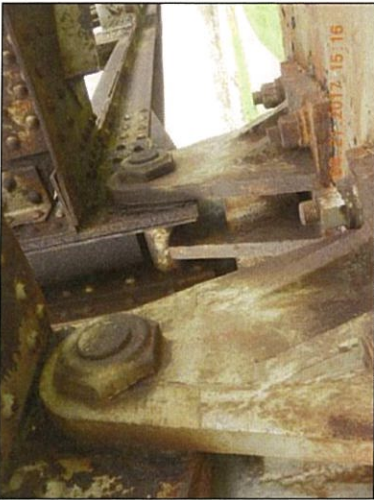
Span 2 L0 Lt interior pin packrust

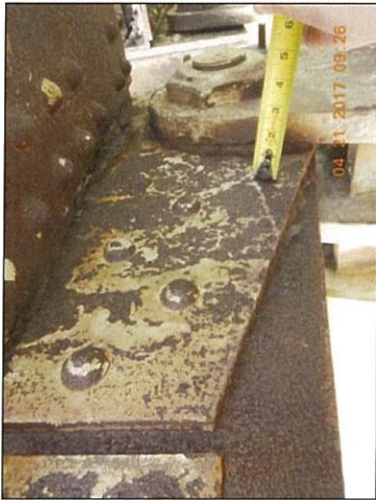
Span 2 L0 Rt interior pin packrust

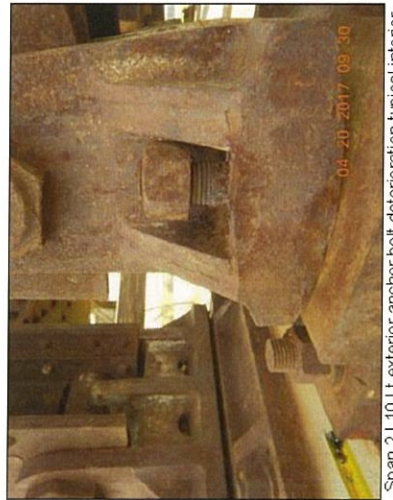
Span 2 L10 Lt exterior anchor bolt deterioration typical interior

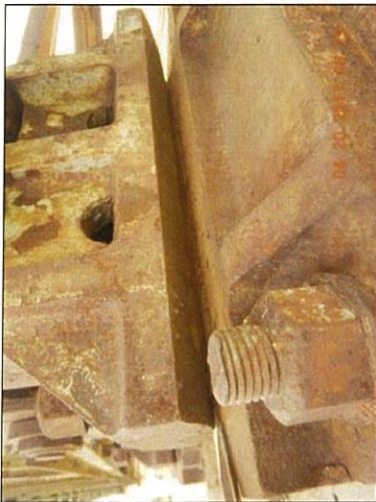
Span 2 L10 Lt minor packrust under bearing

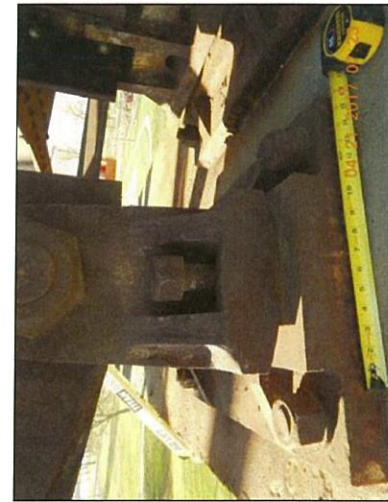
Span 3 L0 Lt exterior anchor bolt bent

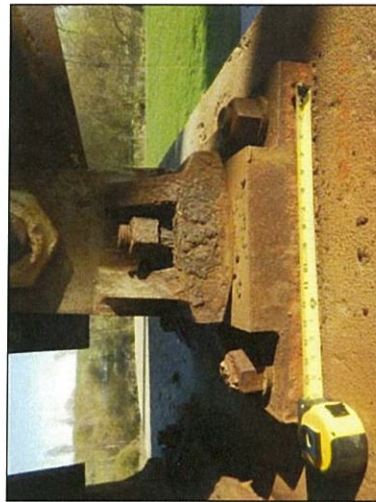
Span 3 L0 Lt interior anchor bolt bent

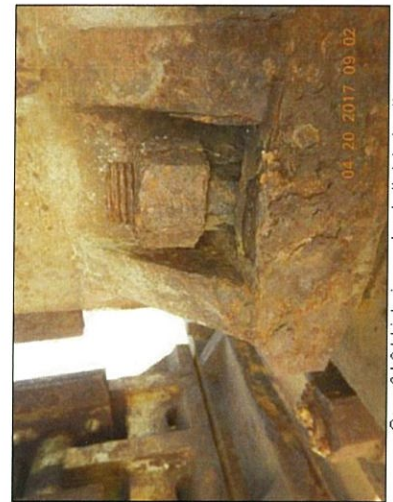
Span 3 L0 Lt interior anchor bolt deterioration

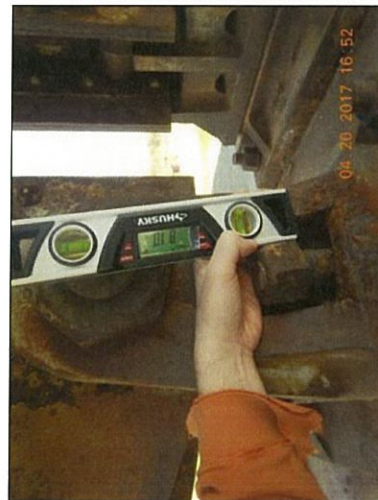
Span 3 L0 Rt interior anchor bolt bent

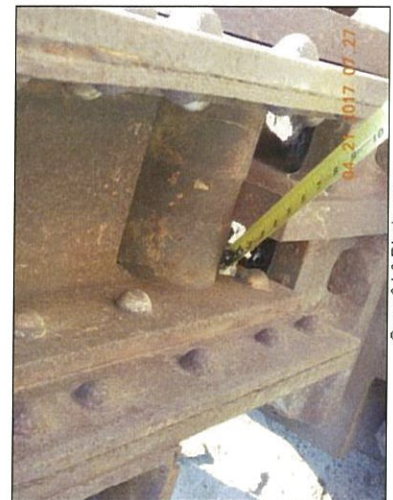
Span 3 L0 Rt pin wear

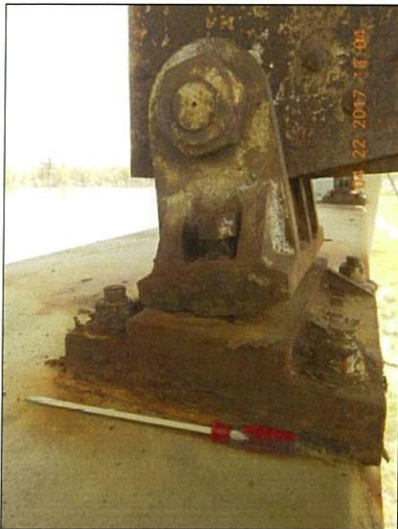
Span 4 L10 Lt rocker shifted east from exterior

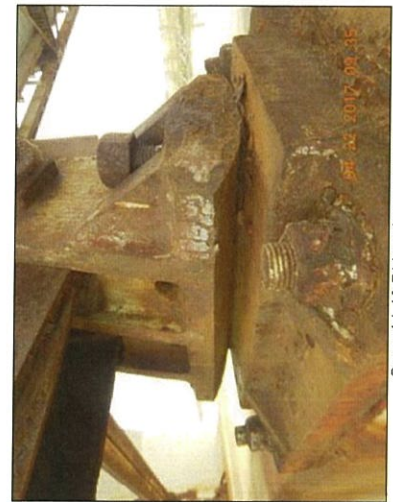
Span 4 L10 Rt bearing packrust

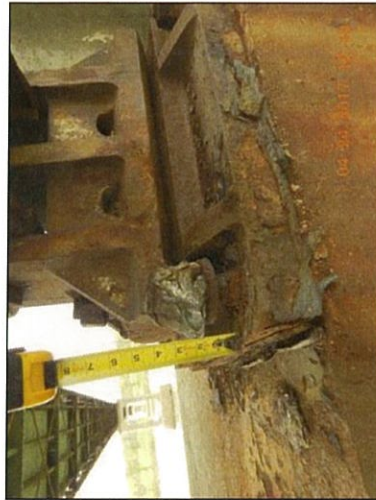
Span 7 L0 Lt front interior nut not down

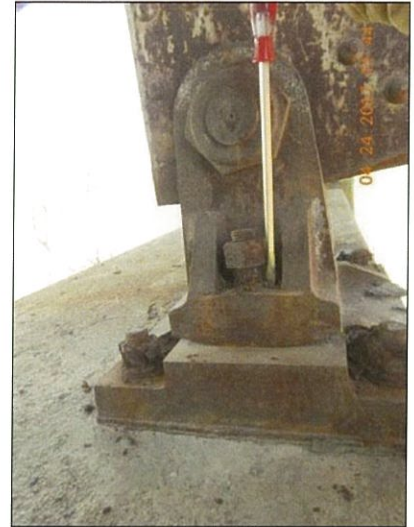
Span 7 L0 Rt bearing exterior face

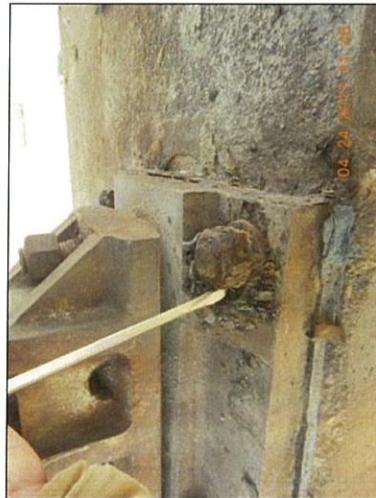
Span 7 L0 Rt bearing nut deterioration

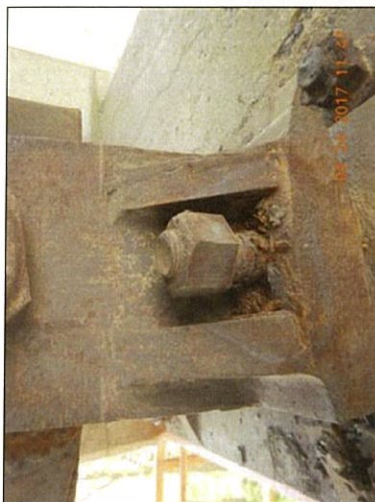
Span 7 L0 Rt interior anchor bolt deterioration

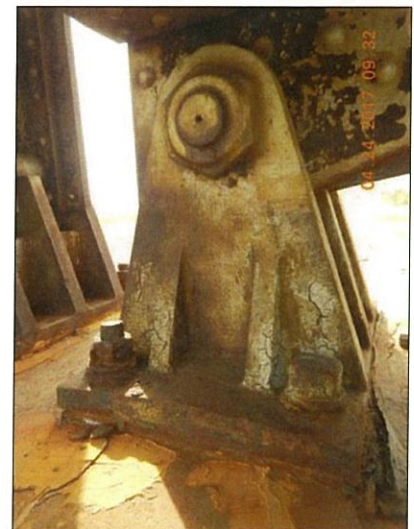
Span 7 L10 Rt bearing interior edge

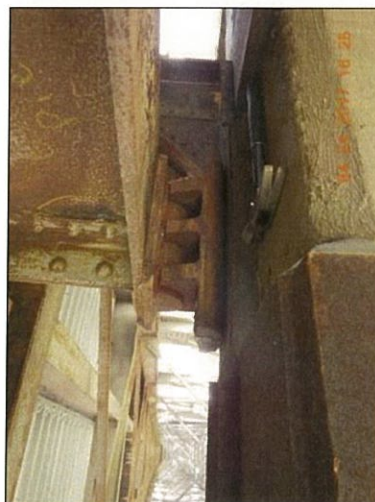
Span 9 Girder 2 bearing at Pier 8

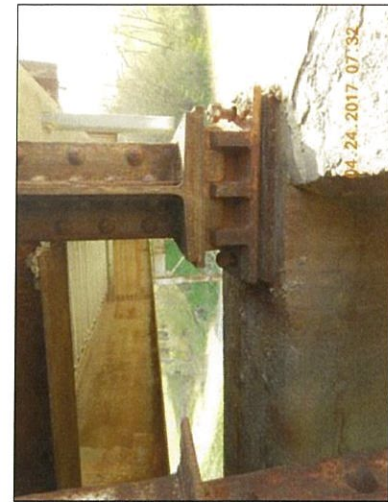
Span 9 Girder 4 bearing at Pier 8 deterioration

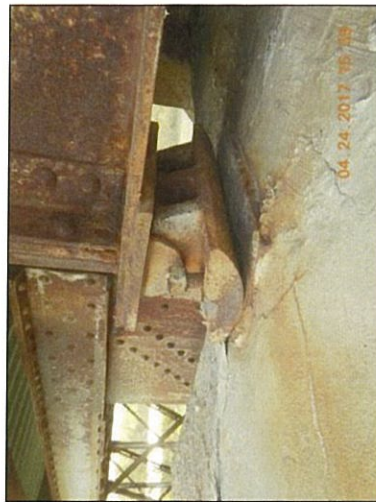
Span 9 Girder 4 bearing exterior at Pier 8

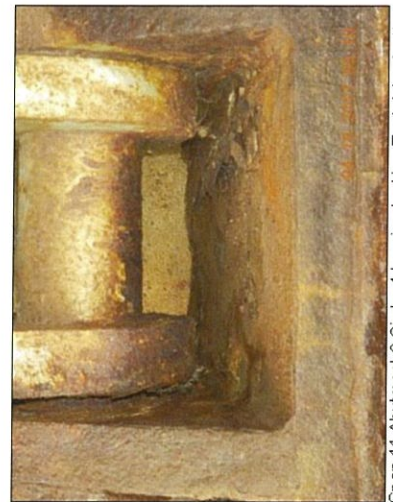
Span 11 Abutment 2 Girder 1 bearing looking East delamination

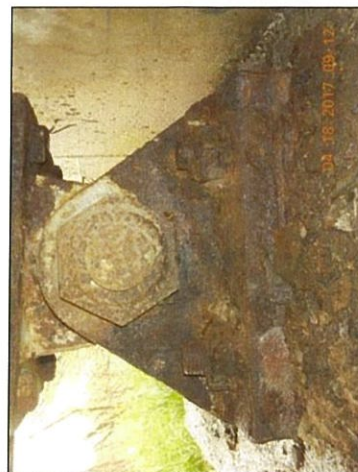
Span 11 Abutment 2 Girder 1 bearing looking North - interior
nuts and bolts deterioration

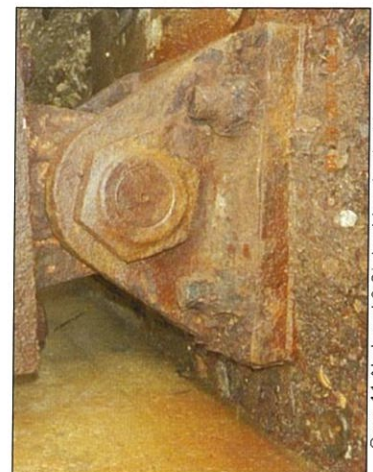
Span 11 Abutment 2 Girder 1 bearing looking South -
exterior nuts and bolt deterioration

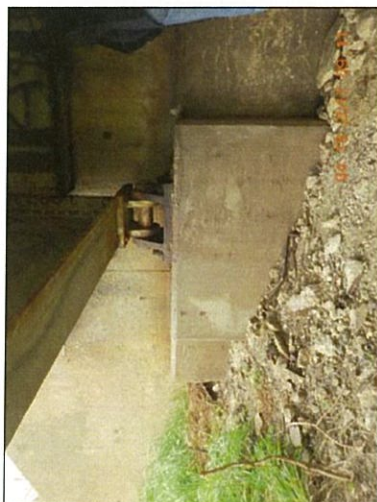
Span 11 Abutment 2 Girder 1 bearing

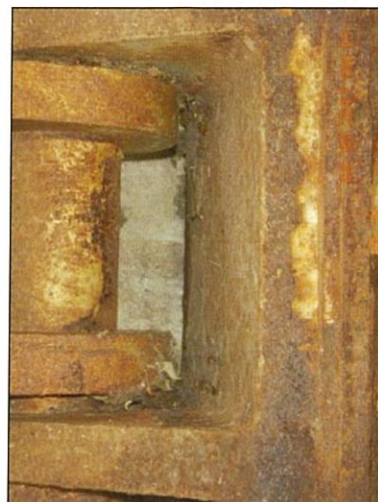
Span 11 Abutment 2 Girder 2 bearing interior

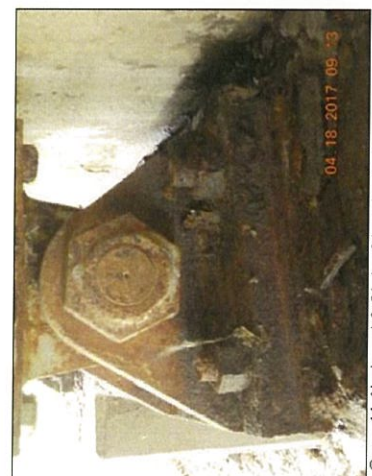
Span 11 Abutment 2 Girder 2 bearing looking North - nuts
and bolts deterioration

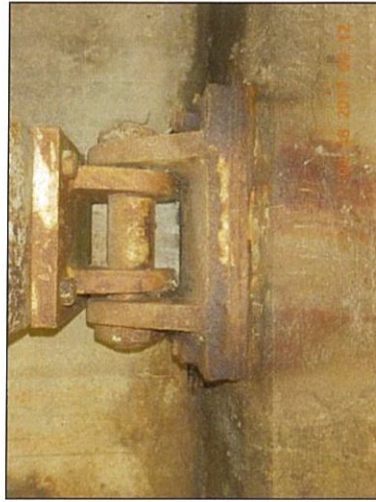
Span 11 Abutment 2 Girder 2 bearing

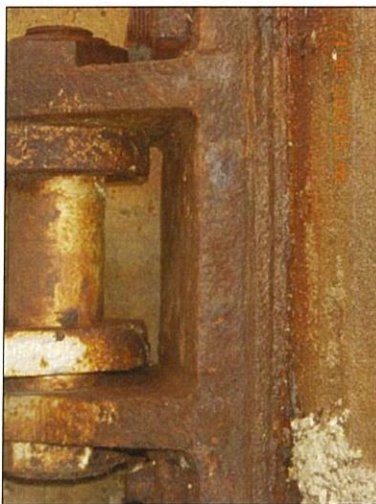
Span 11 Abutment 2 Girder 4 bearing interior

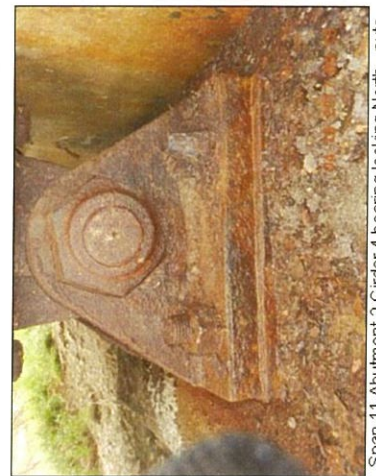
Span 11 Abutment 2 Girder 4 bearing looking North - nuts and bolt deterioration

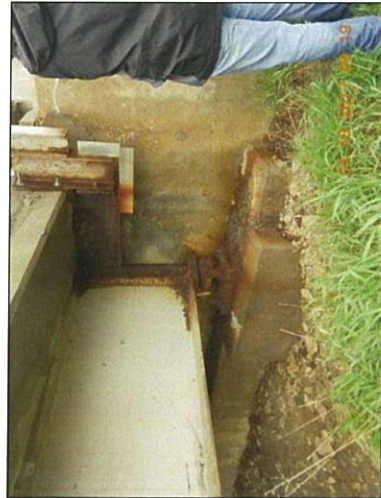
Span 11 Abutment 2 Girder 4 bearing

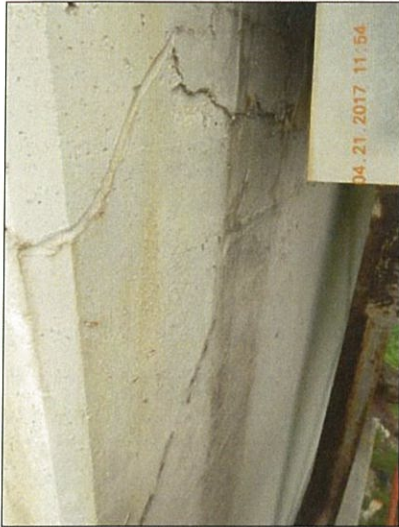
Abutment 1 South water marks from joint leakage

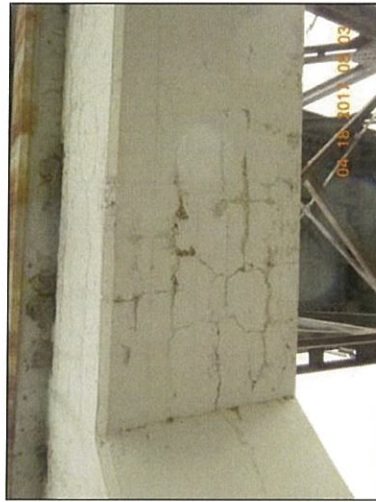
Pier 1 bottom of strut cracking closeup

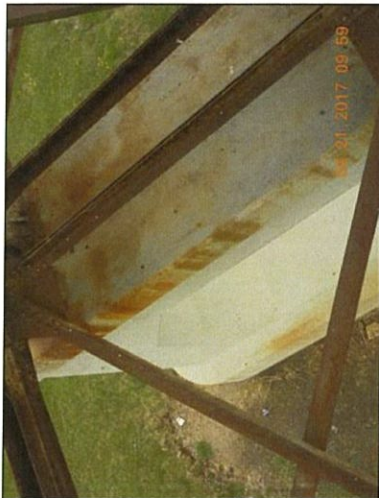
Pier 1 cap crack on West

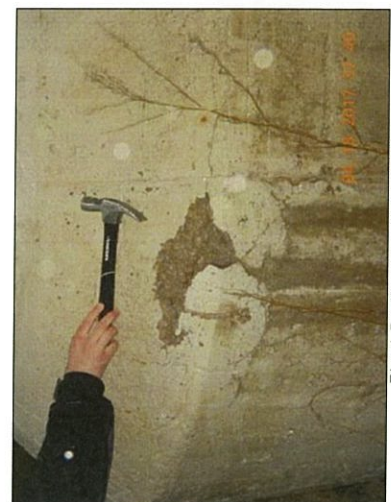
Pier 1 Southeast spall at bottom

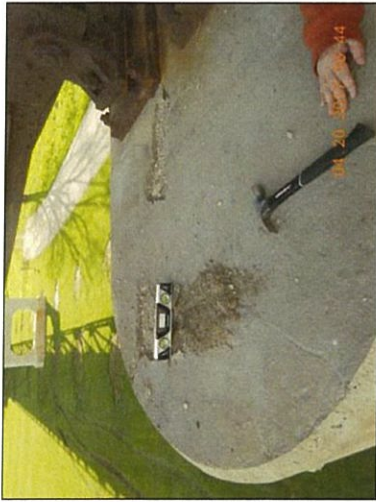
Pier 2 South cap deterioration closeup

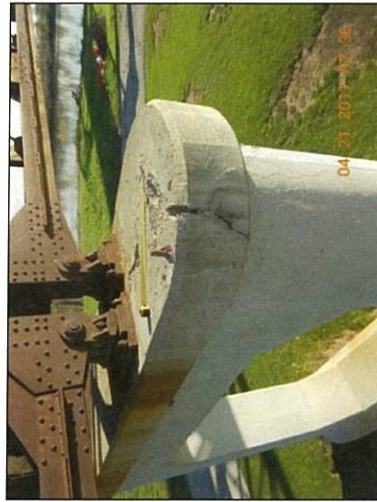
Pier 2 South cap deterioration

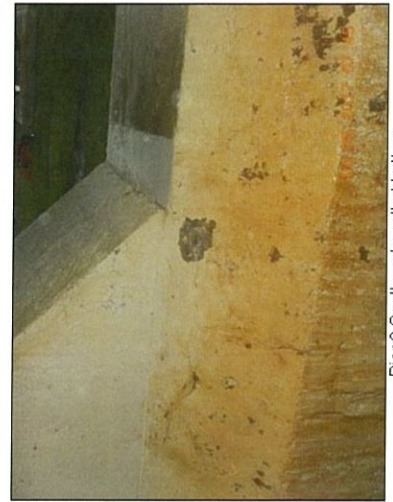
Pier 2 Southeast spall at bottom

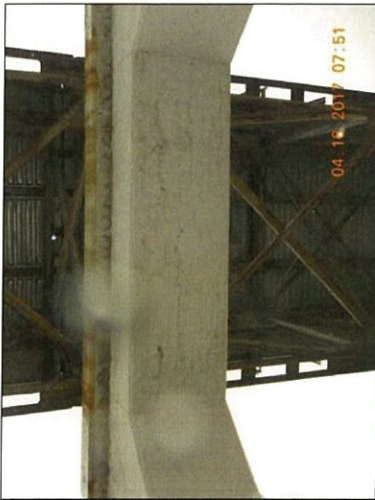
Pier 3 cracking on bottom of strut

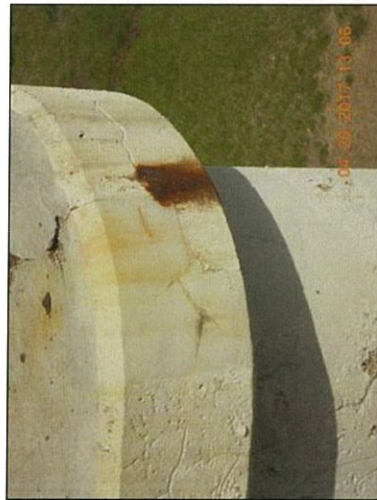
Pier 3 South cap cracking on West

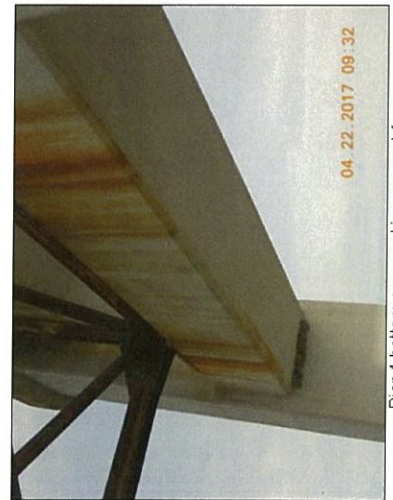
Pier 4 bottom cap cracking on west face

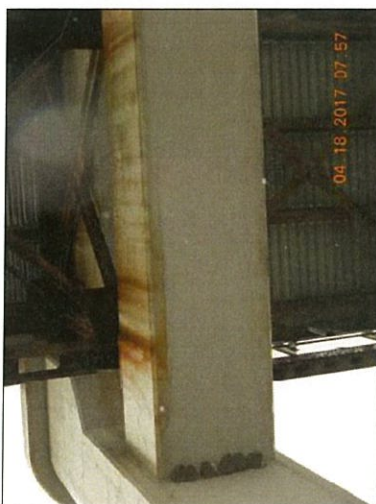
Pier 4 bottom of strut cracking

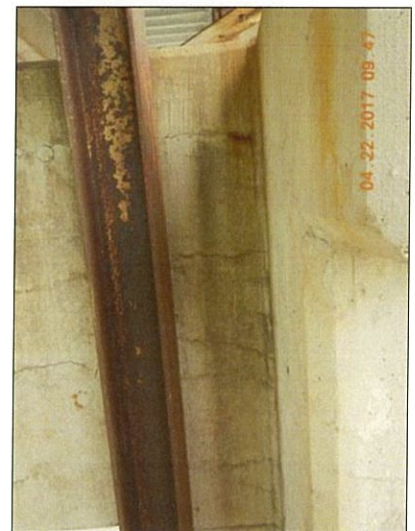
Pier 4 South water lines

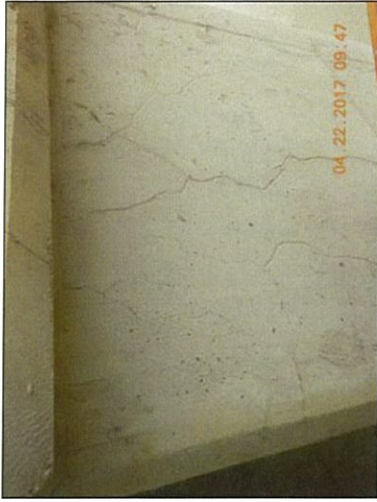
Pier 4 south west face cracking

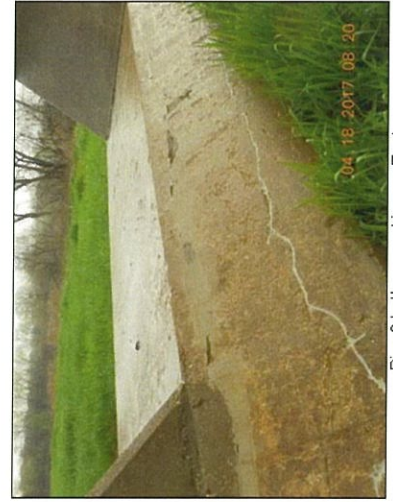
Pier 6 bottom cracking on East

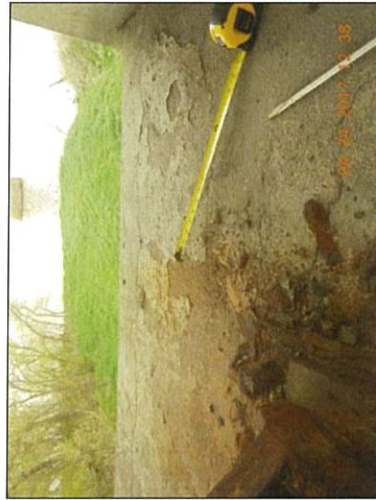
Pier 6 cap deterioration near Span 7 L0 Lt

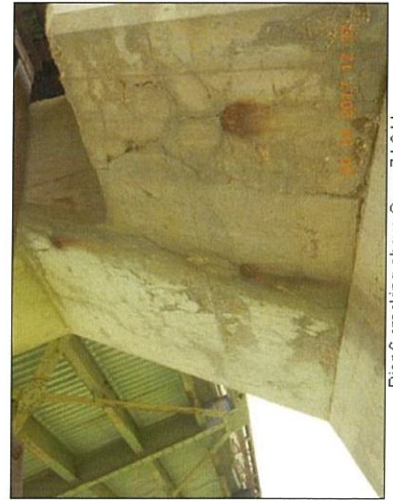
Pier 6 cracking above Span 7 L0 Lt

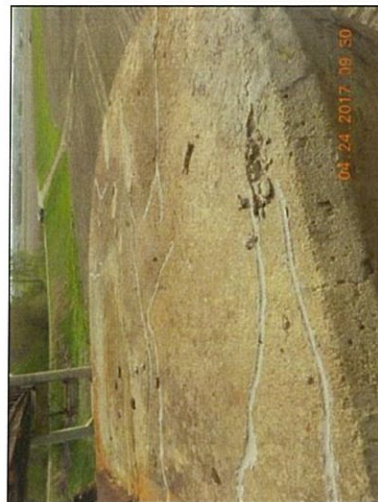
Pier 6 South end cap deterioration

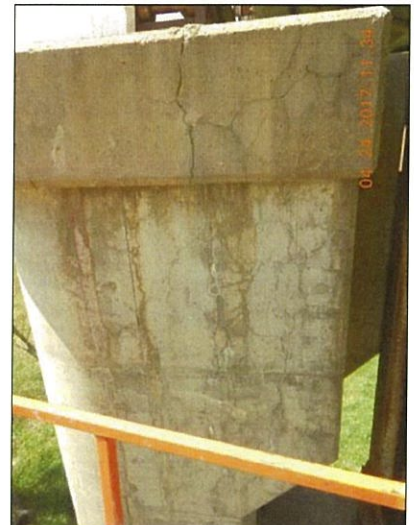
Pier 6 South end top deterioration on west face

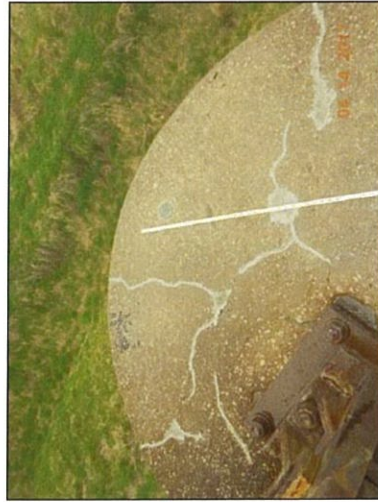
Pier 6 top cracking

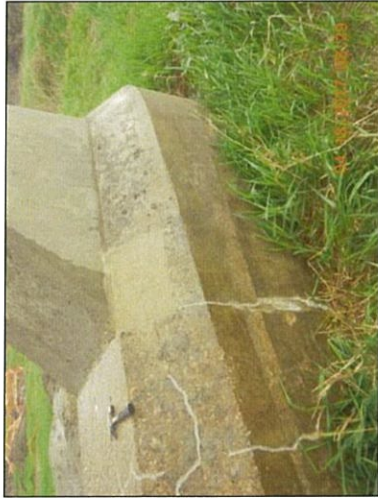
Pier 7 bottom efflorescence at Northeast

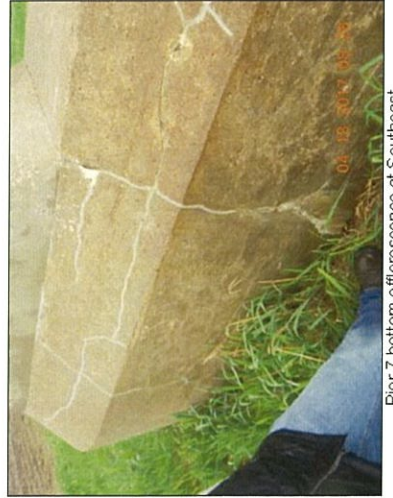
Pier 7 bottom efflorescence at Southeast

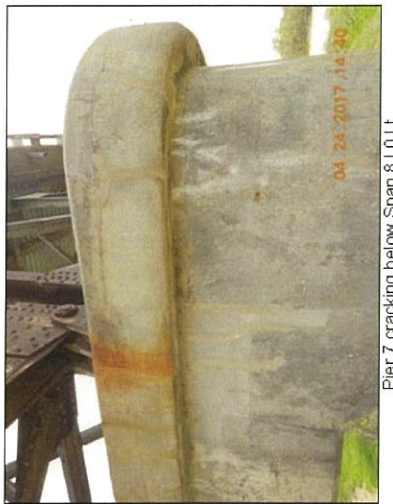
Pier 7 cracking below Span 8 L0 Lt

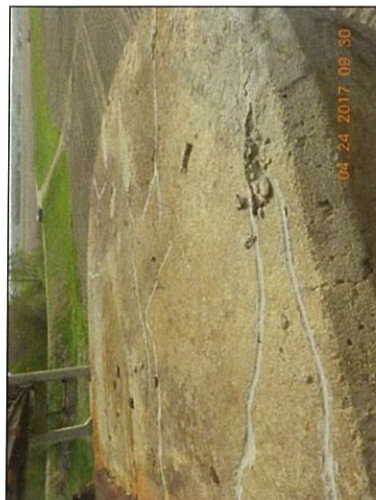
Pier 7 South end cap deterioration

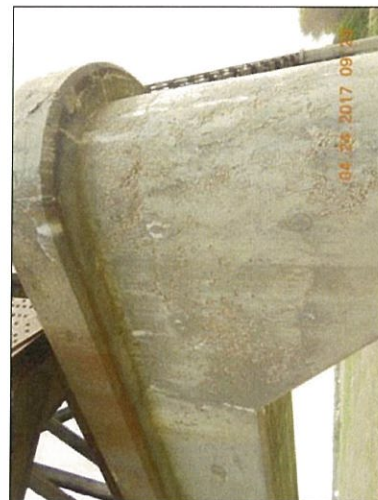
Pier 7 South end west face deterioration

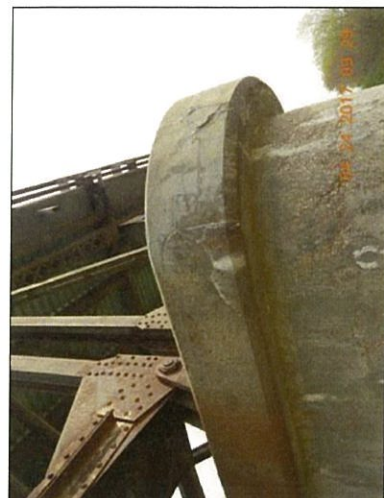
Pier 7 South end West face of cap deterioration

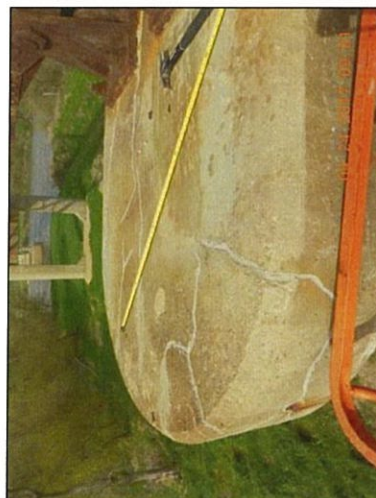
Pier 7 South top deterioration

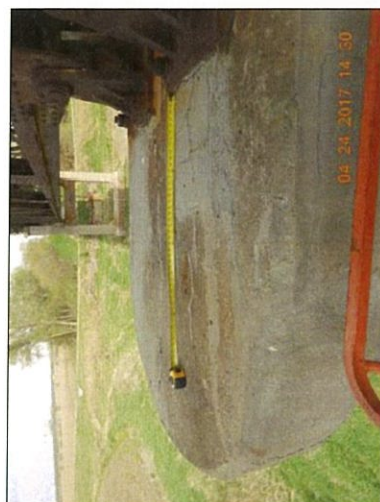
Pier 7 top deterioration

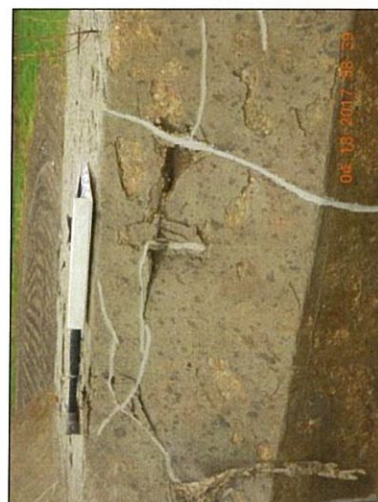
Pier 7 top north deterioration

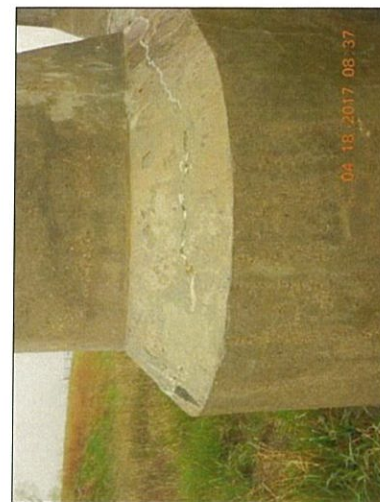
Pier 8 deterioration on Northeast

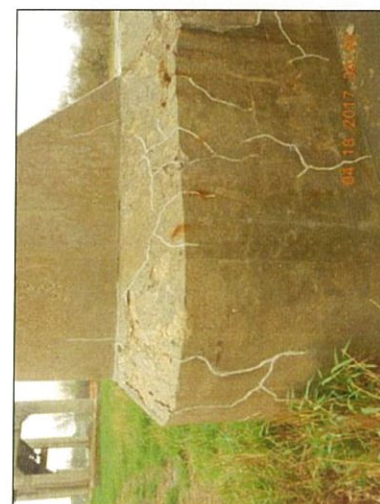
Pier 8 North interior face deterioration

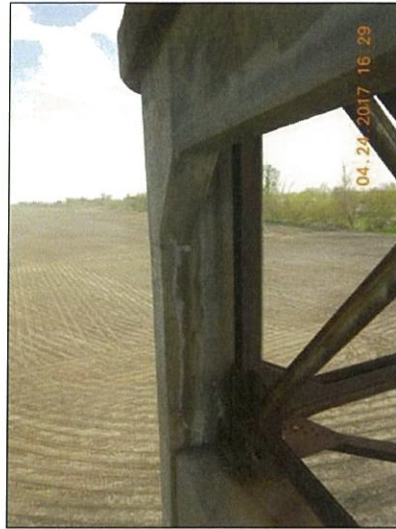
Pier 8 South end west face deterioration

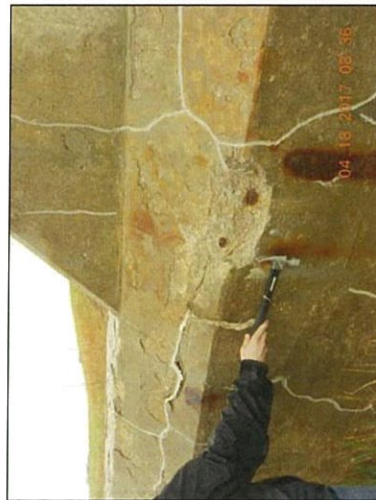
Pier 8 south top deterioration

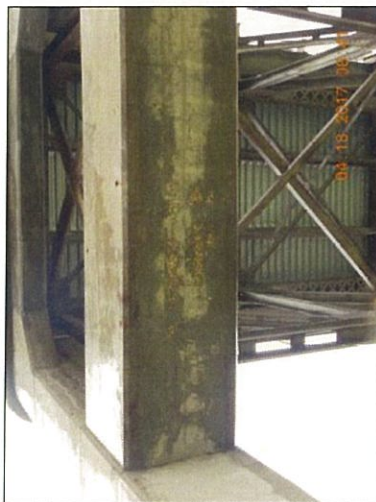
Pier 8 spill near L10 Lt

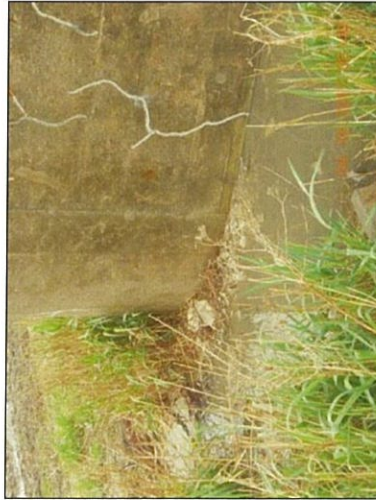
Pier 8 top of footing soft concrete and scaling

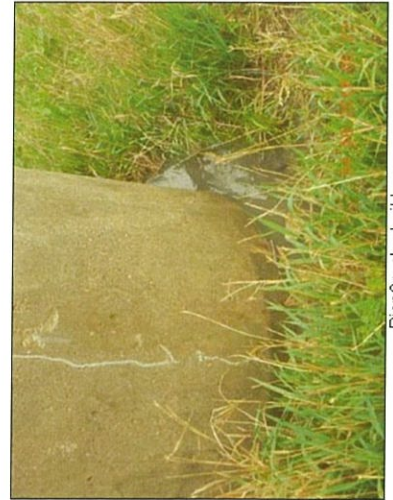
Pier 8 water buildup on South

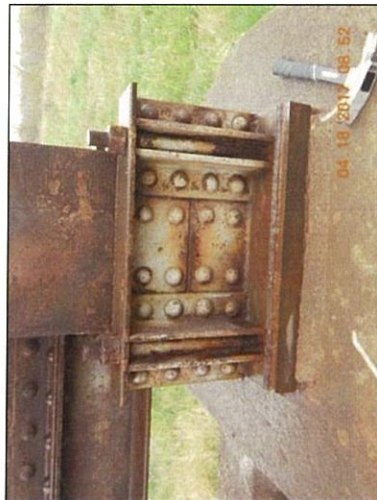
Pier 8 West efflorescence and deterioration

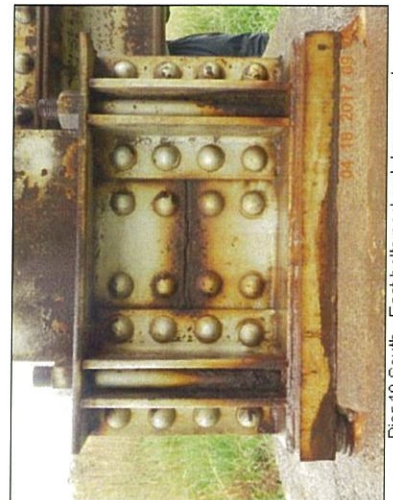
Pier 9 North - East bolts packrust

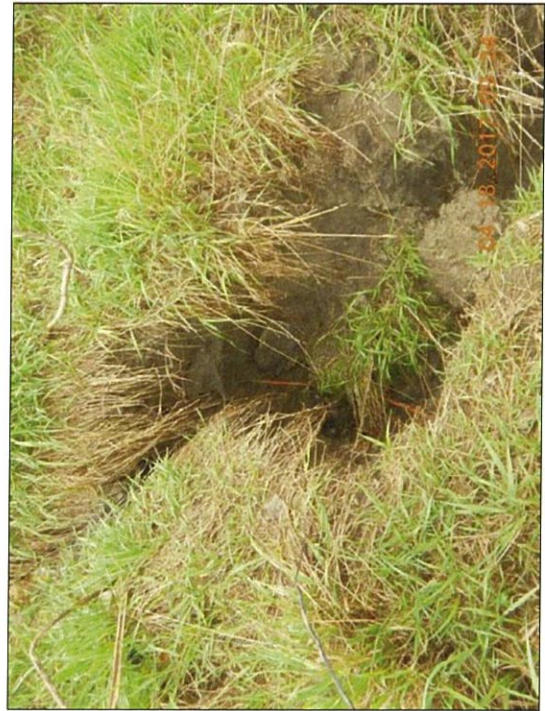
East approach erosion ditch on North measurement

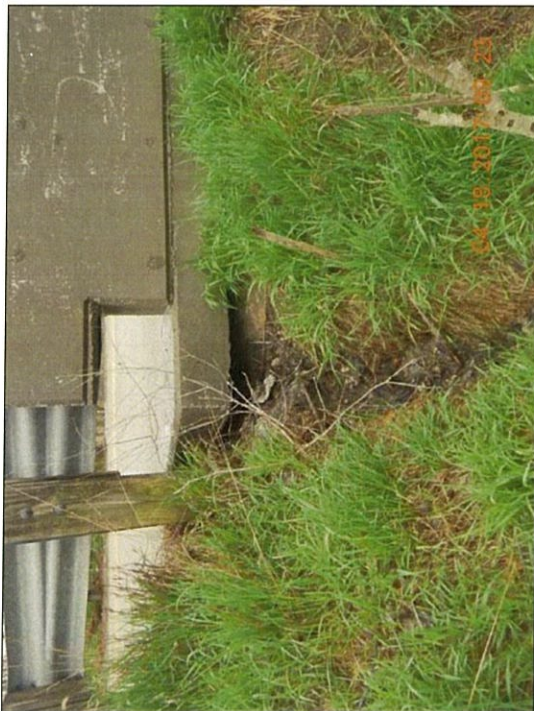
East approach erosion ditch on North

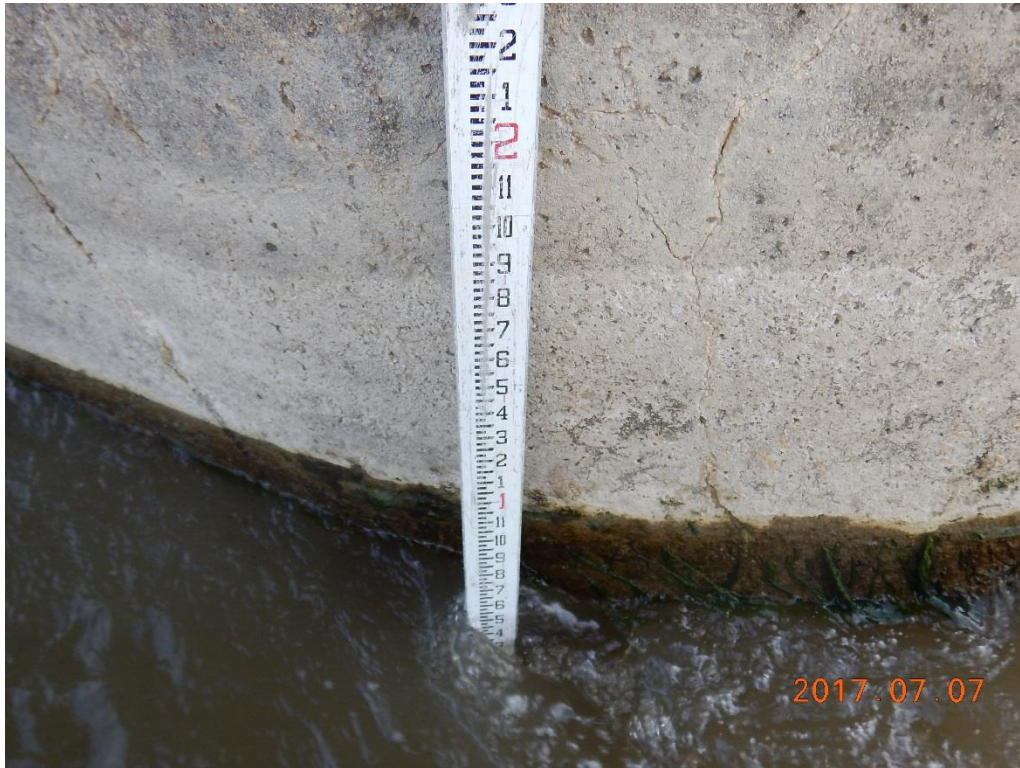
Typical Condition at Waterline

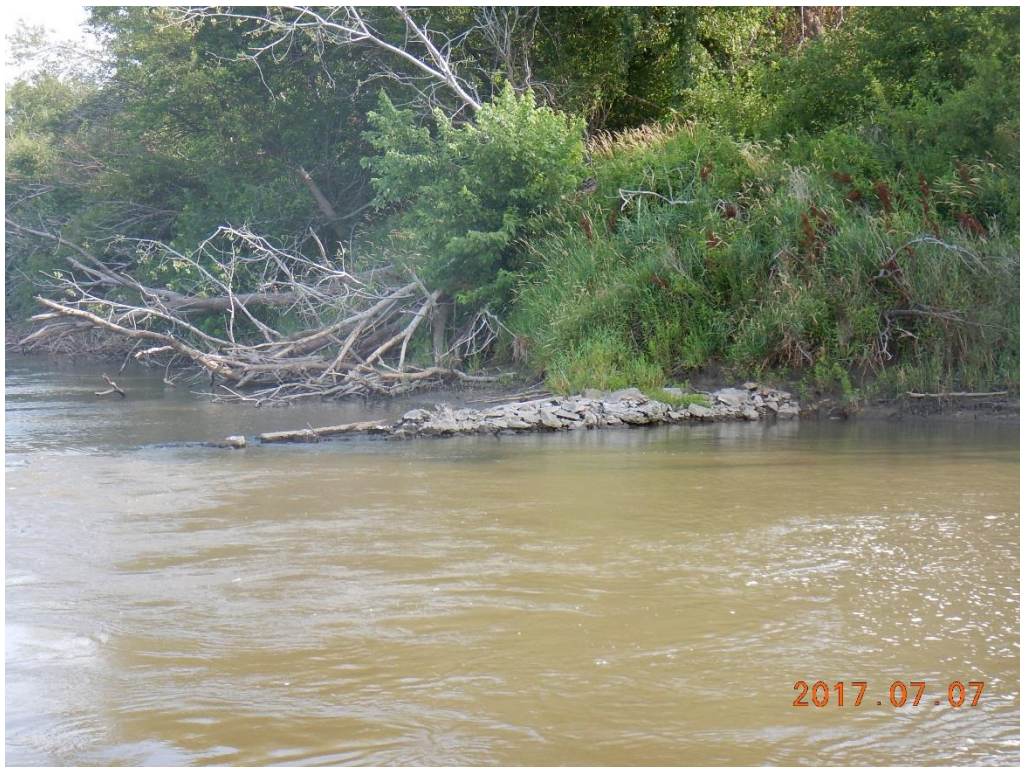
Spur Dyke at East Bank
